Subject: The Dalles North Fish Ladder Inspection
Contract No. W9127N-06-D-0009, Task Order No. 0004
Final Trip Report

**The Dalles Dam North Fish Ladder
Inspection Report**

JANUARY 2007

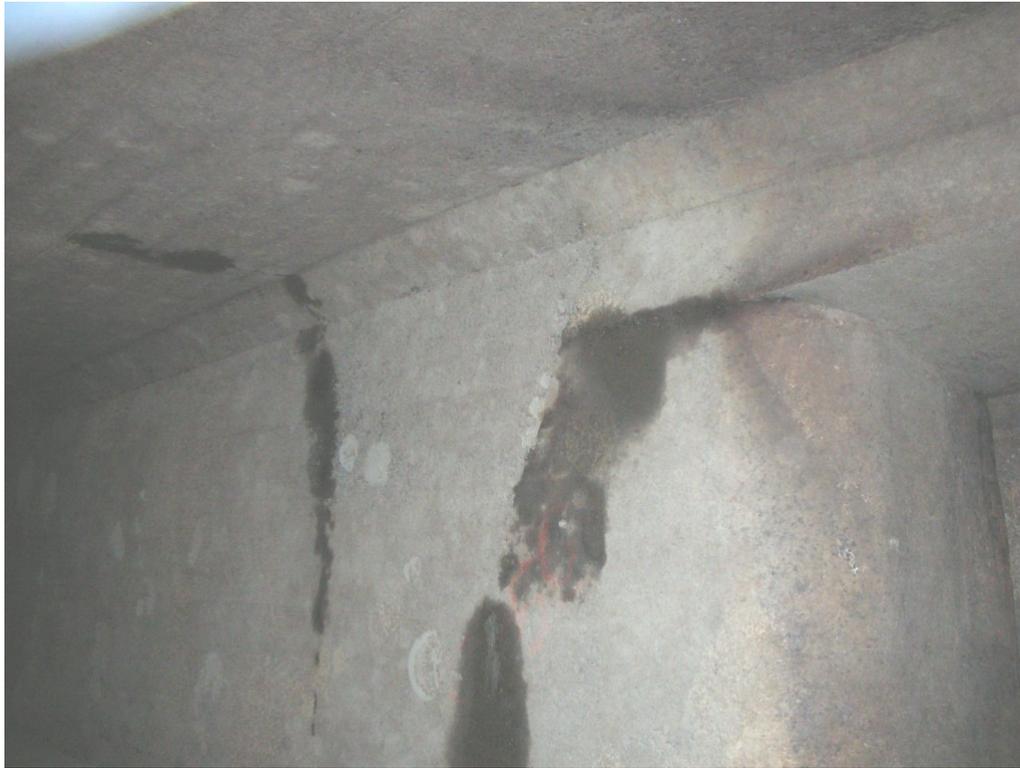
Structural concrete work within the water supply conduit appeared to be maintaining its integrity with mostly hairline cracking revealed by seeping water (Photo **CS-1**).

CS-1 Concrete Crack

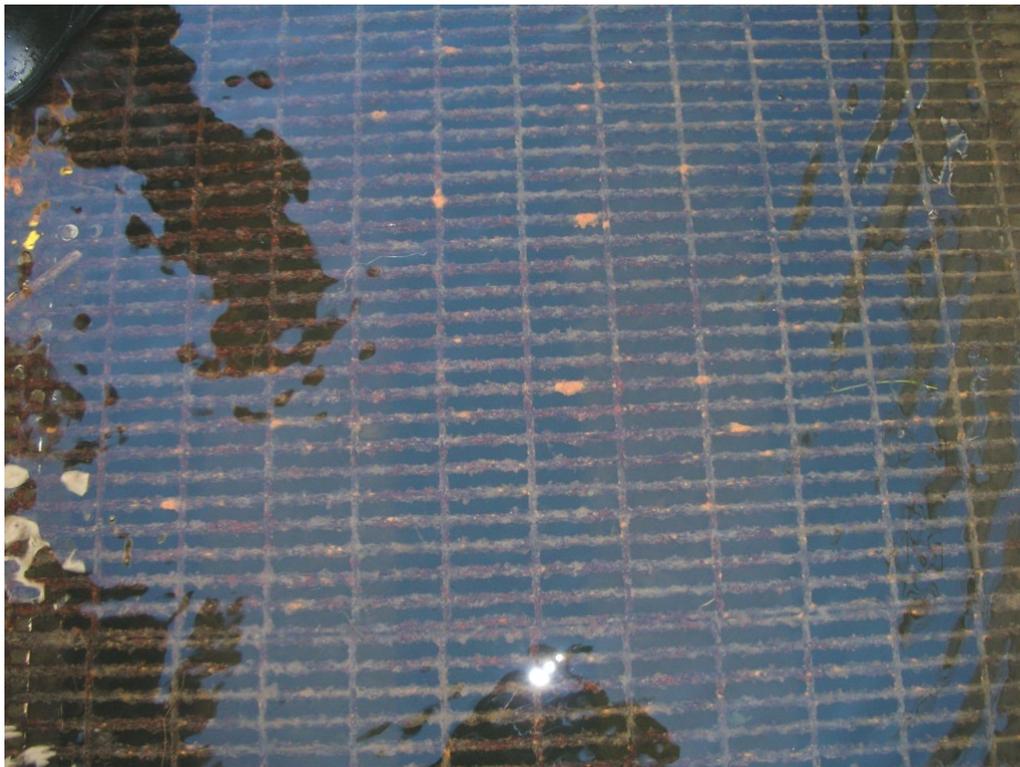
The condition of the various structural elements of the counting station appeared to be generally sound, although the floor diffuser grating appeared to be somewhat corroded (Photo **CS-2**). The District's fishery biologist stated that the diffuser grating just upstream of the counting station had 1-inch openings, which is too coarse to prevent Lampreys from falling or swimming through and getting lost in the exit section's AWS system. The District stated that future analyses will be conducted to determine how reducing the grating opening to prevent the passage of Lampreys and other fish may impact the hydraulics of the fish ladder.

CS-2 Diffuser Grating

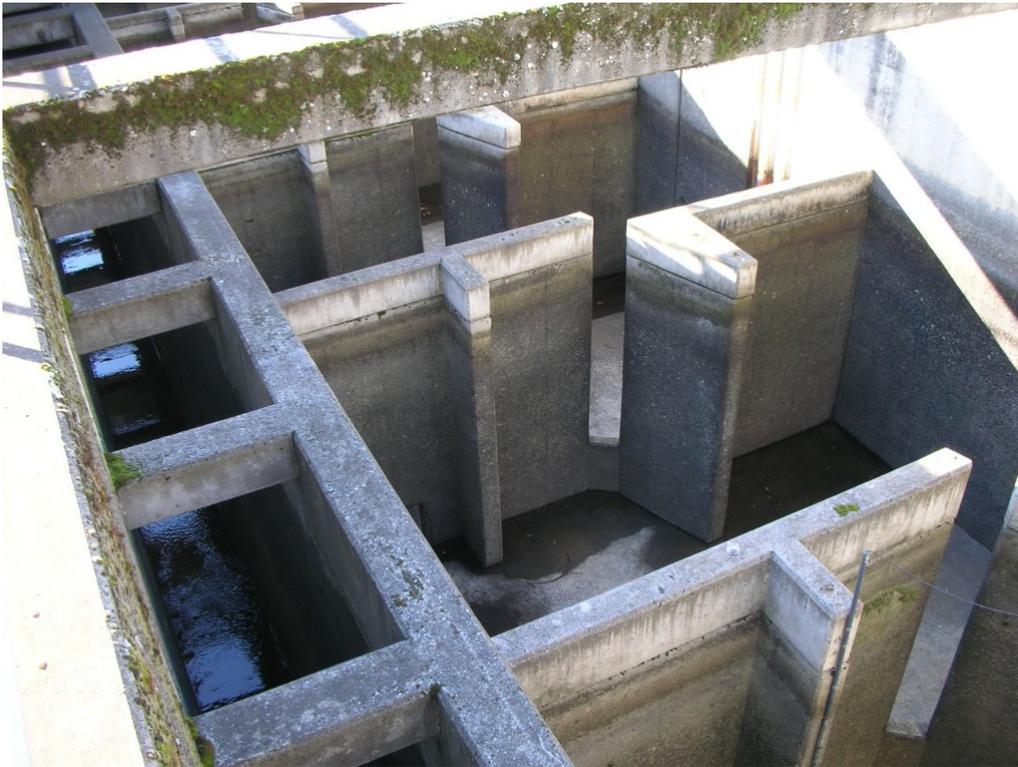
The ladder weirs appear to have been raised by the addition of concrete (Photo **C/S-3**). The walls of the ladder exhibit slight spalling of fines which is normal for concrete exposed to flowing water.

CS-3 Weir Extensions

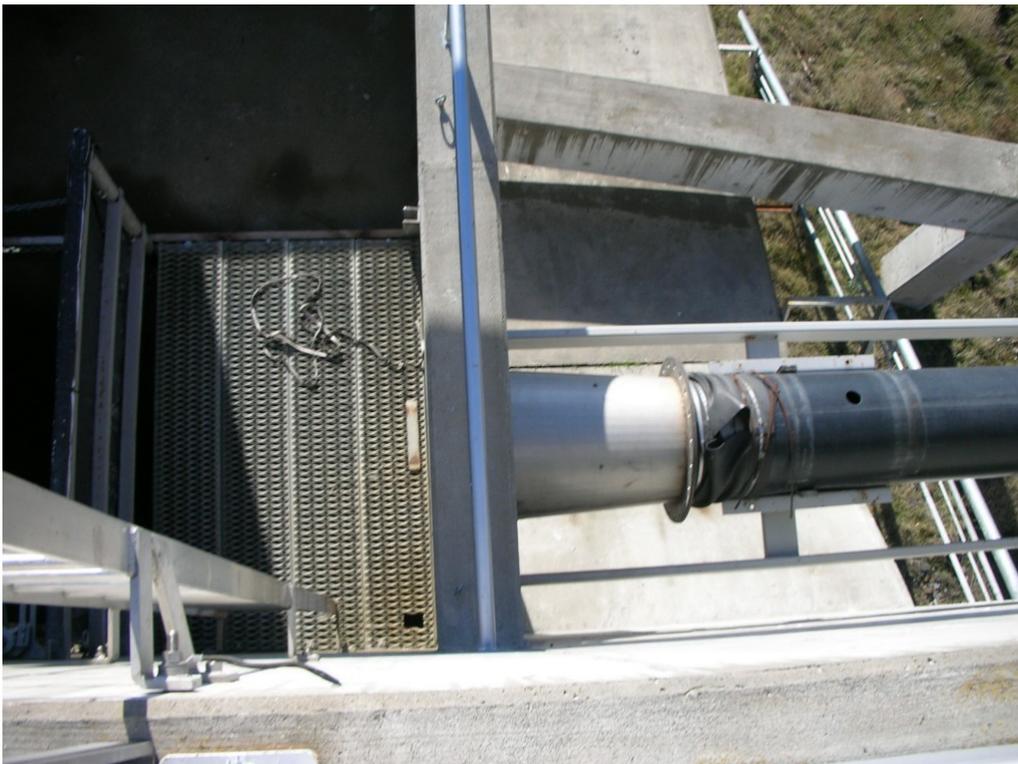
The upper end of the fish bypass pipe (Photo CS-4) is separating from the intake structure wall. The PUD intends to repair it.

CS-4 Fish Bypass Pipe

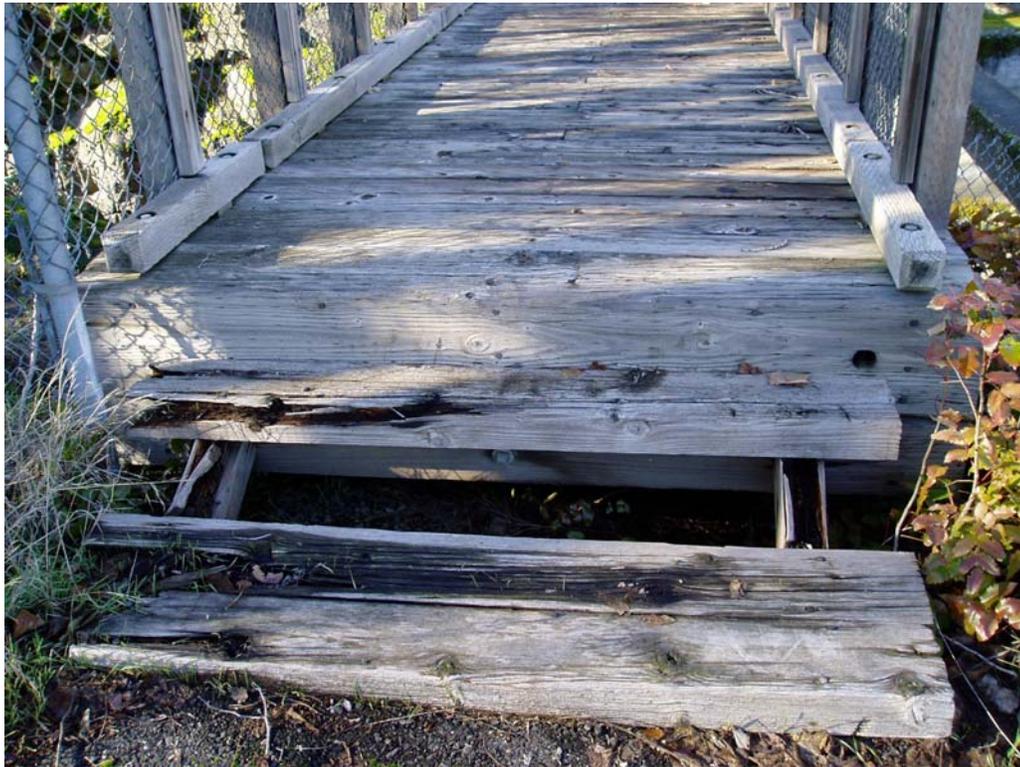
A step on the bridge crossing the transition was damaged (Photo **CS-5**).

CS-5 Crossover Bridge

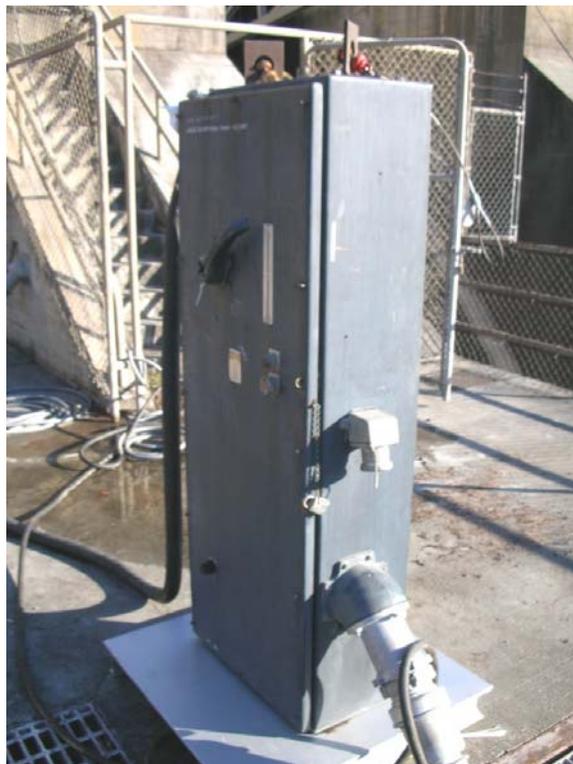
The water supply conduit dewatering pump control enclosure was located on the deck adjacent to the intake (Photo **E-1**).

E-1 Dewatering Pump Panel

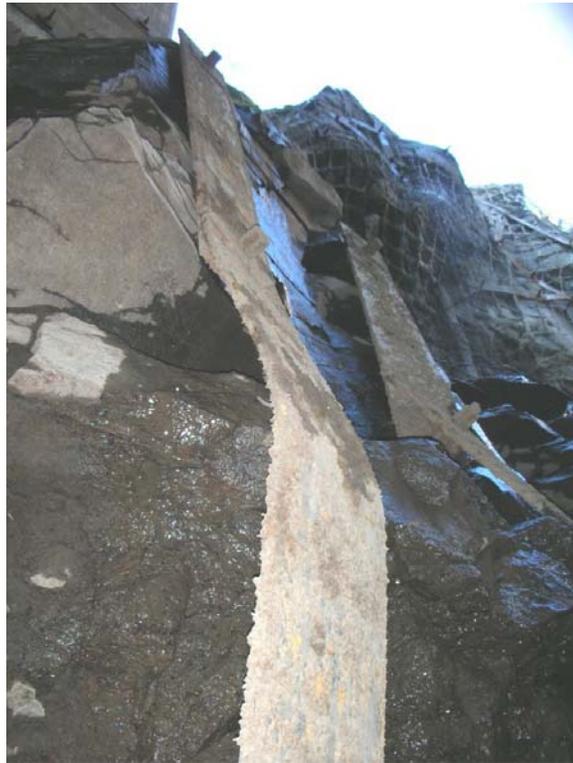
The rock anchors and strapping on the walls of the original AWS plunge pool (Photo **G-1**) were heavily corroded and appeared loosened from the rock face in places. It appeared that rock had fallen out from behind some of the strapping.

G-1 Plunge Pool Tiebacks

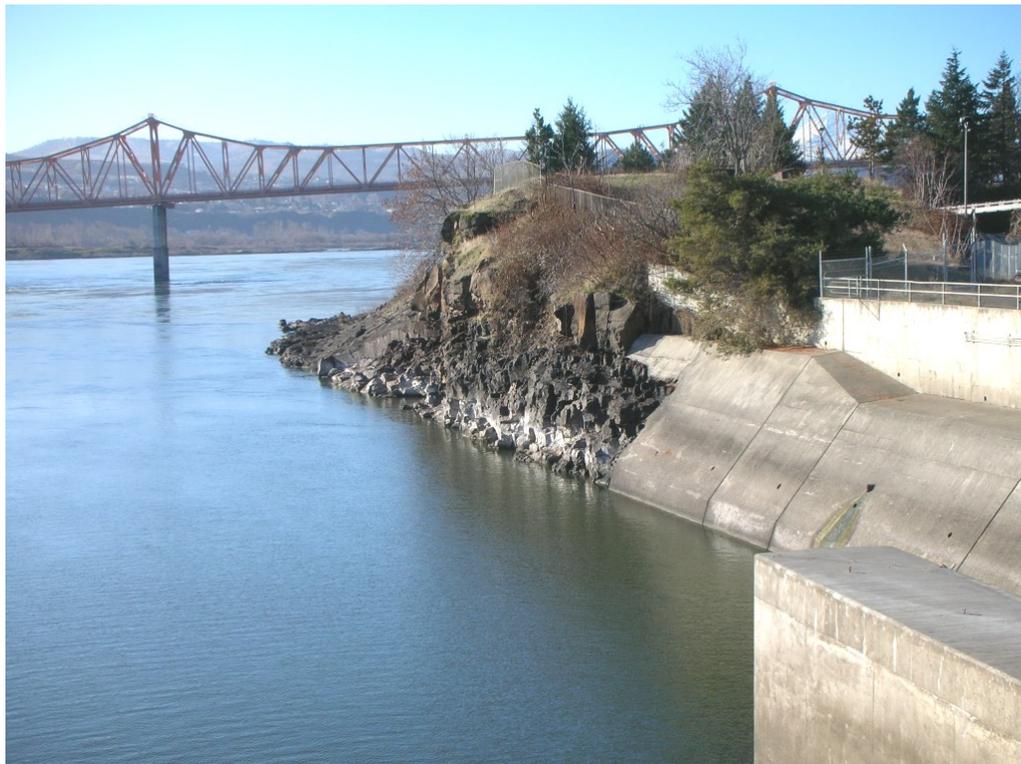
The north shore of the fish ladder facility was visible from this vantage point (Photo **G-2**). From a distance, the bank appears to be rougher than other rock cut slopes in the vicinity. The blocky, near vertical fracture pattern appears to be susceptible to plucking, possible due to the spill turbulence. However, there does not appear to be major local recession of the bank or evidence of caving.

G-2 North Shore View Looking Downstream

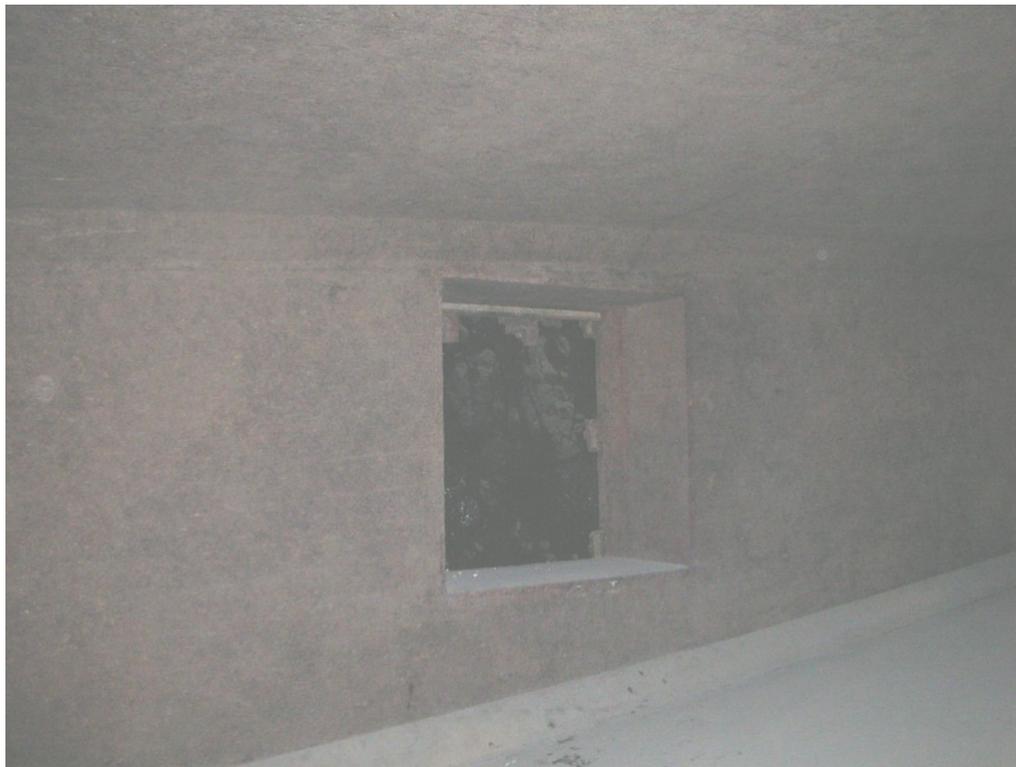
Staff reported that the diffuser outlet gates are designed to operate either fully open or closed. Several of the diffuser outlet gates were observed from units 10 through 15 and were fully open (Photo **H-1**). A few of the diffuser gates from diffuser units 15 through 19 were closed approximately 9 to 15 inches (Note: the project has since opened them). The upstream-most gate opening had been permanently sealed by a metal plate. The diffuser chambers beyond the gated openings are rough rock on the outside wall, much like that observed in the AWS pool and the rock portion of the fish ladder, with considerably higher roughness than the inner concrete walls.

H-1 Diffuser Gate

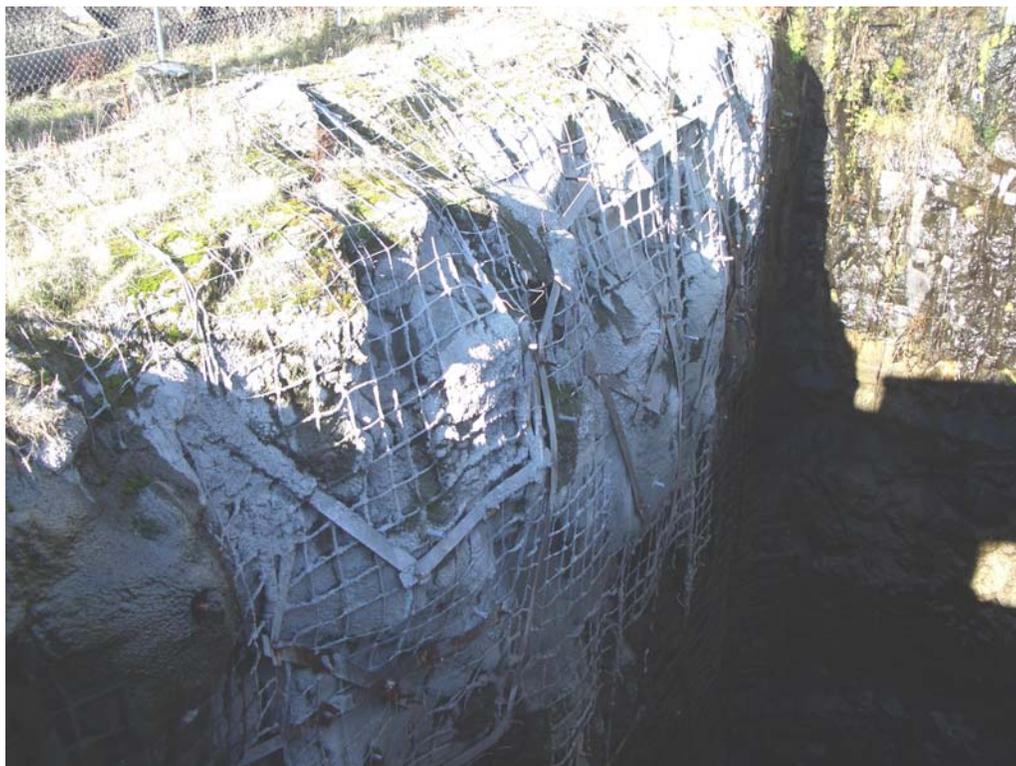
The junction between the original AWS plunge pool and the diffuser conduit was observed from the downstream side. Several structural reinforcements were noticed as described in the geotechnical notes. A view of the plunge pool from the upstream side is shown in Photo **H-2**.

The plunge pool was observed from above as shown in Photo **H-2** previously. The plunge pool structural issues are described in the geotechnical observations section and were noted during the hydraulic inspection.

H-2 Original AWS Plunge Pool

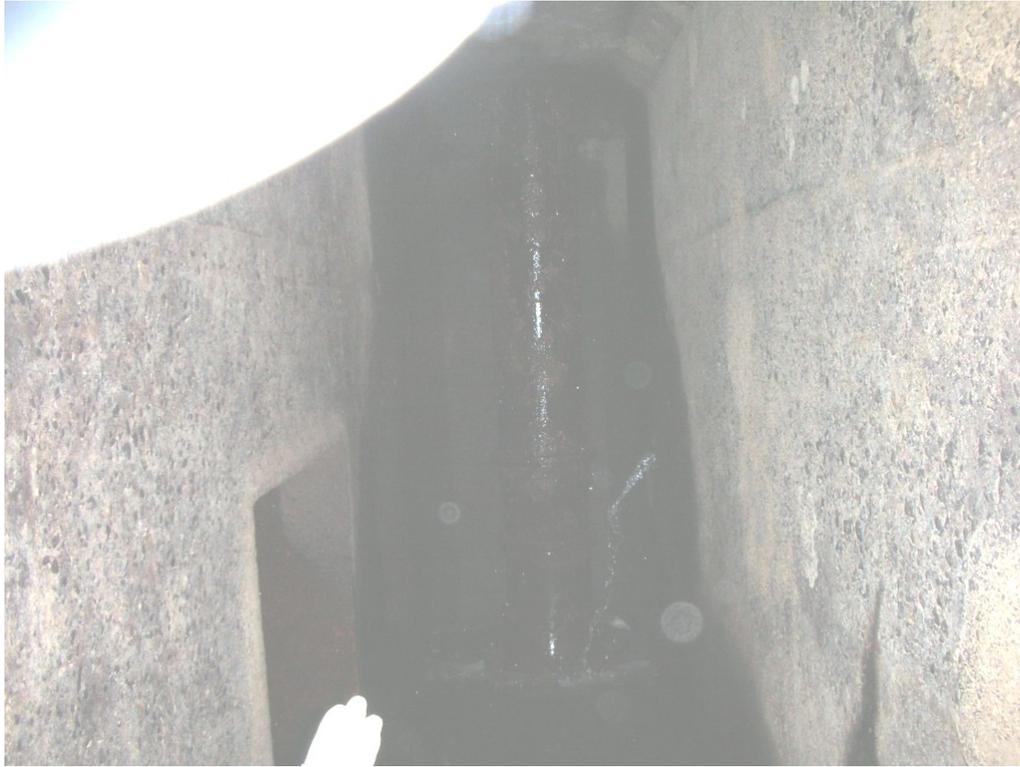
The conduit dewatering pump was operating at the downstream end of the dewatering conduit and 12 to 15 inches of water was present in the conduit (Photo **H-3**).

H-3 Conduit Dewatering Pump

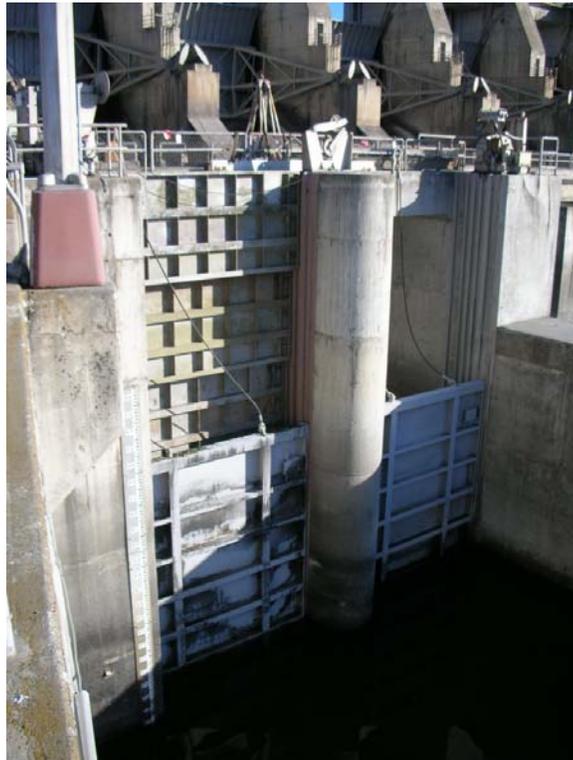
Based on discussions with staff, the N-1 weir is currently being repaired. Maintenance issues have included problems with the hoist cables, the rollers on the weir leaf sides, and the infrequent operation of the lower leaf due to high tailwater elevations. Some of the hoist cable problems have been remedied using a new spreader beam arrangement for operation and hydraulic operation of the entrance weirs has been effective. The weir leaves for N-1 and N-2 are interchangeable with those used for the EFL. The weirs are operated greater than 8 feet below tailwater to achieve a channel to tailwater differential of one foot to two feet under normal operating conditions. Optimum differential is 1.5 feet. Normally, the channel to tailwater differential is 1.3 feet. The closed entrance weirs at N-1 and N-2 are shown in Photo **H-4**.

H-4 Entrance Weirs

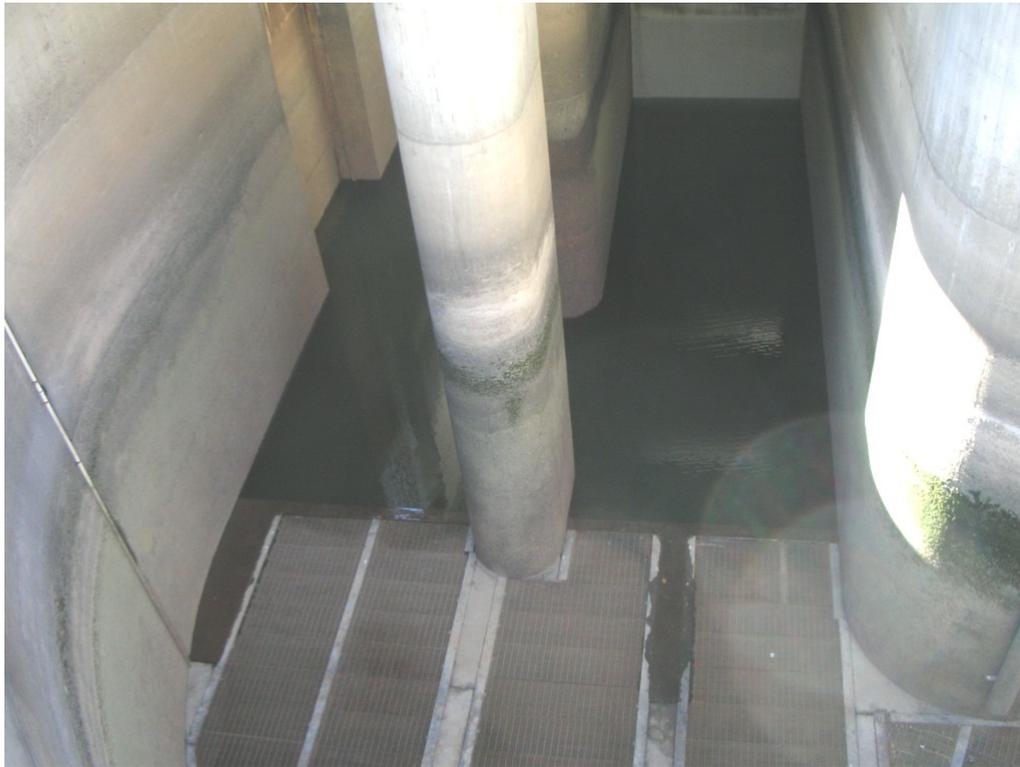
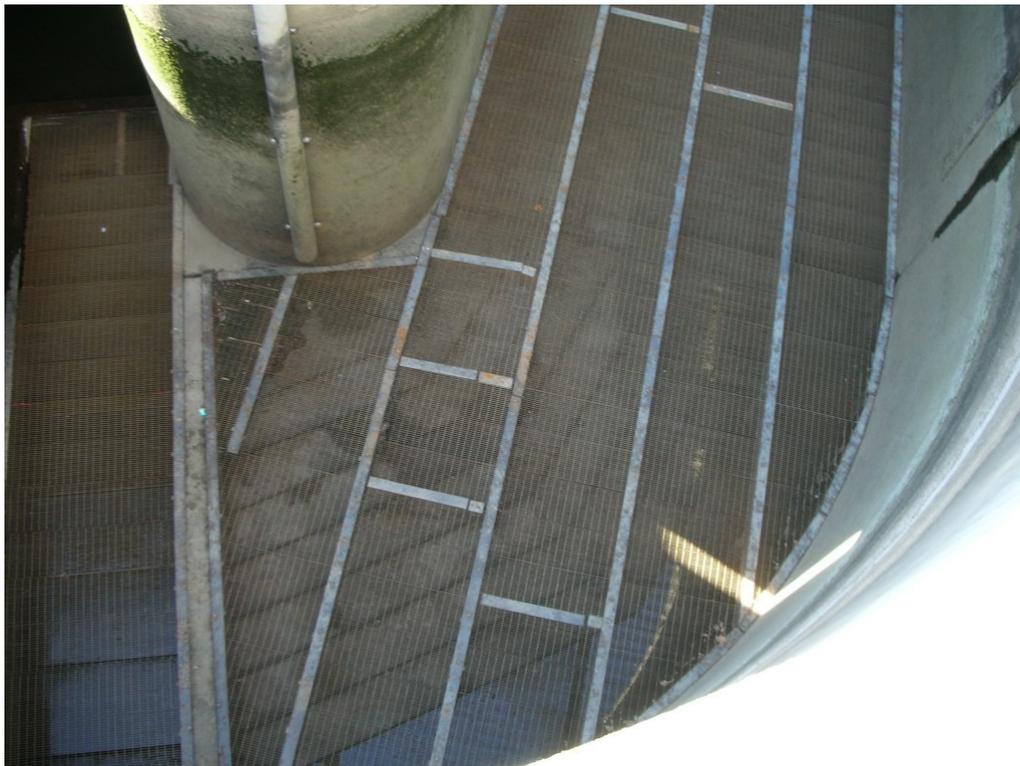
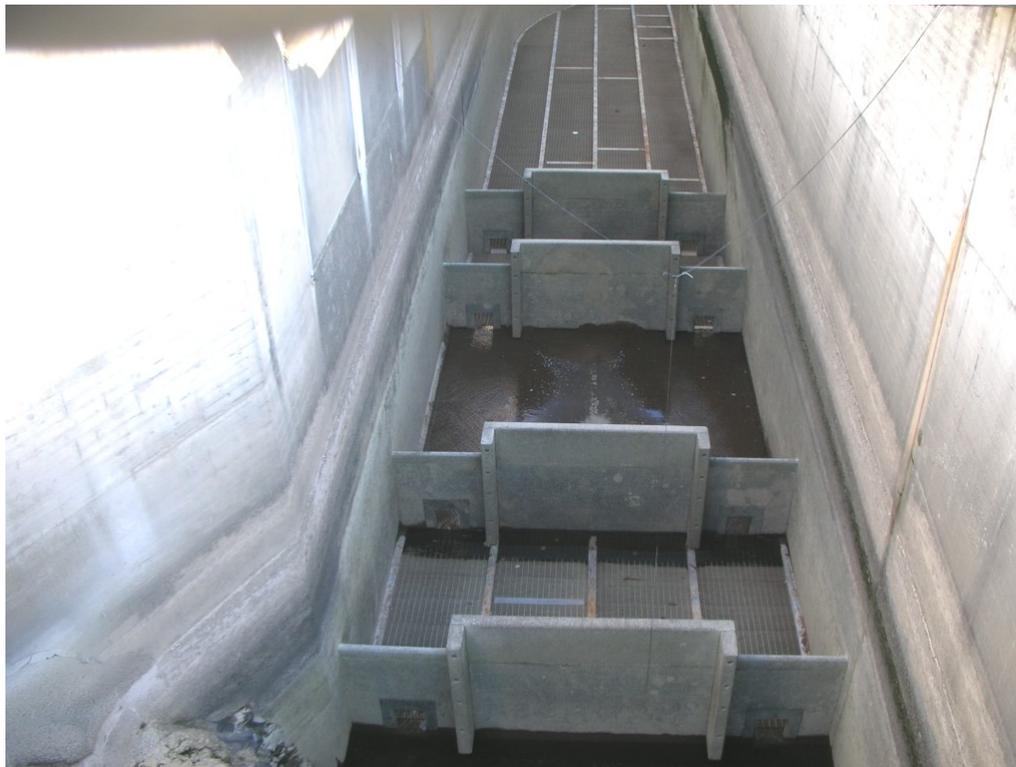
Just upstream of the entrance weirs, the diffuser grating for the AWS system is visible in Photos **H-5**, **H-6**, and **H-7**. The diffuser grating has approximately 1-in by 4-in openings and appears to be in satisfactory condition with plating securing the grating to prevent lifting in the flow. We were only able to view this area from above, not in the ladder channel due to access constraints.

H-5 Entrance Pool Floor Diffuser Grating

H-6 Entrance Pool Floor Diffuser Grating

H-7 Floor Diffusers and Weirs

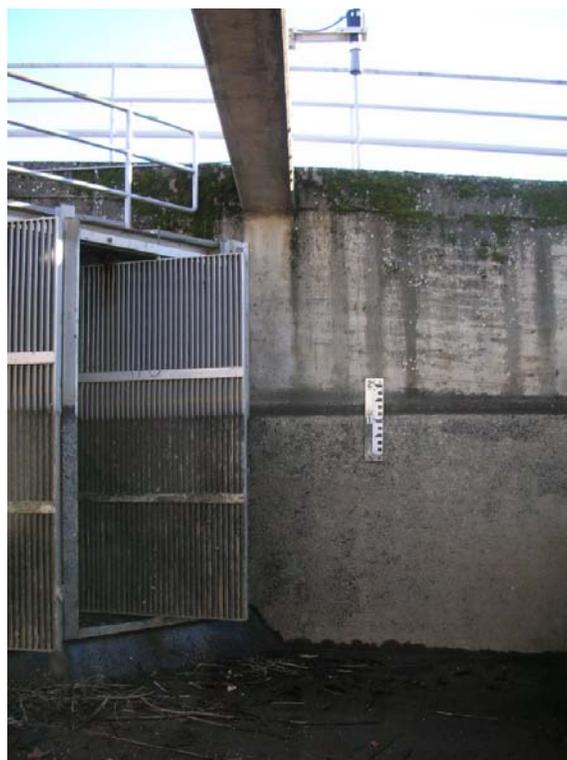
During the crowding operation, picket gates (Photo **H-8**) exclude fish and allow water to pass downstream past the counting station and appeared adequate hydraulically. The opening size on the pickets may be wide enough to allow lamprey to pass through the pickets rather than through the crowder and miss the counting window. Observations about the flow control section and the associated auxiliary water are provided in the Ladder Exit Section.

H-8 Picket Leads at Counting Station

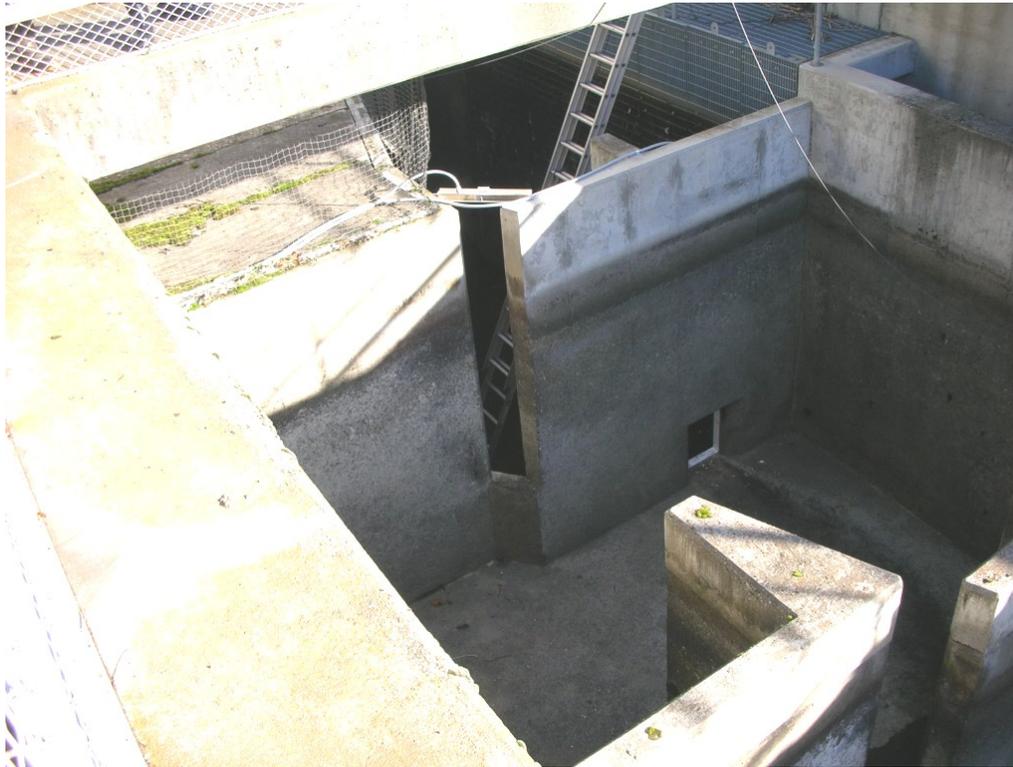
Flow enters from the forebay into the modified flow control section and passes through a slotted weir and orifice section with PIT tag detectors on the slot and orifice (Photo H-9). Flow then passes through a series of slotted weirs with orifice openings. Each weir has a different slot height (Photo H-10). We walked through the entire flow control section and the slotted weirs and orifices appear to be in satisfactory hydraulic condition.

H-9 Exit Section Flow Control Weirs Looking Upstream

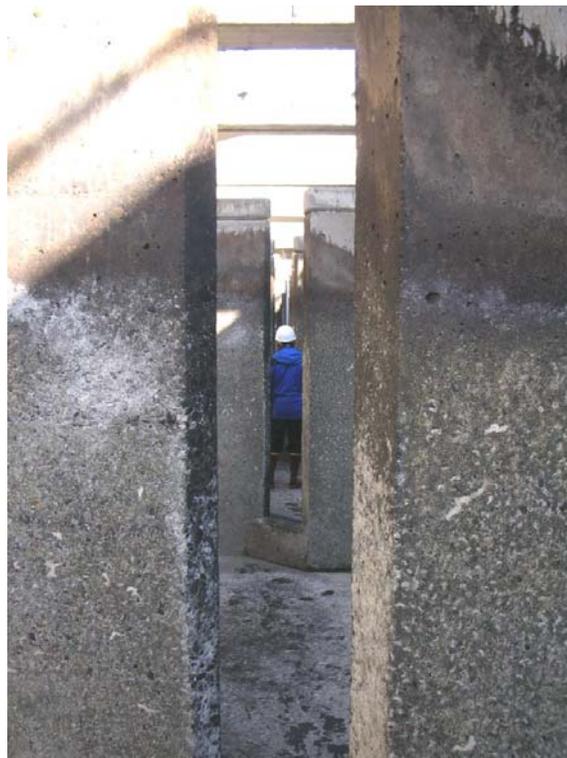
H-10 Vertical Weir Slot Looking Upstream

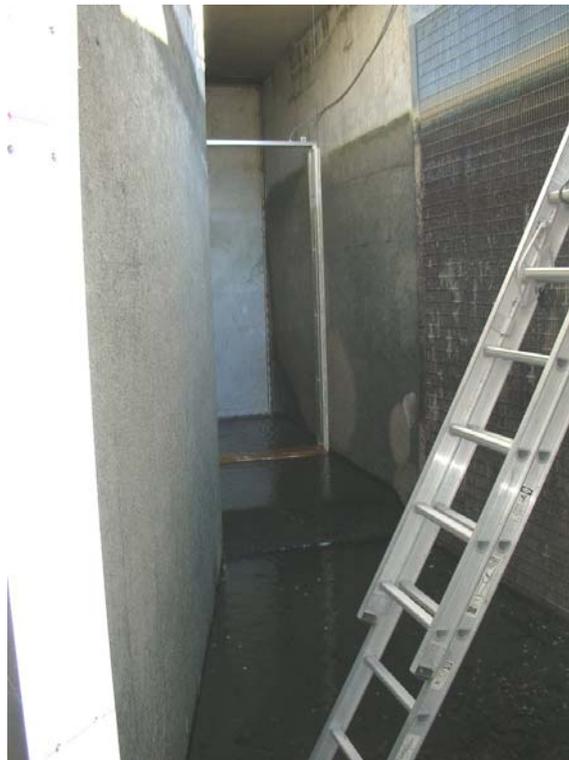
The auxiliary water supply system for the flow control system draws water through the grating shown in Photo H-11 at the upstream end of the flow control section and diffuses flow through the floor grating just upstream of the counting section (Photo H-12). Both areas of grating are 1-in by 4-in grating and have reduced open area due to significant corrosion.

H-11 Fish Channel Exit

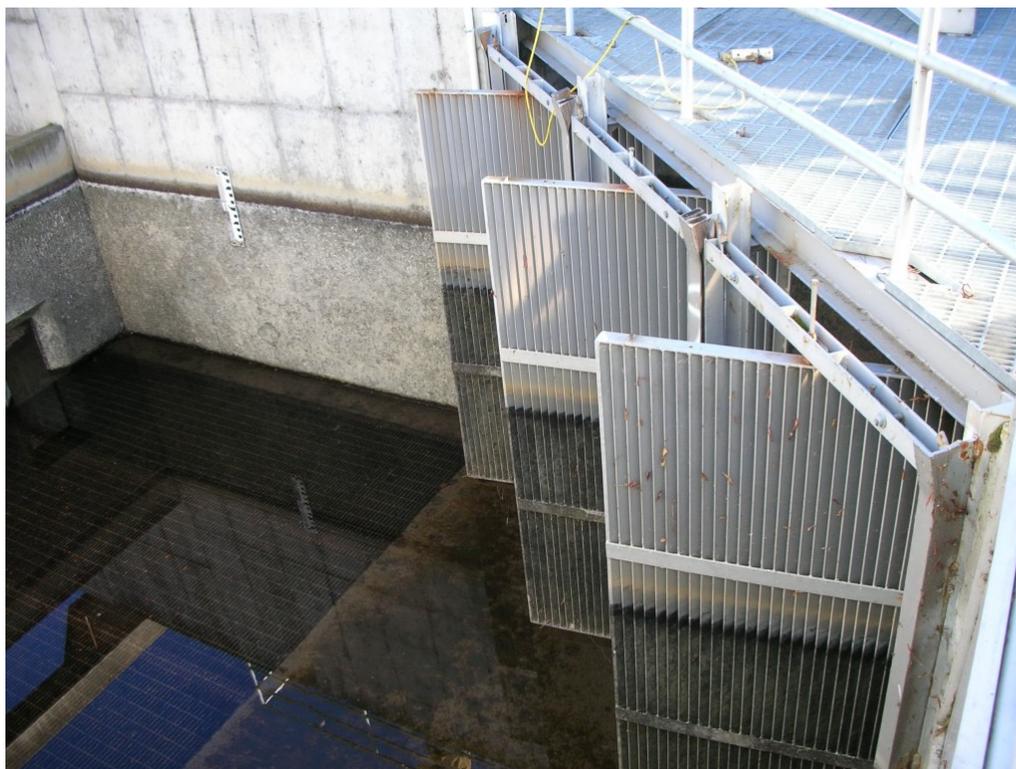
H-12 Counting Station Floor Diffuser Grate and Picket Leads

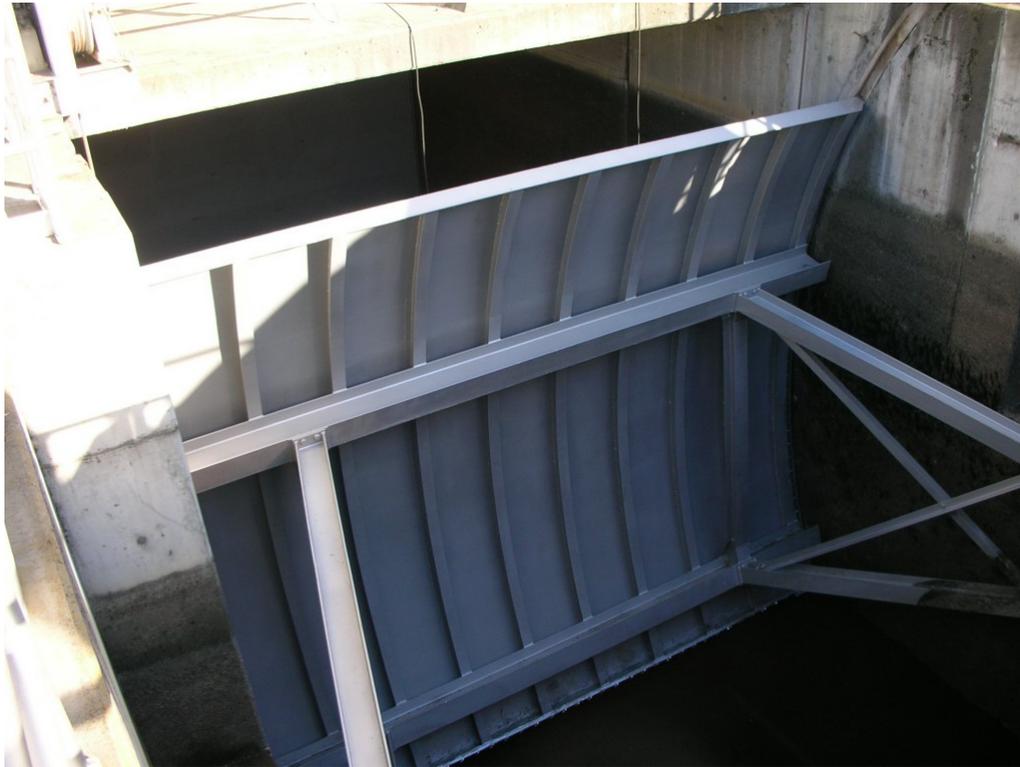
The AWS tainter gate shown in Photo **H-13** and the fish channel structure were observed from above. The fish screen was not visible from above and was not accessed during the trip. The tainter gate has new side seals and staff reported that the gate operation is improved with the new seals.

H-13 Tainter Gate

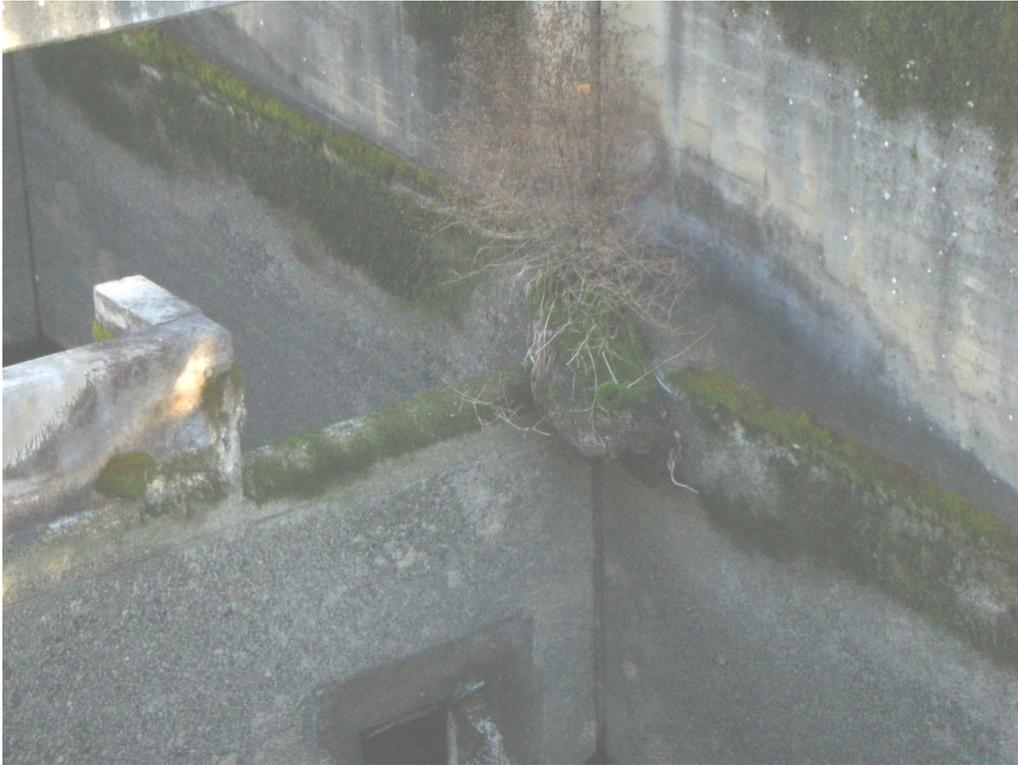
Just upstream of the transition to the rock-lined channel, a root wad was observed growing into the weir opening on one of the ladder weirs (Photo **H-15**). The operating water line is also visible in Photo **H-15** at the mossy line, with a gray line extending above the water line from splash and/or the higher operating levels for shad migration.

H-15 Root Ball in Channel

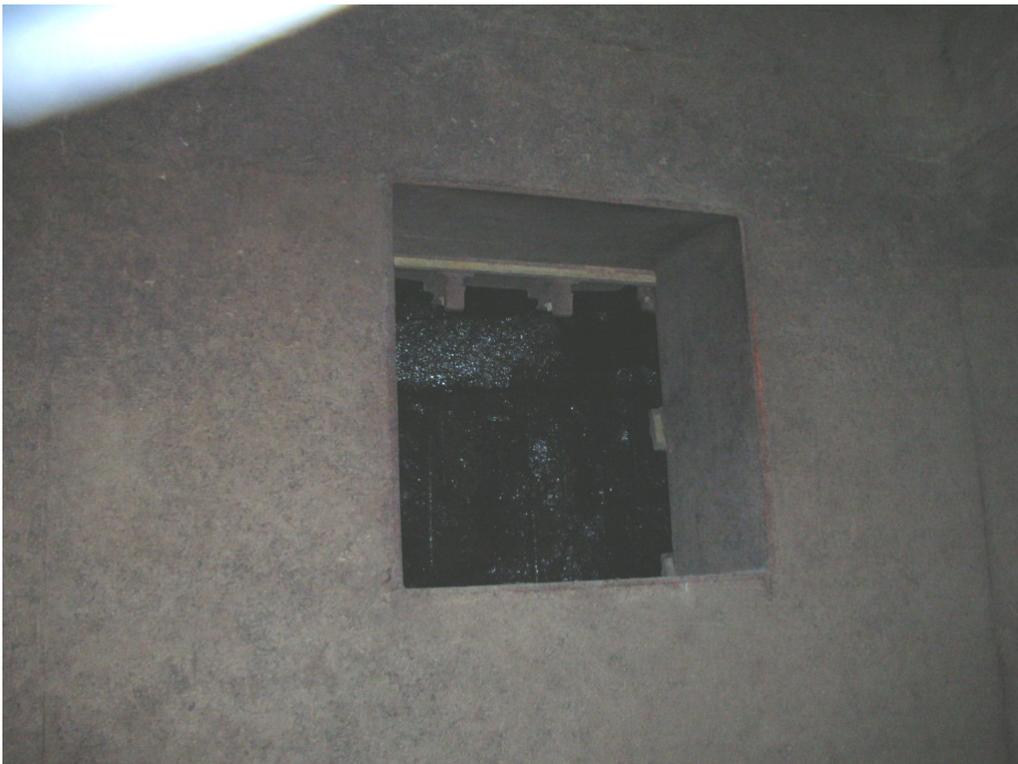
It was reported that the slide gates in the lower section of the water supply conduit (Photo **M-1**) are designed for unseating head and therefore need to be fully open or fully closed in order to operate correctly. A few of the gates downstream of Unit 15, however, were observed to be partially open. It was unclear whether this indicated that the gates were stuck, or if they were intentionally placed in a partially open position (Note: the project has since opened them).

M-1 Diffuser Gate Opening In AWS Chamber

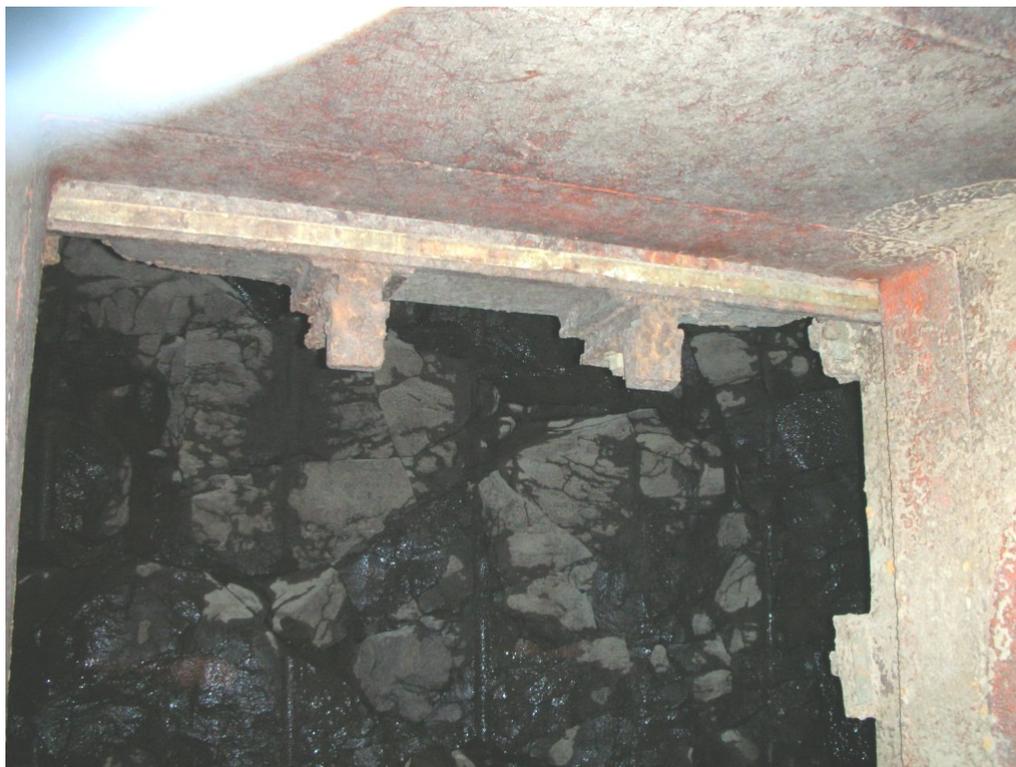
Considerable corrosion was evident on the gates (Photo **M-2**). The PUD operator advised that the gates were exercised within the past year, and that normally they are left in a fully open position.

M-2 Diffuser Gate Corrosion

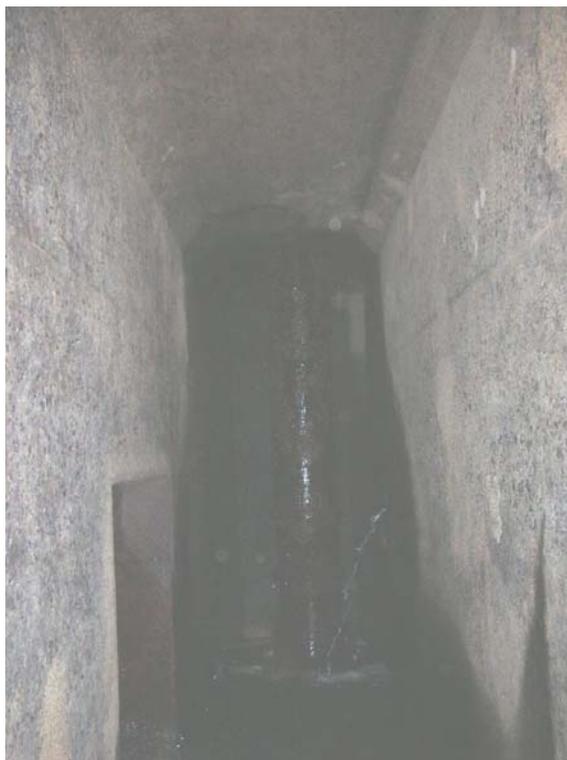
A submersible centrifugal pump is located in a pipe well at the downstream end of the water supply conduit (Photo **M-3**) and is used to dewater the conduit for inspection and maintenance purposes. The pump was operating during the inspection to remove water that was seeping from the river into the water supply conduit.

M-3 Conduit Dewatering Pump

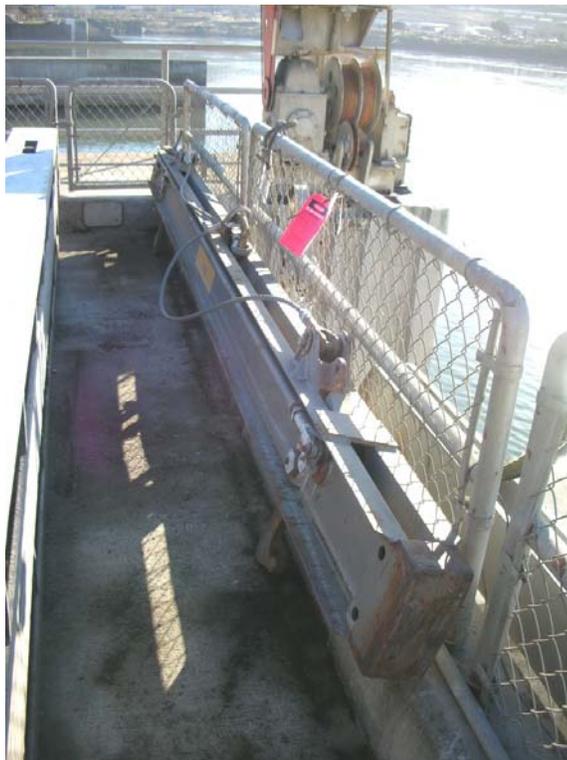
The District and the PUD agreed that their current number one need is to obtain a new set of entrance weirs. They also shared that the guide rollers for the original weirs were thought to be damaged by pulsating water from the adjacent spillway, which made raising the leaves difficult, that the leaves often became disconnected from each other when being raised, and that the hoist's wire ropes had failed in the past, possibly due to vibration or being submerged for long periods. The method for lifting the leaves was improved by adding a lifting beam (Photo **M-4**).

M-4 Entrance Weir Lifting Beam

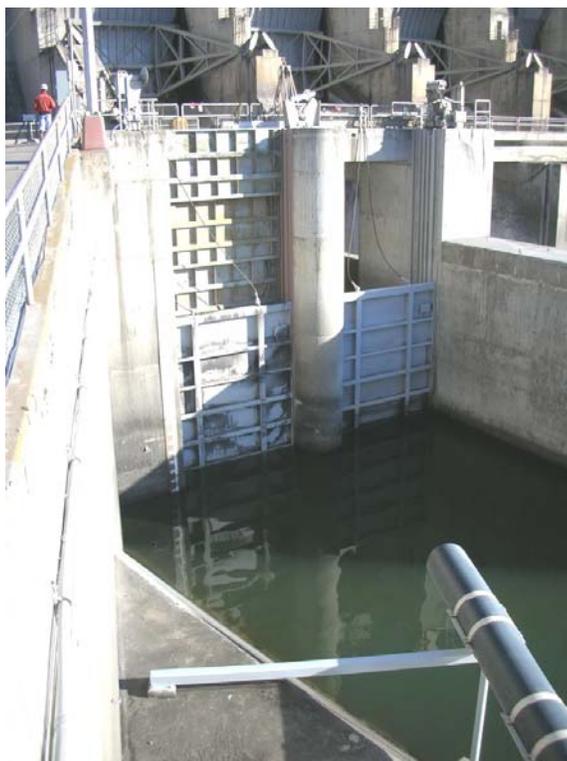
Steel bulkheads were installed in weir gate bays N-1 and N-2 during the inspection (Photo **M-5**). The gate leaves were evident in N-1, but missing from N-2.

M-5 Entrance Weirs

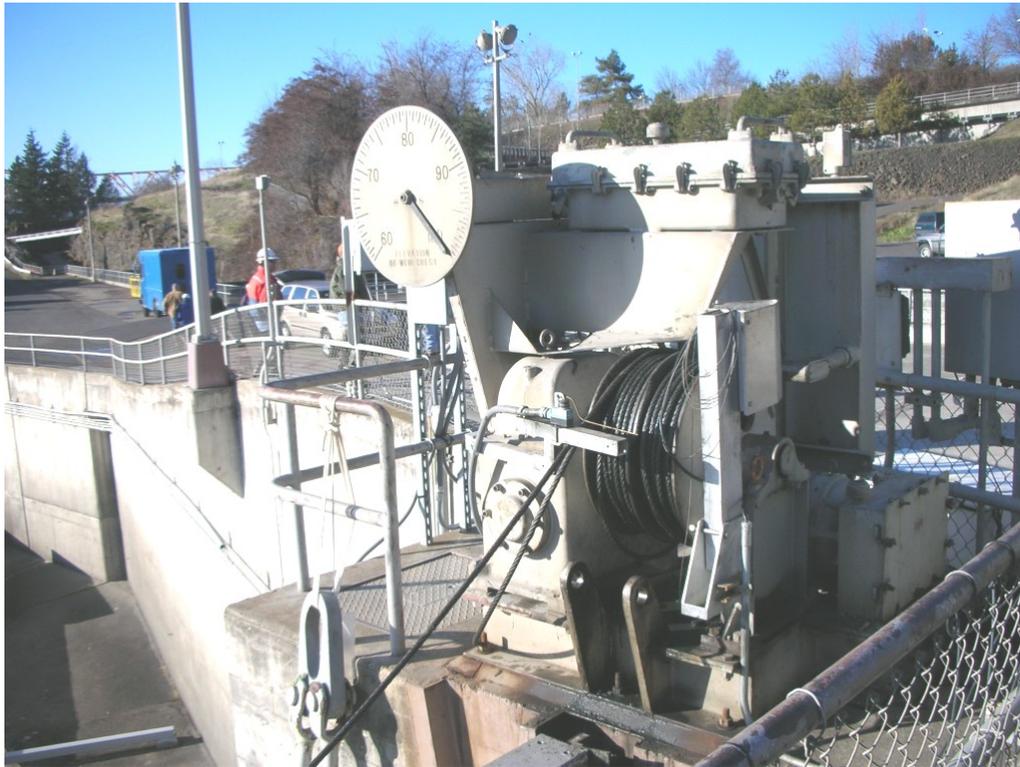
The electric hoist (Photo **M-6**) used to raise and lower the weir gates appeared to be in serviceable condition.

M-6 Entrance Weir Hoist For Gate N-1

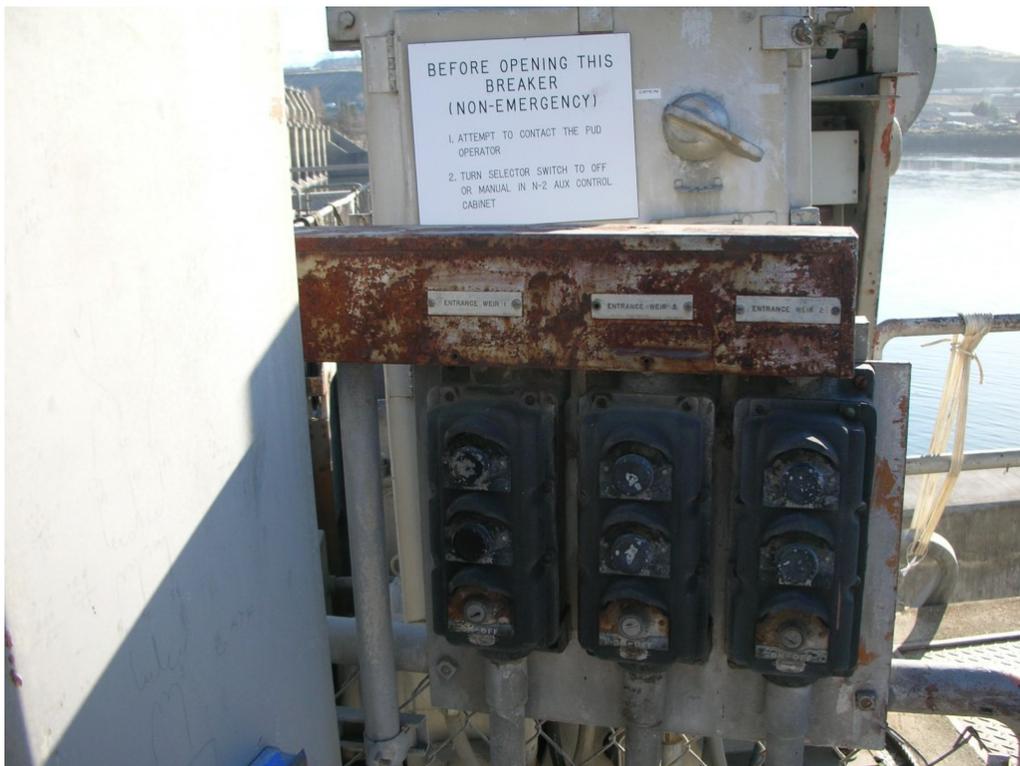
The hoist push button control enclosure (Photo **M-7**) was fairly corroded.

M-7 Entrance Weir Controls

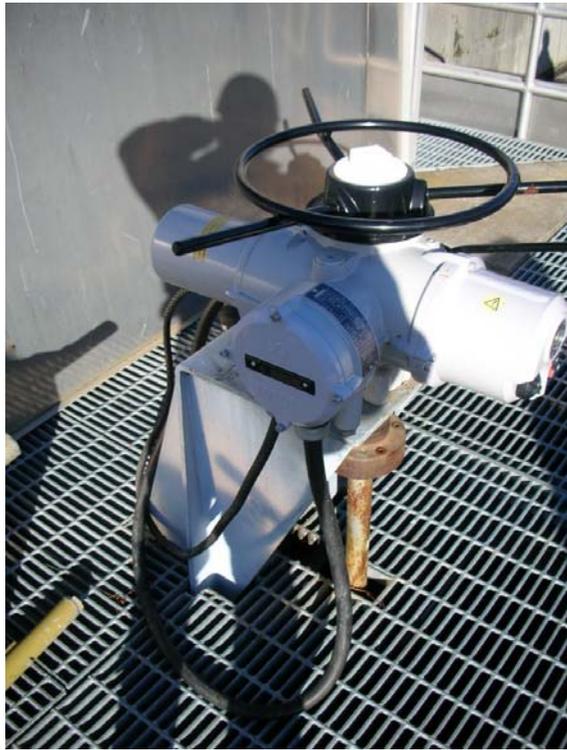
The fish crowder operates to crowd fish towards and past the viewing window for counting. A Rotork actuator (Photo **M-8**) drives two Acme screws (Photo **M-9**) that translate the moving half of the crowder towards or away from the viewing window. The range of movement is a reported 12 to 36 inches. The Rotork actuator appeared to be relatively new.

M-8 Counting Window Crowder Actuator
