Subject: The Dalles North Fish Ladder Inspection
Contract No. W9127N-06-D-0009, Task Order No. 0004
Final Trip Report

**The Dalles Dam North Fish Ladder
Inspection Report**

JANUARY 2007

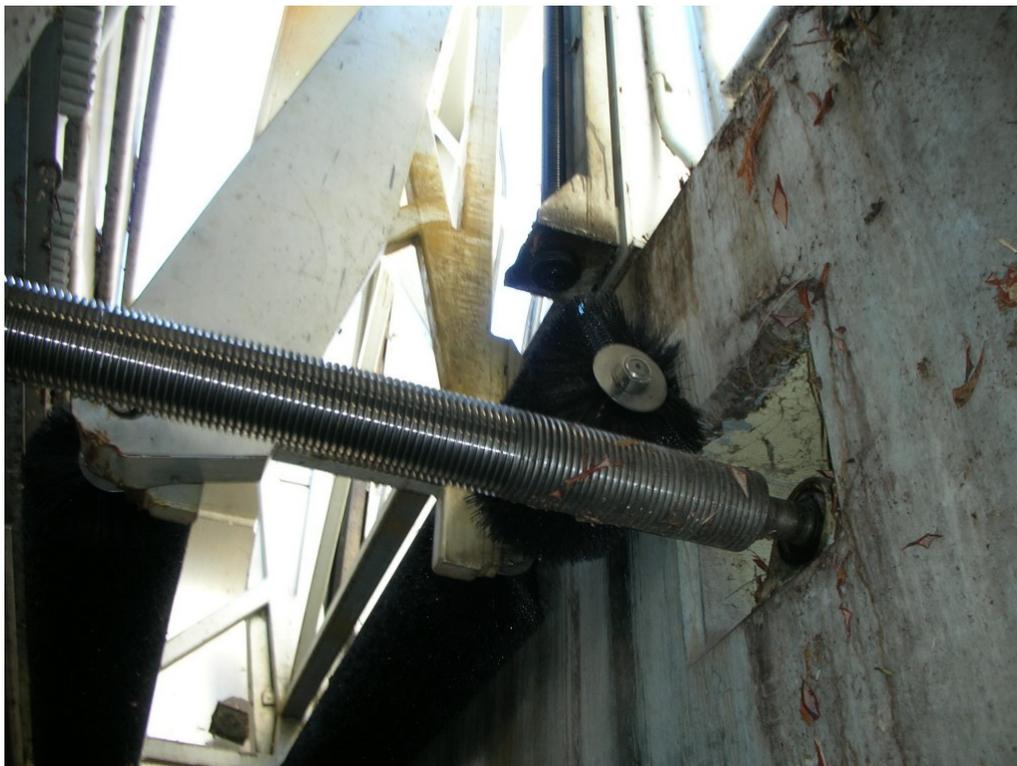
The fish crowder operates to crowd fish towards and past the viewing window for counting. A Rotork actuator (Photo **M-8**) drives two Acme screws (Photo **M-9**) that translate the moving half of the crowder towards or away from the viewing window. The range of movement is a reported 12 to 36 inches. The Rotork actuator appeared to be relatively new.

M-9 Counting Window Crowder Drive Screw

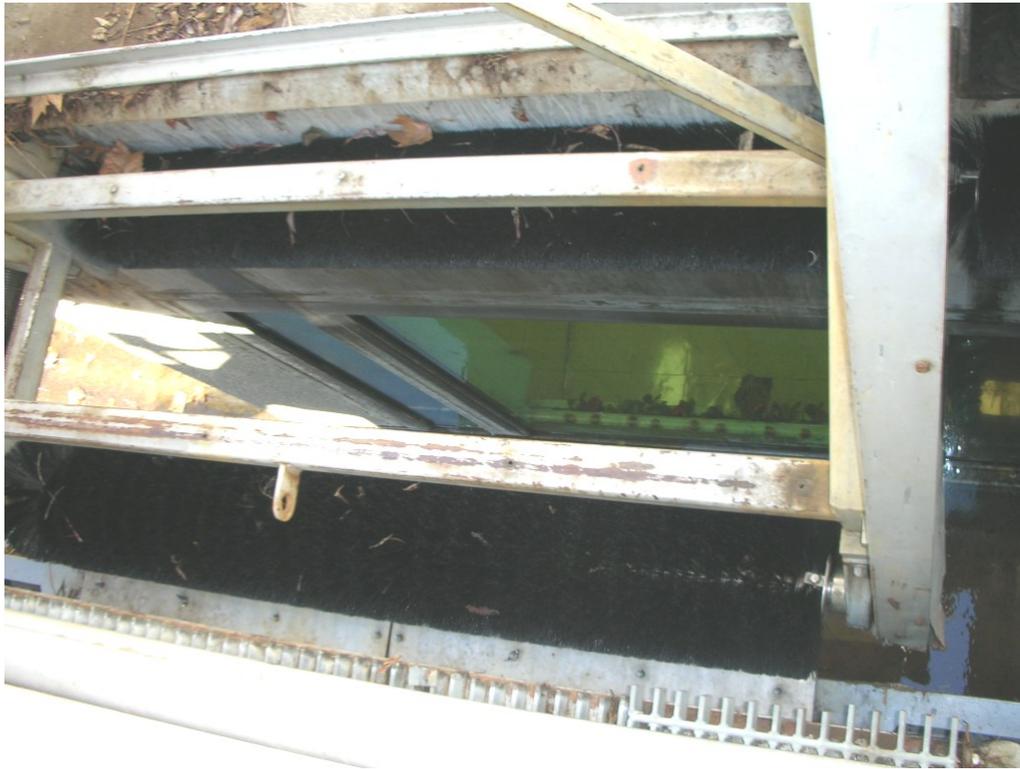
The viewing window (Photo **M-10**) and opposing light box are cleaned using an electric rotary brush mechanism (Photo **M-11**). District staff reported that the mechanism had been troublesome in the past, but that routine maintenance had corrected the situation.

M-10 Counting Window (View from above)

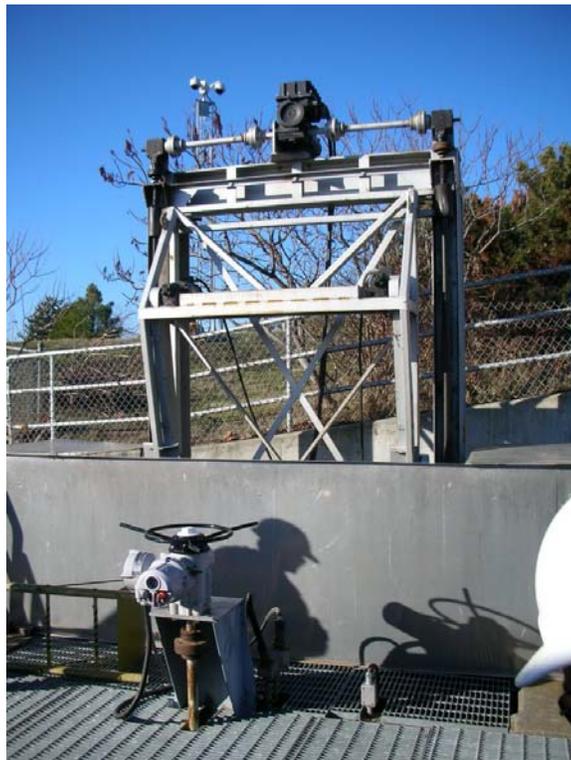
M-11 Counting Window Cleaner

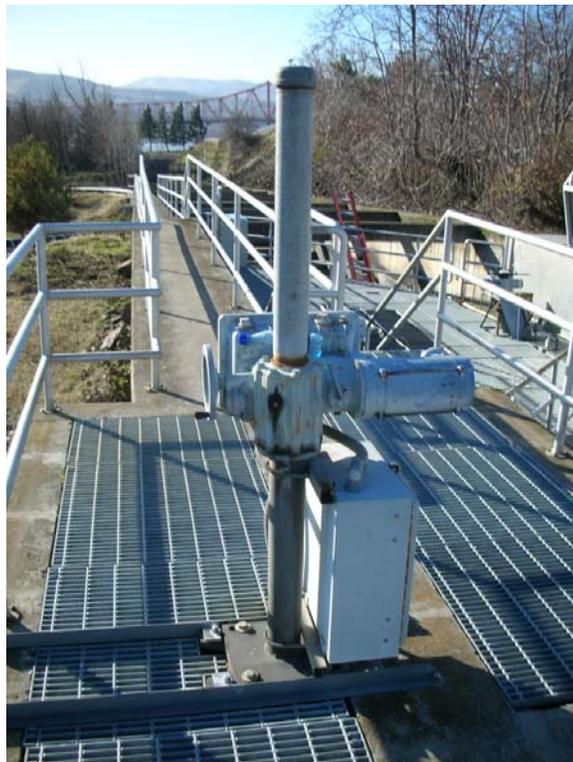
The electric gate actuator (Photo **M-12**) used to control flow to the floor diffuser appeared to be in serviceable condition.

M-12 Juvenile Fish Bypass Gate Actuator
