Subject: The Dalles East Fish Ladder Inspection
Contract No. W9127N-06-D-0009, Task Order No. 0004
FINAL Trip Report

THE DALLES DAM
COLUMBIA RIVER BASIN, WASHINGTON - OREGON

**The Dalles Dam East Fish Ladder
Inspection Report**

MARCH 2007

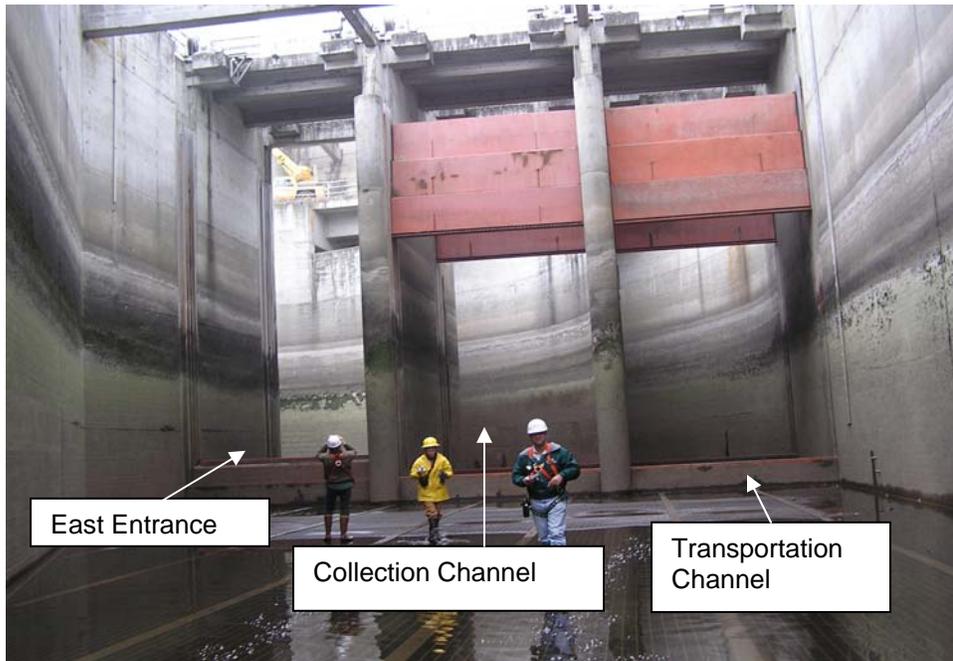
There are low concrete sills, about 3 feet high, between the junction pool and the east entrance, collection channel, and transportation channel. The collection and transportation channels have telescoping weirs stored in a raised position out of water as shown in Photo CS-1.

Photo CS-1 Overall view of the East Entrance, Collection Channel and Transportation Channel

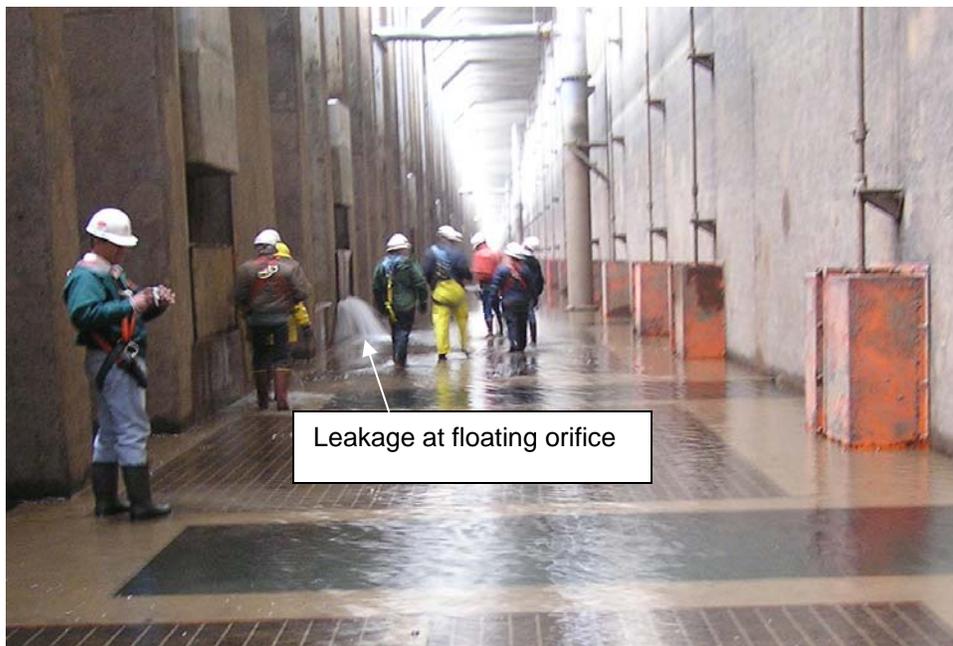
The only major leak observed on the inspection tour was found at one of the floating orifices. All the floating orifices were closed, and only the one exhibited significant leakage (Photo CS-2). The concrete bulkheads exhibited very small leakage in varying amounts. We were advised that the seals were new. The dewatering pumps were also new. These items were part of the "Adult Fishway Dewatering Improvements" undertaken since the Inca condition inspection report recommended them ten years ago. Only a few of the joints in the concrete walls showed dampness. Structural condition of the concrete work appeared excellent.

Photo CS- 2 Collection Channel. Note leakage at one floating orifice.

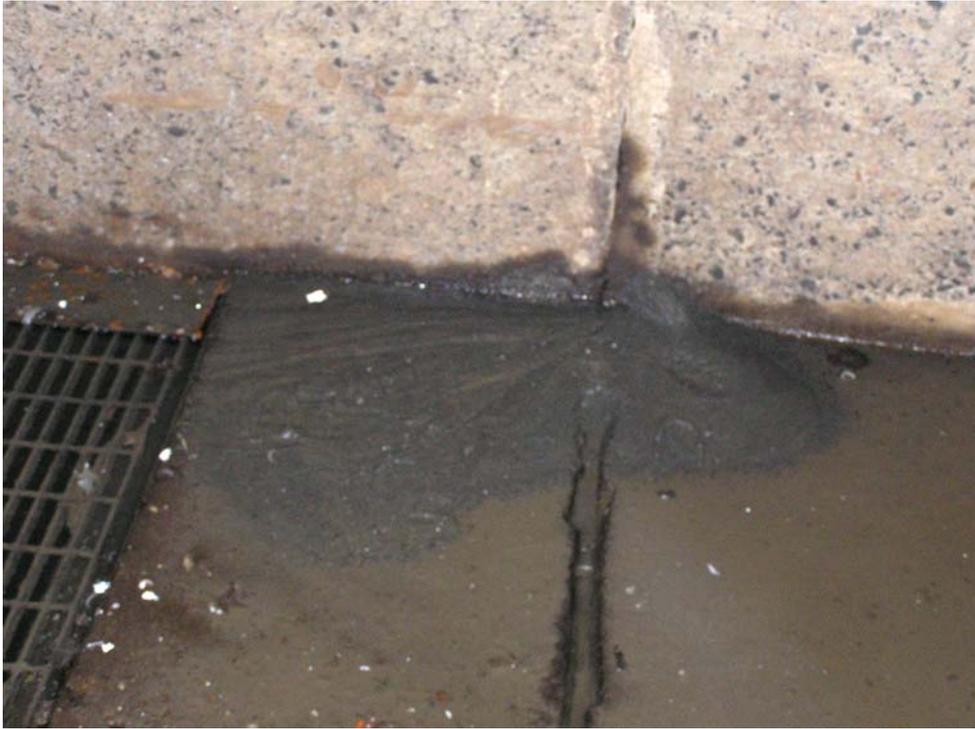
As viewed from grade, the open-cut concrete walled portion of the transportation channel appeared to be in good condition. There was approximately one-inch of water in the Transportation Channel. Locally, there were pieces of spalled concrete on the floor of the channel. There was also some miscellaneous debris that had fallen from the grating above, i.e., keys, coins, bolts, etc. At one location near the entrance of the transportation channel near the junction pool, an area of sand approximately 1 to 2-feet in dimension was present at the floor of the channel near a construction joint as shown in Photo CS-3.

Photo CS-3 Sand accumulated from seepage at joint between concrete sections in Transportation Channel

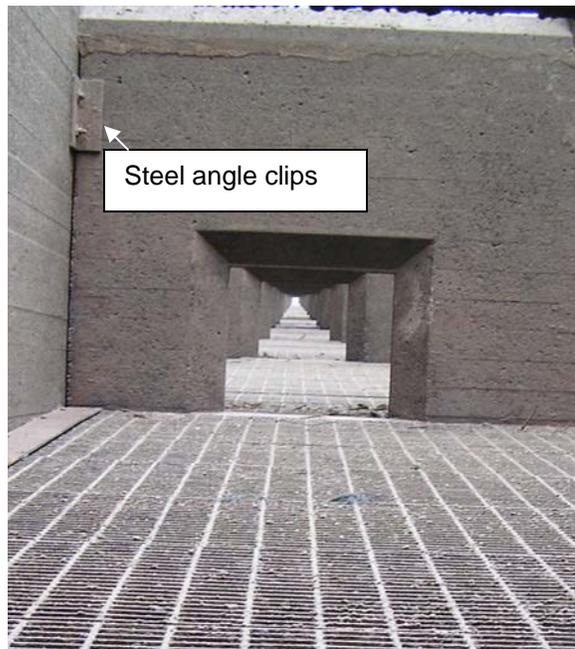
Photo CS-4 – East Fish Ladder Concrete Weir supported by steel angle clips

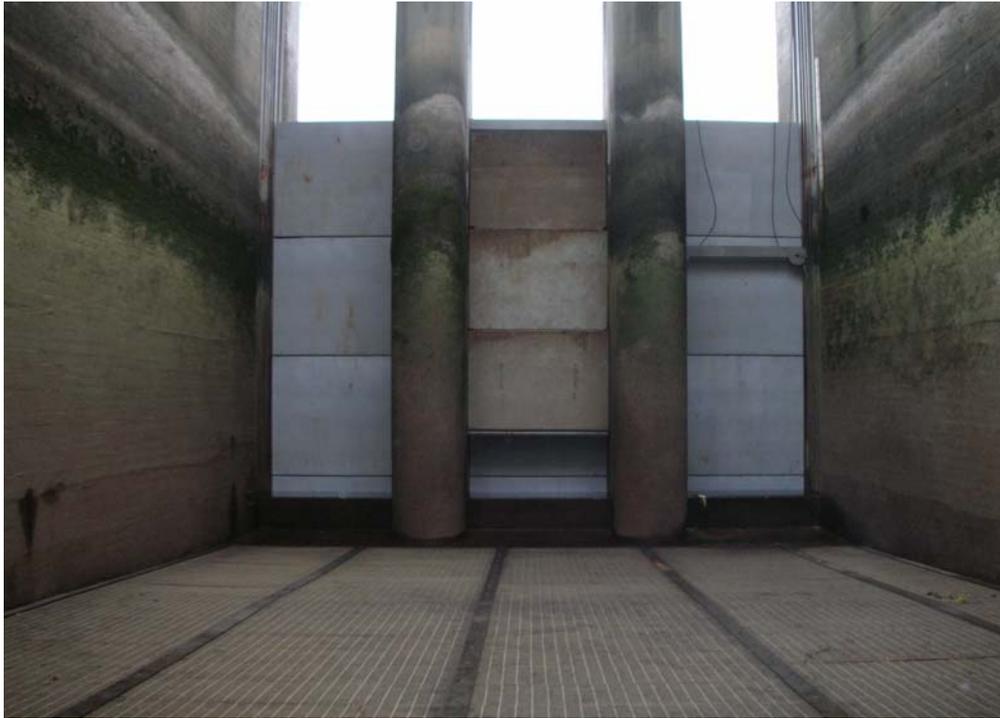
Bulkheads were observed to be installed in the three east fish entrance gate openings. (Photo ME-1) A telescoping gate was suspended by wire rope in the center opening. Gate slots and seals appeared to be in good condition. Three pairs of telescoping weirs (called out as junction pool weirs on drawings) were observed between the east entrance and the junction pool. The two northernmost weirs were suspended in what appeared to be the full up position; the southernmost weir was dropped to the floor in what appeared to be a full down position. Leaf seals on the southernmost weir were observed to be in good condition. (Photo ME-2) Crustacean shell fragments were observed to be piled against the sill of the weirs at the bottom of the gate slots.

Photo ME-1 Bulkheads present in the three east fish entrance gate openings

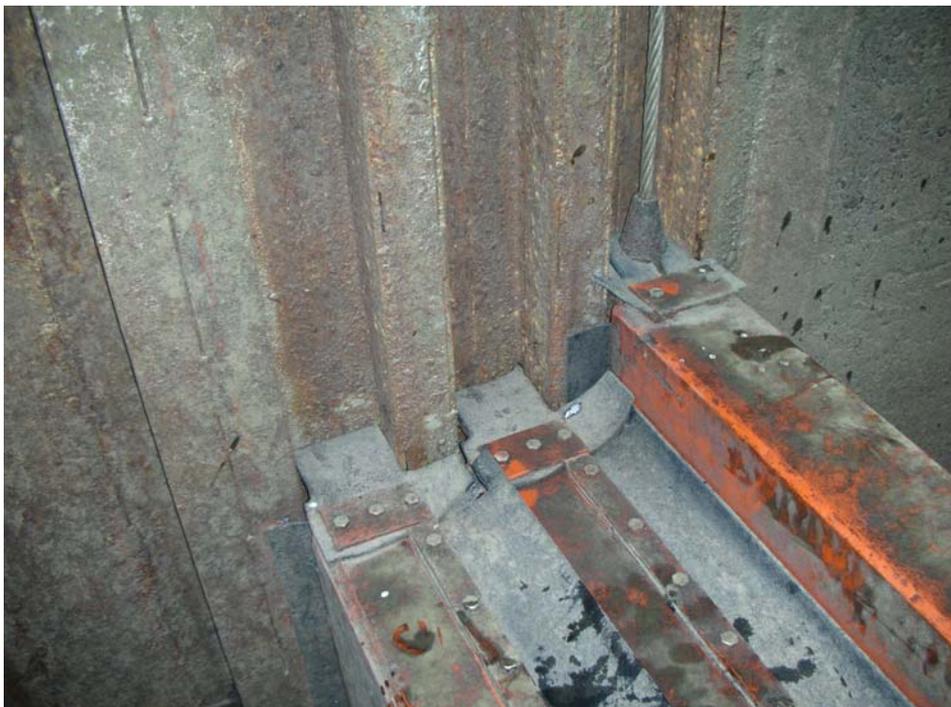
Photo ME-2 Leaf seals on the southernmost weir at East Entrance

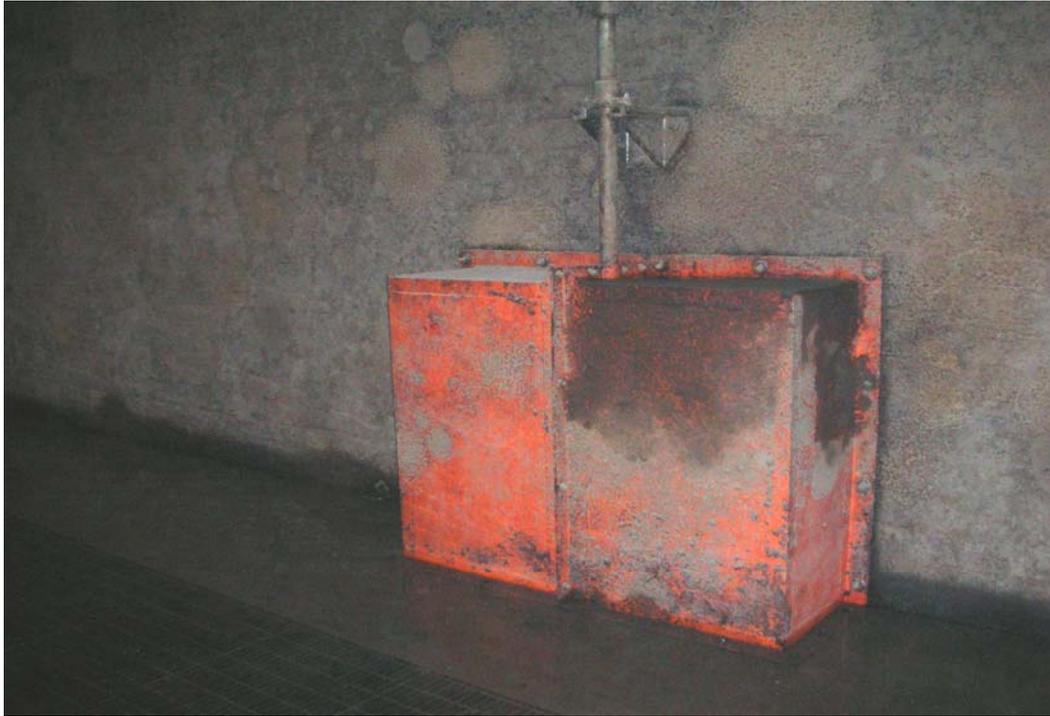
A series of diffuser gates were observed at regular intervals along the upstream wall of the fish collection channel. (Photo ME-3) District staff advised that the gates were fully closed and were maintained in the fully closed position. A few gates appeared to be partially open, allowing water to enter the collection channel through the diffuser gratings. Six dewatering pump casings were observed at regular intervals along the upstream side of the channel. (Photo ME-4) The pumps were operating and removing water that was leaking into the channel past bulkheads or the partially open diffuser gates. Floating orifices were abandoned in place along the downstream wall of the channel. Water was observed to be leaking past the downstream bulkheads in a few locations. (Photo ME-5)

Photo ME-3 Diffuser gates along upstream wall of fish collection channel

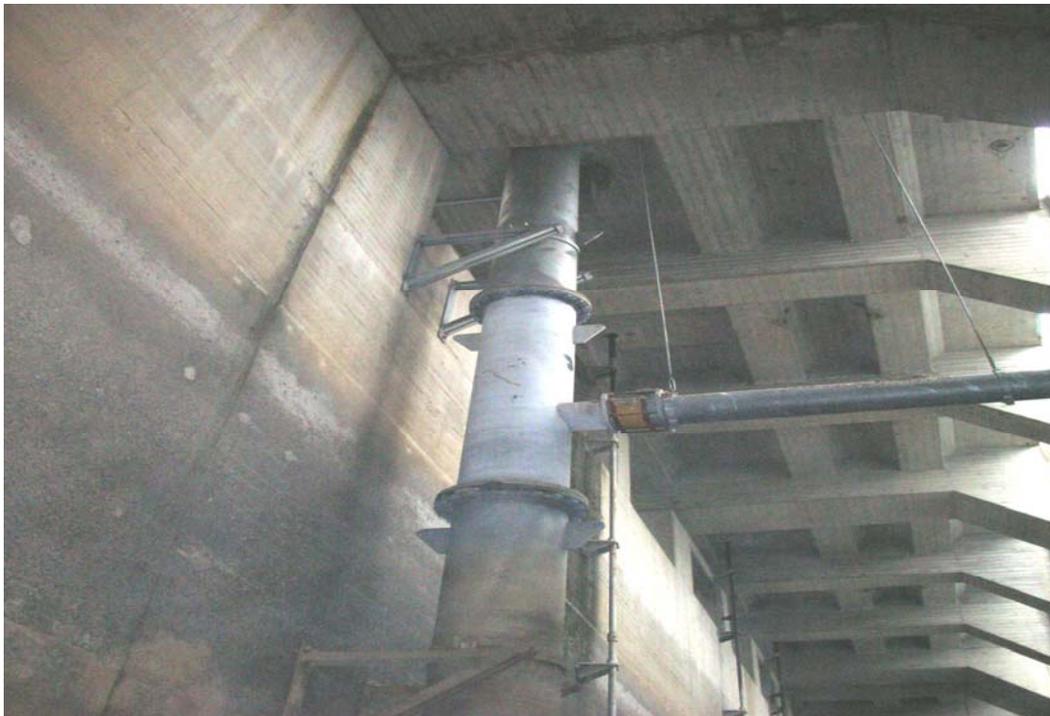
Photo ME-4 Dewatering pump casings along upstream side of collection channel

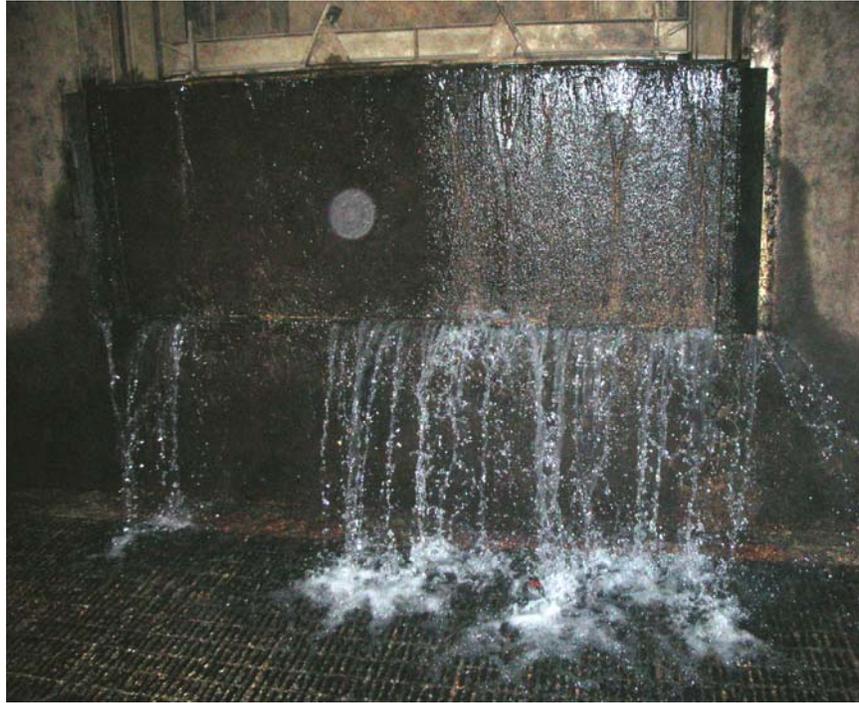
Photo ME-5 Water leaking past downstream bulkhead in collection channel

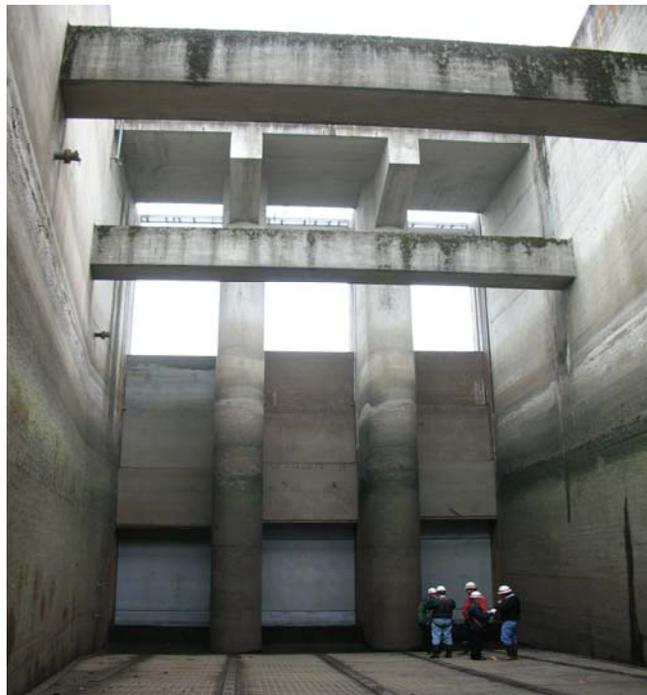
Bulkheads were installed in all three west fish entrance openings. (Photo ME-6) Telescoping weirs were suspended in each opening. Gates, slots, and seals appeared to be in good condition. A fourth telescoping "bypass" gate was

Photo ME-6 Bulkheads at west fish entrance openings

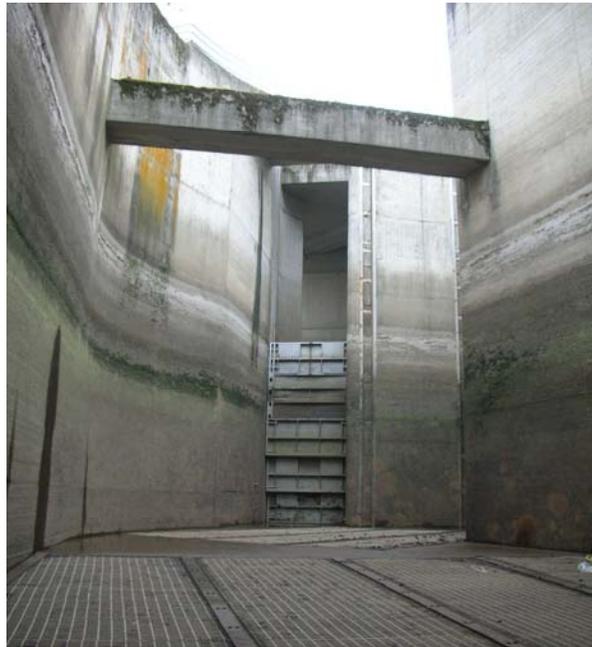
observed between the collection channel and the transportation channel. (Photo ME-7) All four gates appeared to be in good condition.

Photo ME-7 Telescoping “bypass” gate between collection and transportation channels

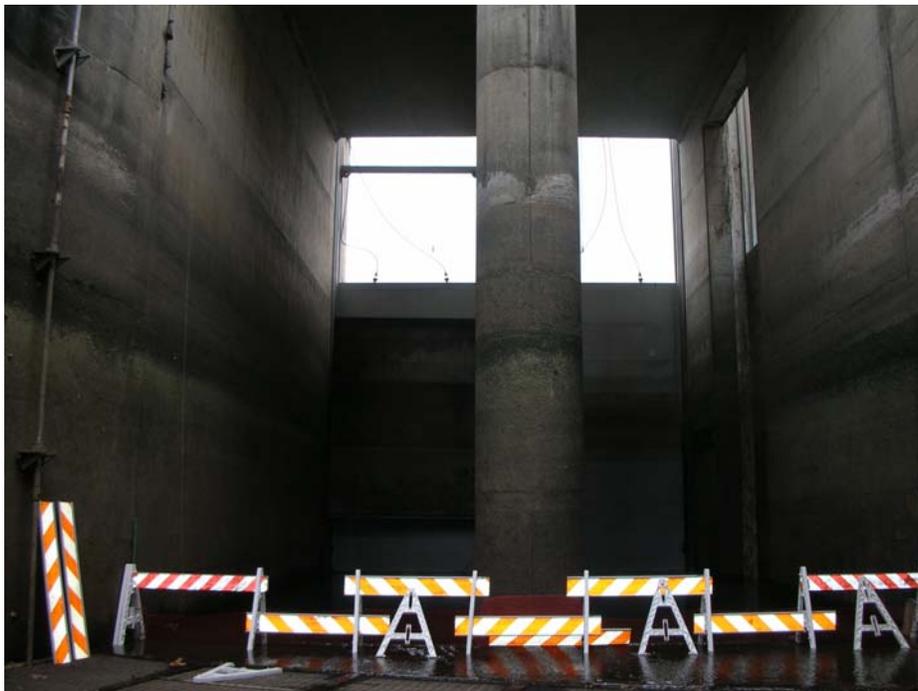
Bulkheads were installed in both south fish entrance openings. (Photo ME-8) A telescoping weir was suspended in the south opening; the north opening weir was missing and reported to be installed in the North Fish Ladder Entrance. A dual sheaved lifting beam used to raise and lower the telescoping weirs was observed. (Photo ME-9) The beam is a relatively recent addition designed to improve the reliability of the gate by removing the wire ropes from the flow stream. Hoists used to raise and lower the telescoping gates were observed to be in good condition. (Photo ME-10) Gate slots also appeared to be in good condition. Hoist electrical controls appeared to be somewhat weathered and old but no reports of malfunction were reported. (Photo ME-11)

Photo ME-8 South fish entrance bulkheads

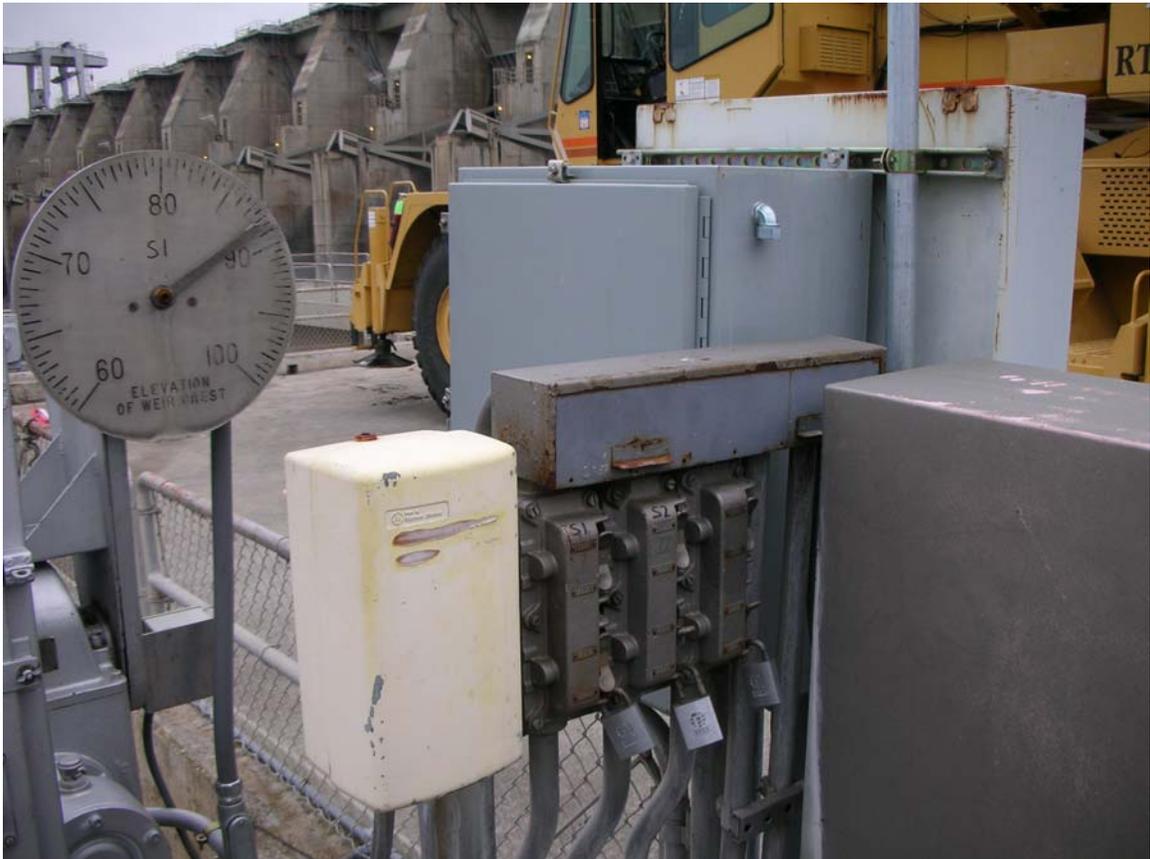
Photo ME-11 Hoist electrical controls at South Entrance showing older condition

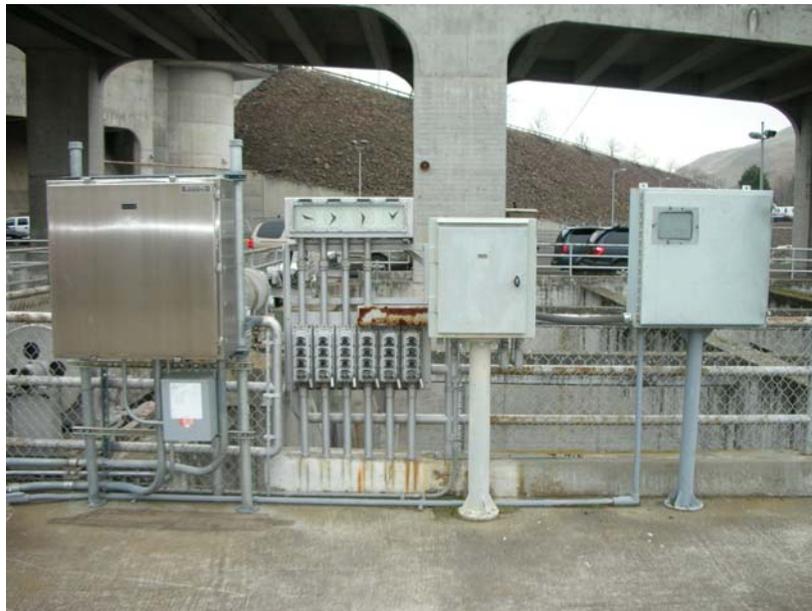
A hoist control station appeared to be somewhat weathered and old, but no reports of malfunction were reported. (Photo ME-12) Hoists and rigging appeared to be in good condition. Evidence of regular changing of hoist gearbox oil was noted on several gearbox housings. (Photo ME-13) District staff pointed out that the gearboxes were located over water.

Photo ME-12 Hoist Control Station at Junction Pool

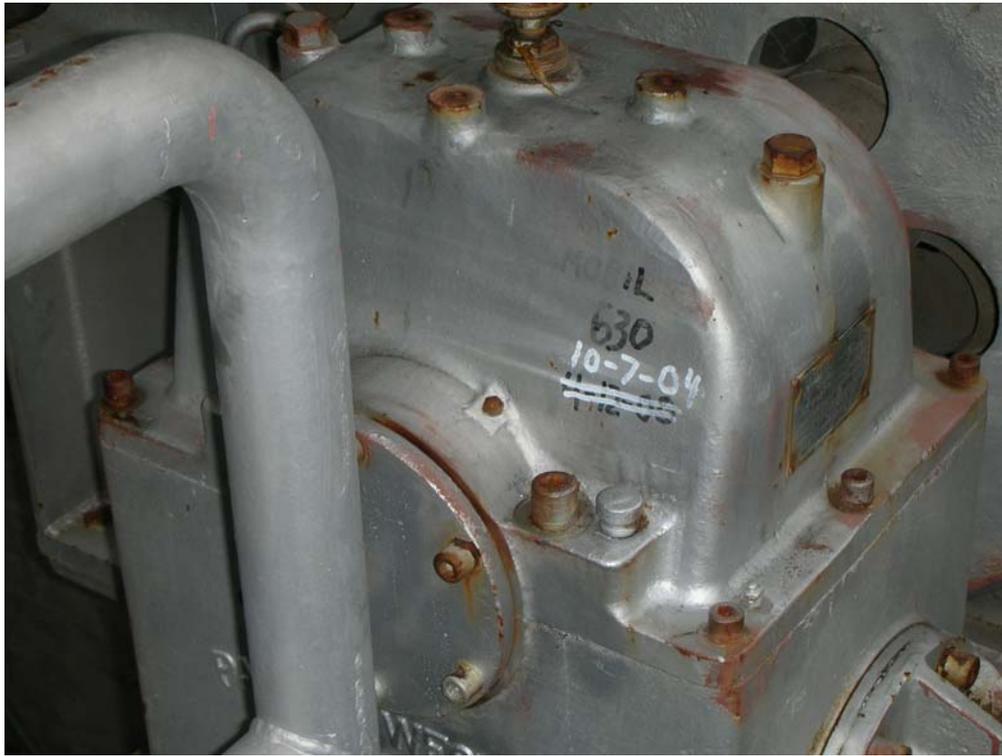
Photo ME-13 Gearbox Housing

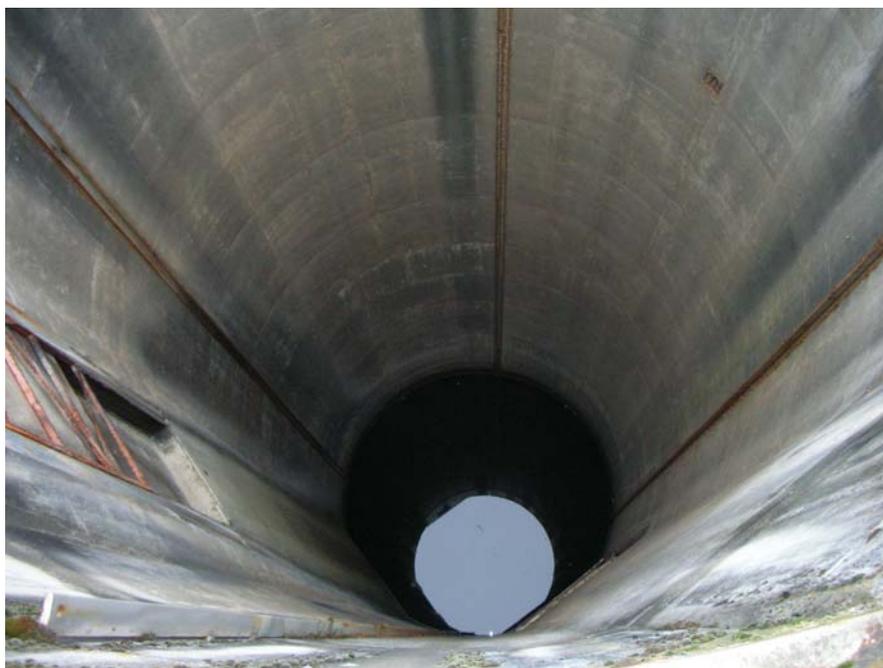
The original east fish ladder construction included a fish lock designed to lift fish from the junction pool to the ladder exit. (Photo ME-14) The fish lock had not been used in several years; District staff reported that 1) fish were not inclined to enter it, and 2) fish that did enter it experienced descaling during the lifting operation. A valve room used to supply forebay water to the fish lock and other areas was entered and observed. (Photo ME-15) The valves, actuators, and controls appeared to be in good condition. District staff shared that operation of the valves had been considered to supply additional attraction flow to the east fish ladder via the fish lock.

Photo ME-14 Fish Lock – View from top

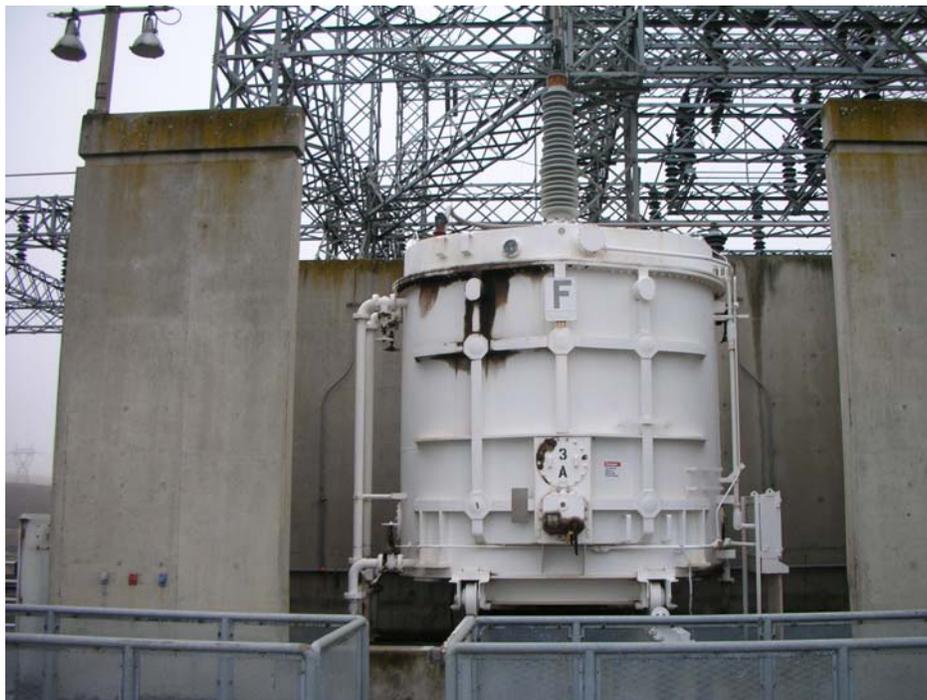
The two fish turbine transformers (one per unit) were observed and appeared to be in good condition. (Photo ME-16) The fish turbine units and controls were observed and appeared to be well-maintained. (Photo ME-17, ME-18)

Photo ME-16 Fish Turbine Transformer

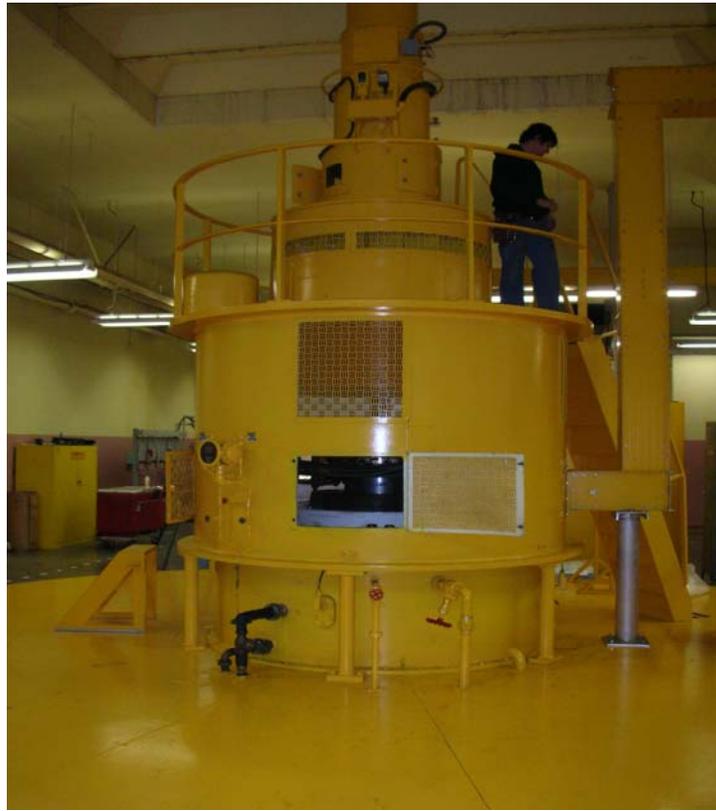
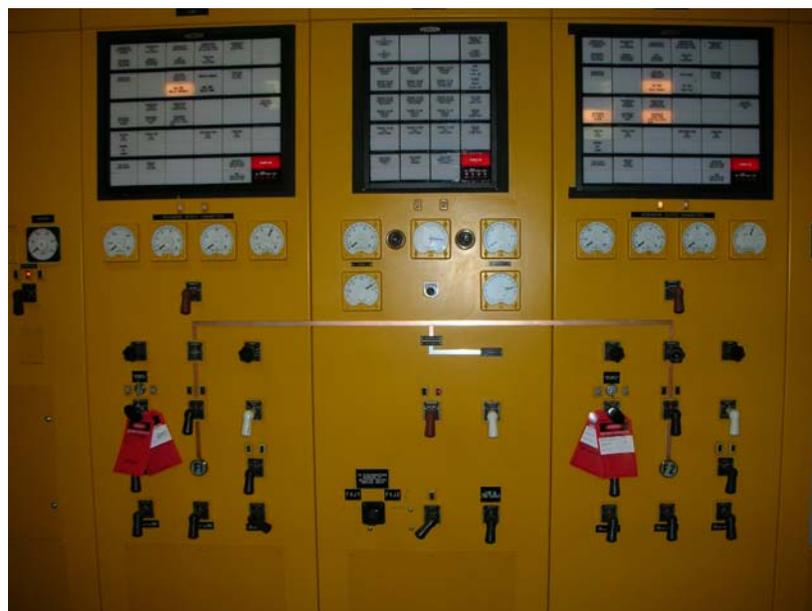
The condition of the fish turbines was discussed. Although they have been very reliable, they are showing signs of age. New windings have been installed. The

original 50-year-old bearings are “sagging.” The carbon packing would be the first item to fail and would take 3 weeks to replace. If replacing the packing only was not sufficient, it would then take 3 months to replace the bearings.

Photo ME-17 Fish Turbine Units

Photo ME-18 Fish Turbine Controls

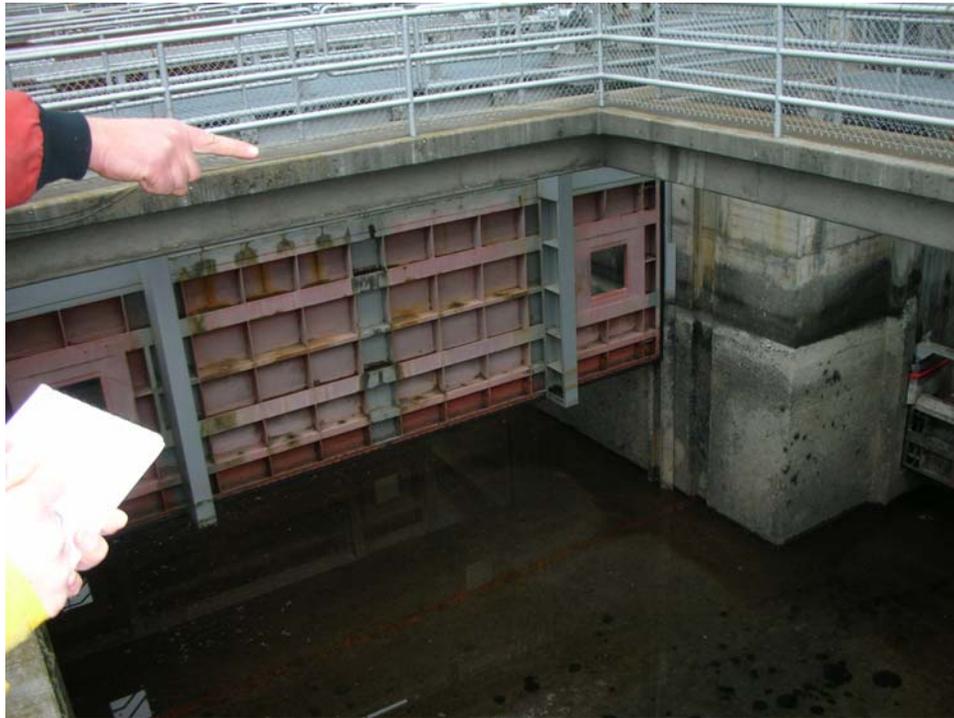
Several adjustable weirs were observed in the ladder exit section. (Photo ME-19) The weirs were in various positions. District staff reported that the number of adjustable weirs added complexity and maintenance to the operation of the ladder, and questioned whether they were needed. The ladder exit consists of two smaller adjustable weirs that appear to have been fabricated from a former single weir. (Photo ME-20) Bulkheads were observed on the upstream side of the weirs. The various adjustable weirs are controlled by a motor control center and PLC located in a room adjacent to the gates. (Photo ME-21) No electrical or control problems were reported.

Photo ME-19 Adjustable weirs in fish ladder exit section

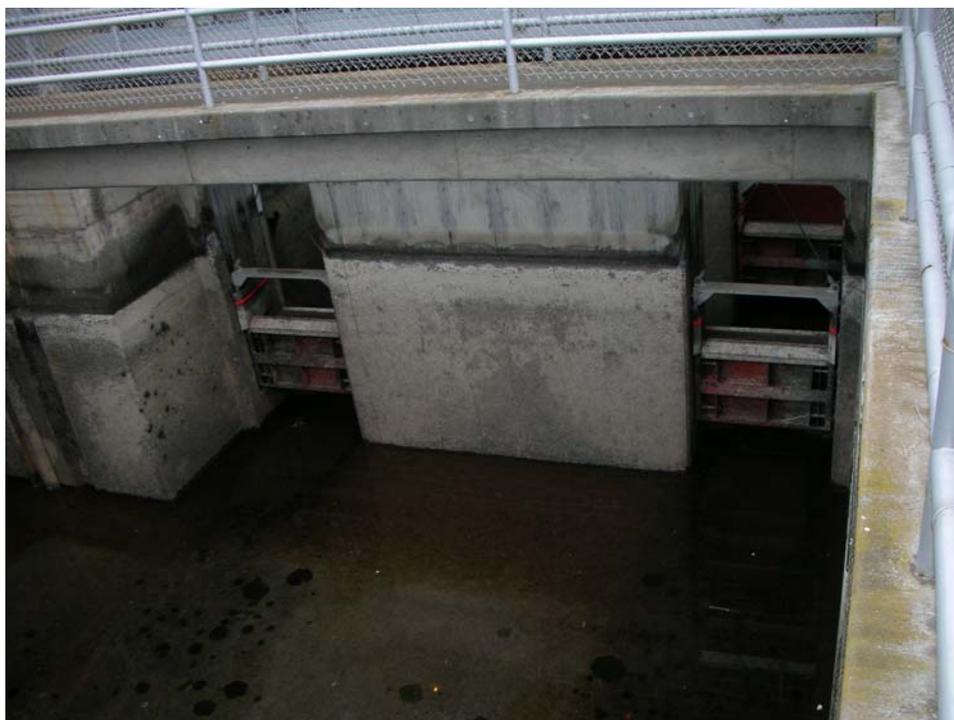
Photo ME-20 Weirs fabricated from a former single weir

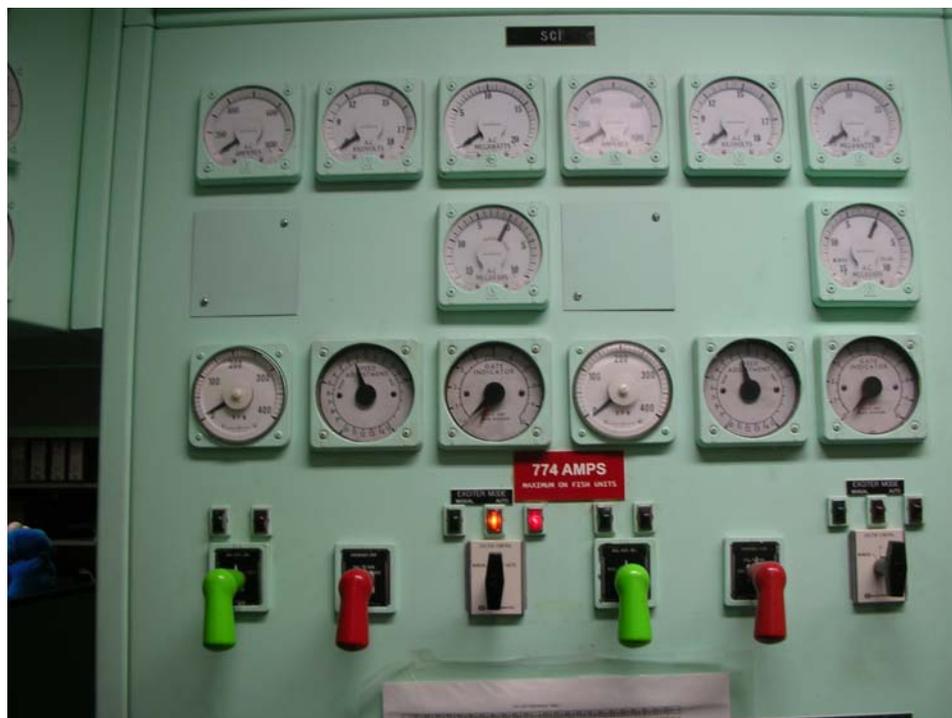
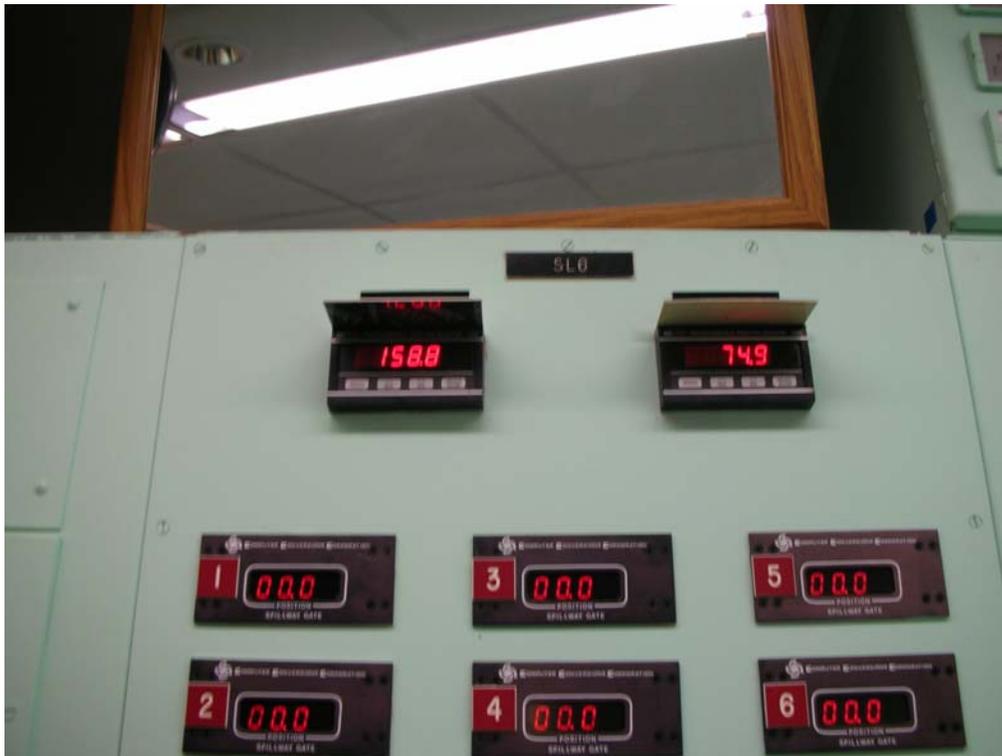
The fish turbine control panels located in the powerhouse control room were observed. Operators reported no problems with their operation. (Photo ME-22, ME-23)

Photo ME-22 Fish Turbine Control Panels

Photo ME-23 Fish Turbine Control Panels

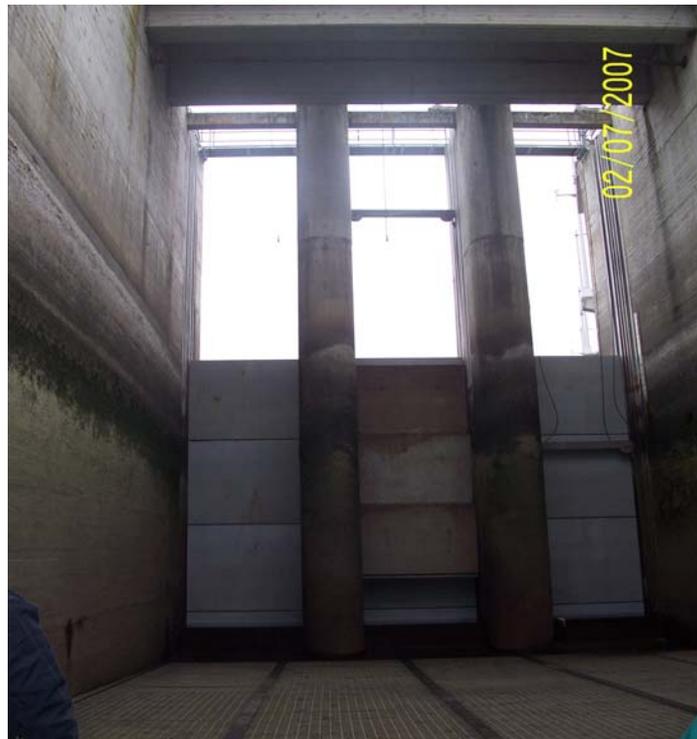
The east entrance gates appear to be in satisfactory condition, except the center gate is under repair as shown in Photo H-1. The east entrance gates operate with the same lifting beam mechanism used for the North Fish Ladder. The diffuser grating in the east entrance appears to be in satisfactory condition and the diffuser panels in the entrance area operate as part of the auxiliary water supply.

Photo H-1 EFL East Entrance

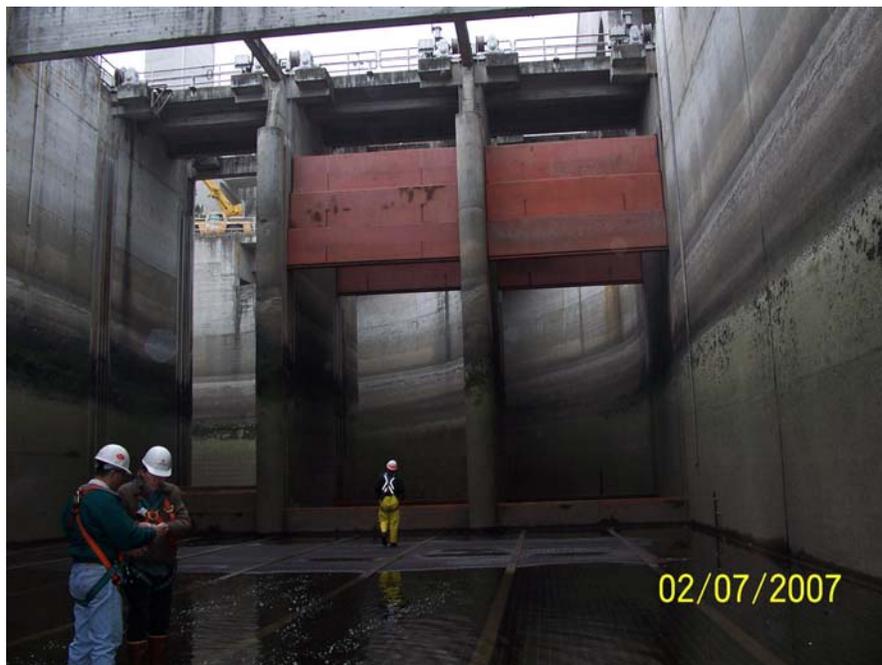
The junction pool was observed as shown in Photo H-2. USACE staff noted that the junction pool 3-leaf weirs are open to the collection and transportation channels and operated at 7 feet below tailwater in the east entrance channel. The 1" by ~ 4 in" floor diffuser grating appeared to be in satisfactory condition. The diffuser panels in the junction pool are normally in operation for the auxiliary water supply.

Photo H-2 EFL Junction Pool

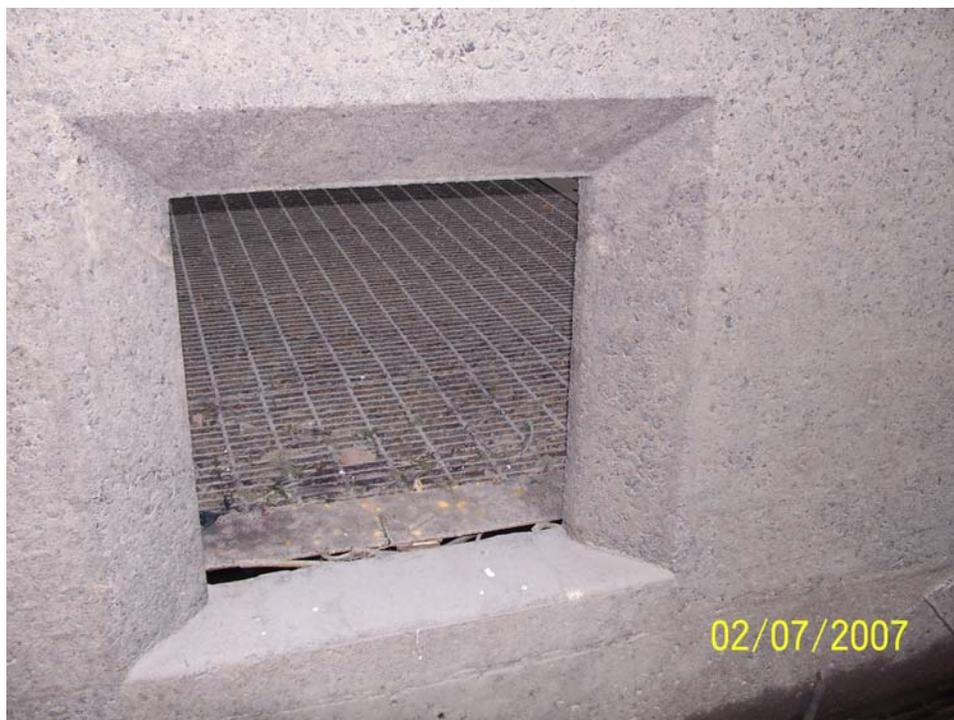
The lower weirs for the East Fish Ladder are shown in Photo H-3. Some debris was caught in the gap between the grating and the orifice floor at each orifice opening as shown in Photo H-4. We also observed the bulkhead for the fish lock channel entrance to the junction pool. The fish lock is not operated at this time.

Photo H-4 Debris between diffuser grating and orifice

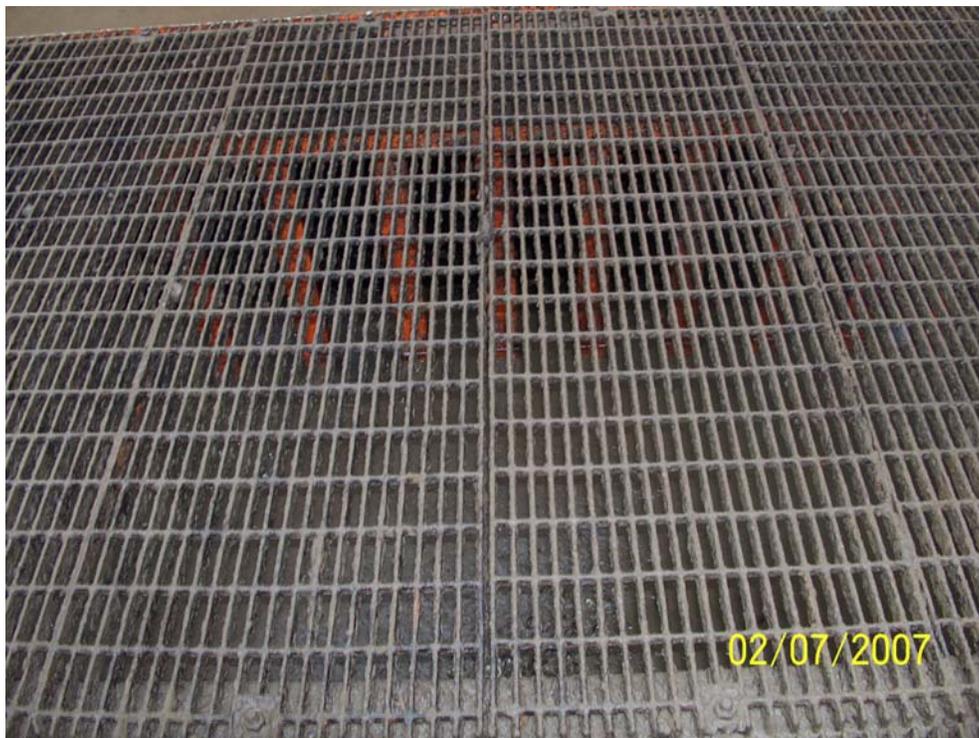
During the site visit some of the diffuser gate wells were drained below the floor level. This was likely due to some leakage through the diffuser gates in these wells. In the gate wells with lower water levels, sedimentation and growth of mussels or other bivalve populations were observed. It is possible that the

sediment prevents full closure and sealing of the diffuser gates. Photo H-8 shows one of the diffuser wells that was partially drained. The diffuser grating appeared to be in satisfactory condition but showed signs of sedimentation.

Photo H-8 Sediment on diffuser grating

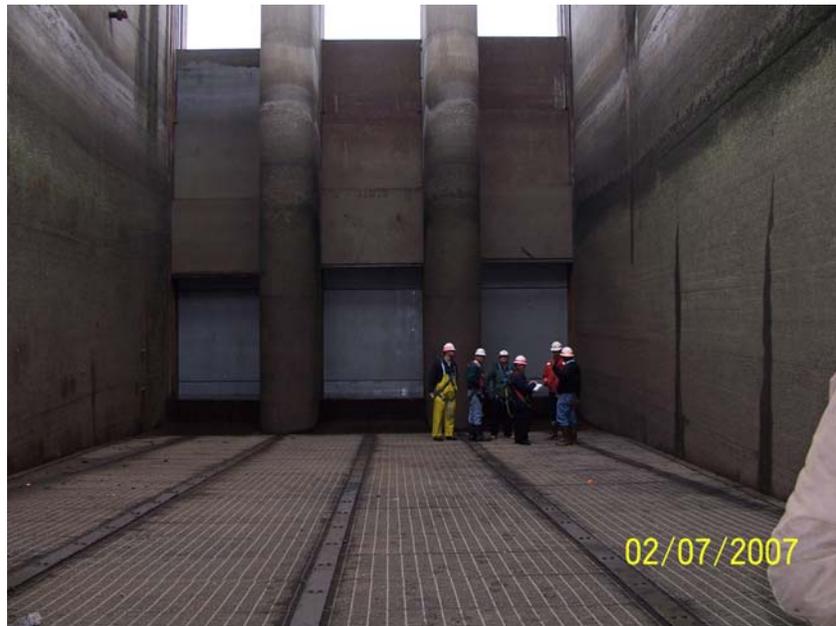
The West Entrance gates were observed and appear to be in satisfactory condition as shown in Photo H-9. The diffusers in the west entrance operate during normal operations and the grating appeared to be in satisfactory condition.

Photo H-9 West Entrance

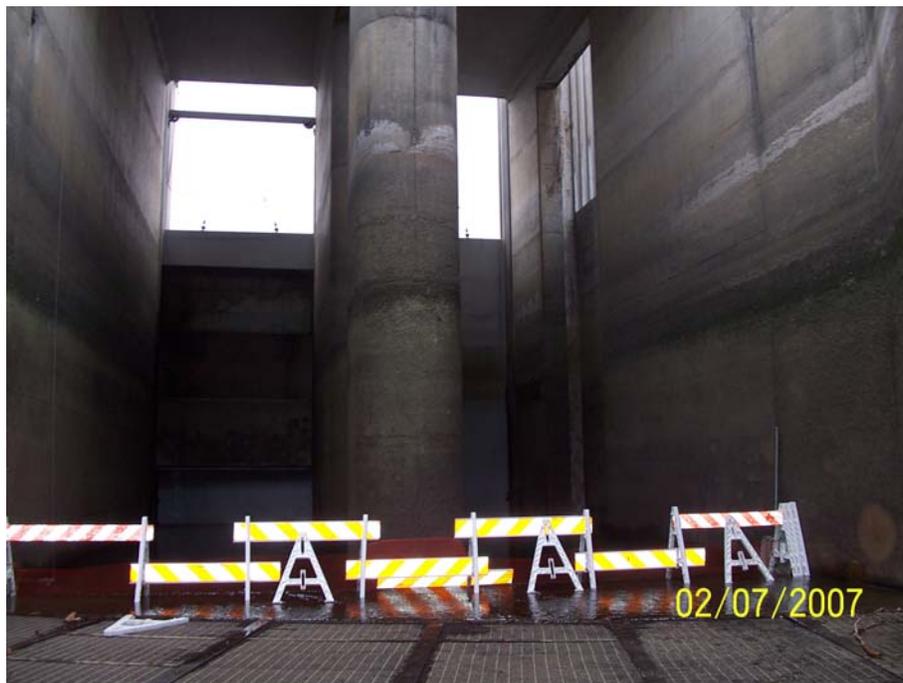
The South Entrance gates and diffusers were observed as shown in Photo H-10 and appeared to be in satisfactory condition. The diffusers in the South Entrance operate during normal operations as part of the auxiliary water supply.

Photo H-10 South Entrance

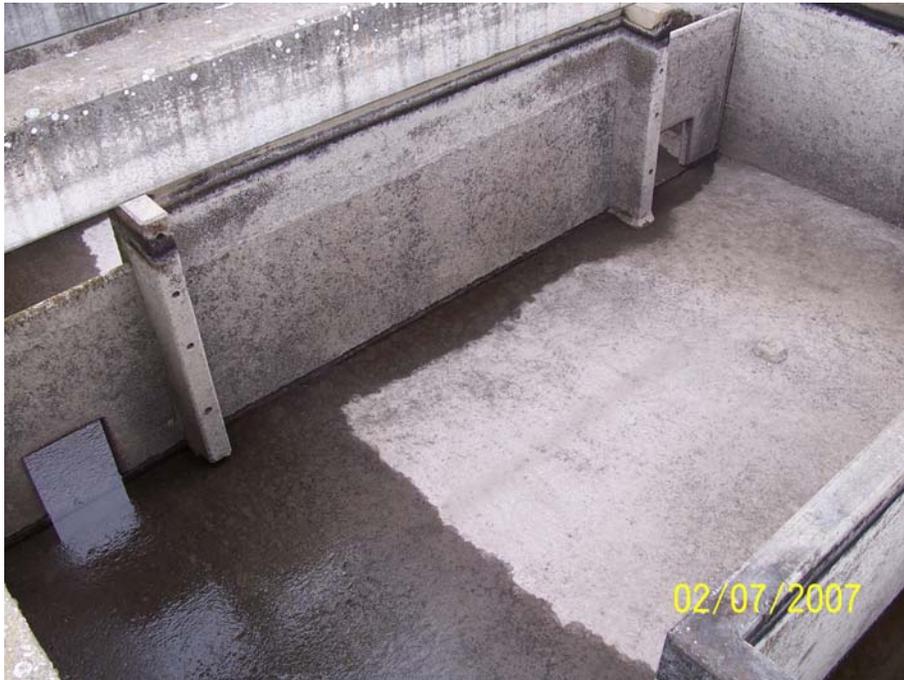
The East Ladder appeared to be in good condition, with the weirs and orifices appearing in satisfactory condition. On the lower approach to the junction pool, several weir pools contained chunks of concrete as shown in Photo H-11. It appears that the concrete may have come from under the upstream weir approach wall. Several of the diffuser sections have new grating.

Photo H-11 Typical East Ladder Weir

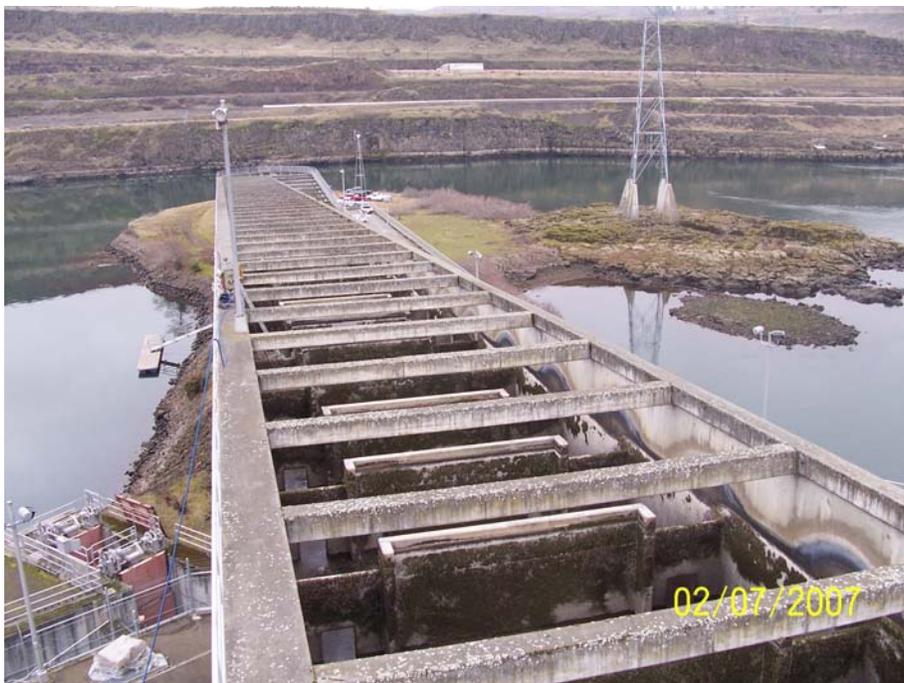
The upper section of ladder weirs upstream of the 180° bend was observed to have significantly greater algal growth as shown in Photo H-12.

Photo H-12 Upper EFL
