Subject: The Dalles East Fish Ladder Inspection
Contract No. W9127N-06-D-0009, Task Order No. 0004
FINAL Trip Report

THE DALLES DAM
COLUMBIA RIVER BASIN, WASHINGTON - OREGON

**The Dalles Dam East Fish Ladder
Inspection Report**

MARCH 2007

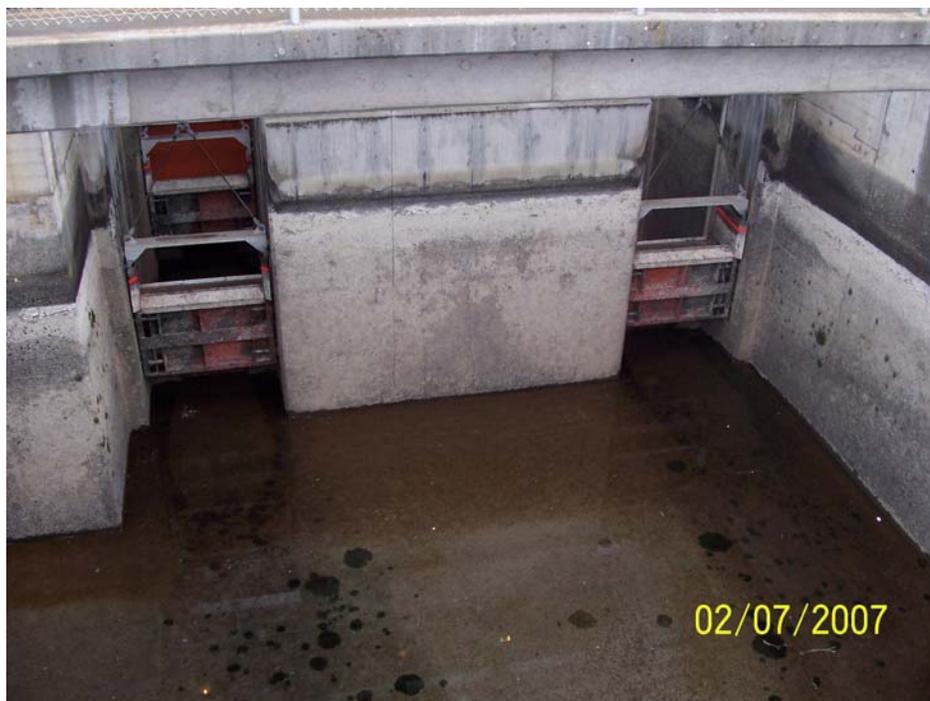
The exit weirs are shown in Photo H-14. The pair of weirs are automatically operated based on forebay elevation. The downstream weir tracks at 1 foot below the upstream (weir 159) weir elevation. The weirs appear to be in satisfactory condition.

Photo H-14 Exit Weirs

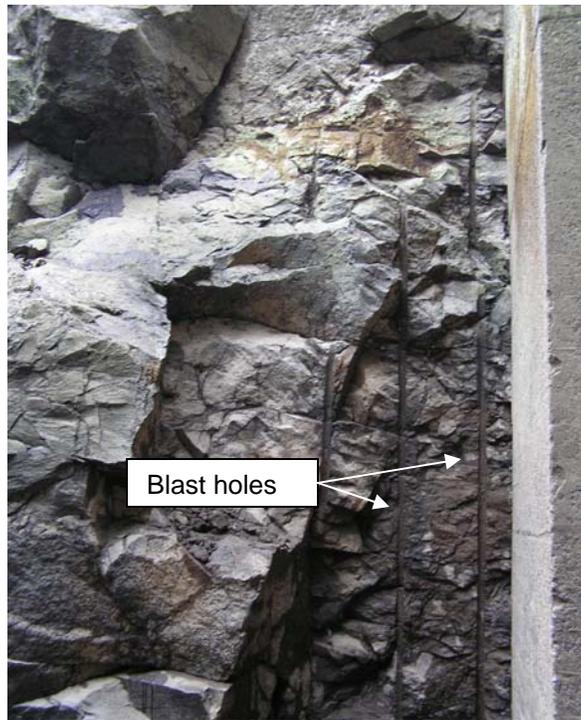
The rock in the channel is part of the Columbia River Basalt Group. Two flows were noted during the inspection and are separated by a thin layer of material that supports growth of a moss layer with minor vegetation. The lower layer had a closer spaced joint pattern and the upper layer tended to be more massive. The rock required blasting to be constructed and the blast holes are still evident in the rock slopes (Photo G-1). The rock maintains vertical slopes. The basalt is

Photo G-1 Blast holes drilled for the construction of the channel

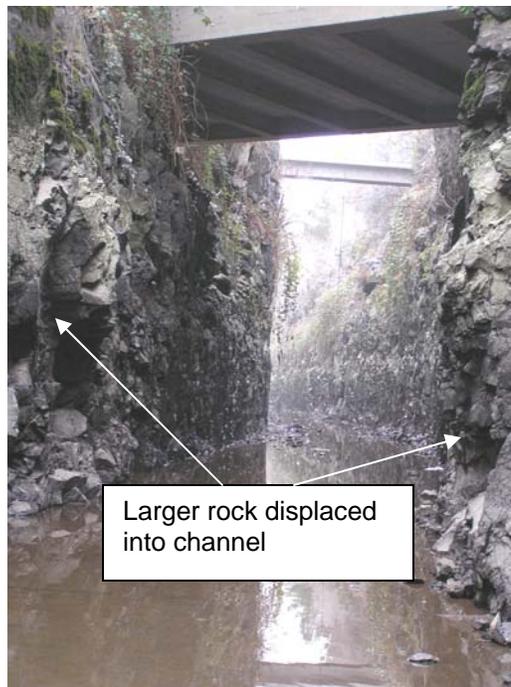
fresh to slightly weathered. Although it is jointed, due to cooling, no pervasive joint pattern was noted that was deleterious to the stability of the slope. Most rock fall that has occurred is likely the result of loosening of individual basalt rocks (Photo G-2). A few areas of large blocks that have been loosened from the slope are also shown in this photograph.

Photo G-2 Vertical slopes in the rock-lined channel. Notice zones where larger rocks have been displaced into channel. Only minor amount of rock debris on floor of the channel.

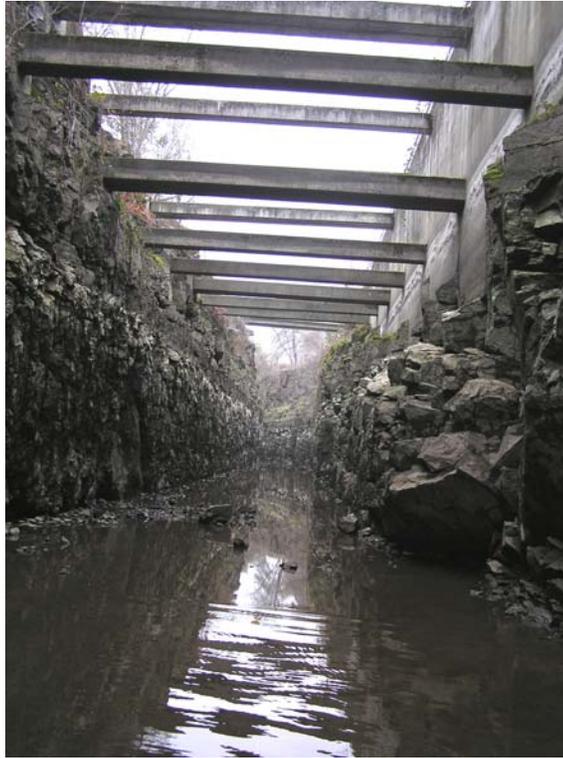
Photo G-3 – Area of rock-lined channel that is stabilized with concrete and cross struts.
