Evaluating Cumulative Ecosystem Response to Restoration Projects in the Columbia River Estuary

Summary of 2008 Accomplishments

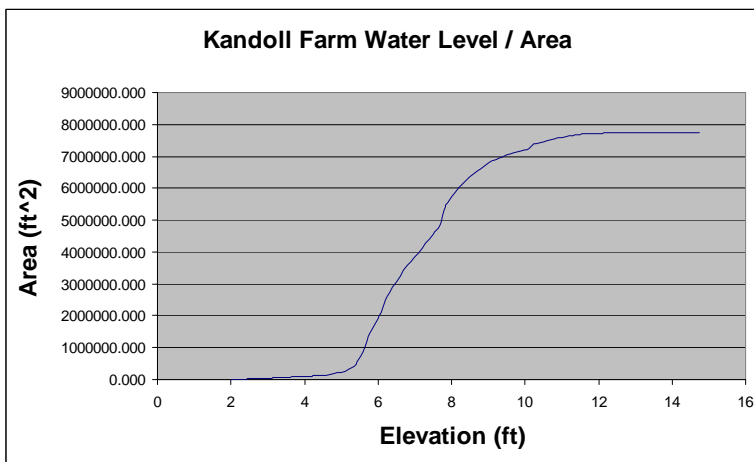
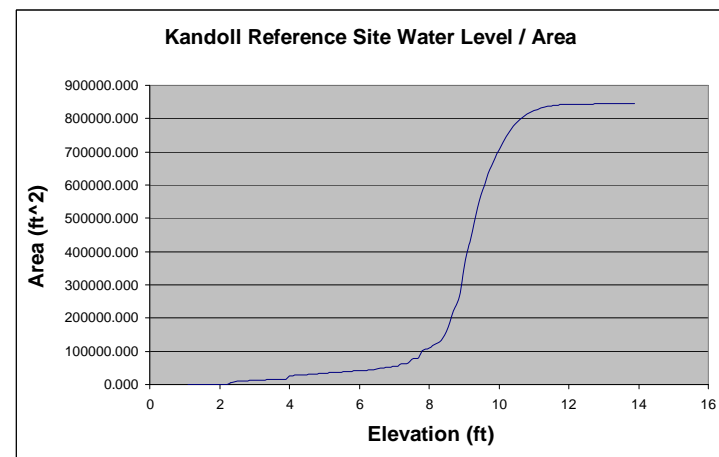
4. Hypsographic Curves: Restoration & Reference

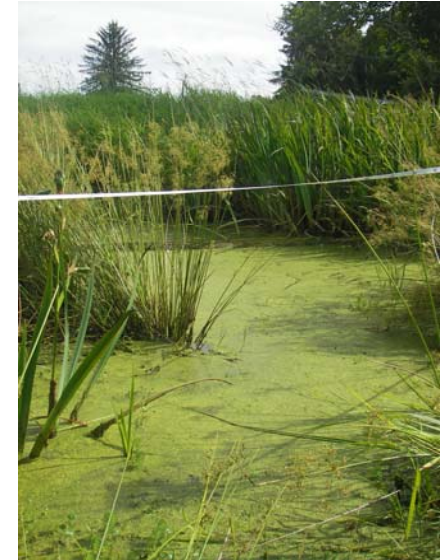
Elevation of Plant Species and Landscape Features

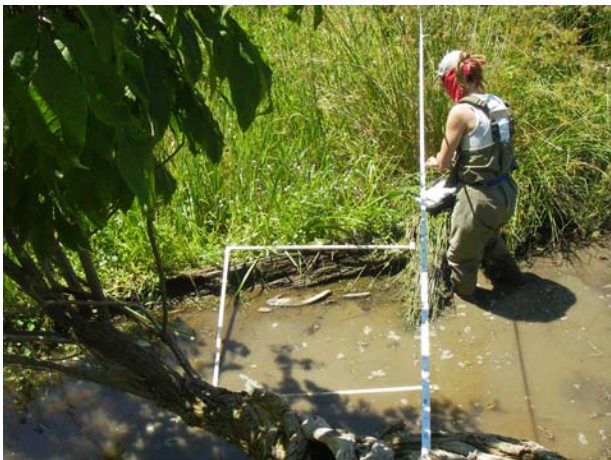
Nutrient and Chlorophyll Flux between Blocked Channels and the Main Stem Columbia River

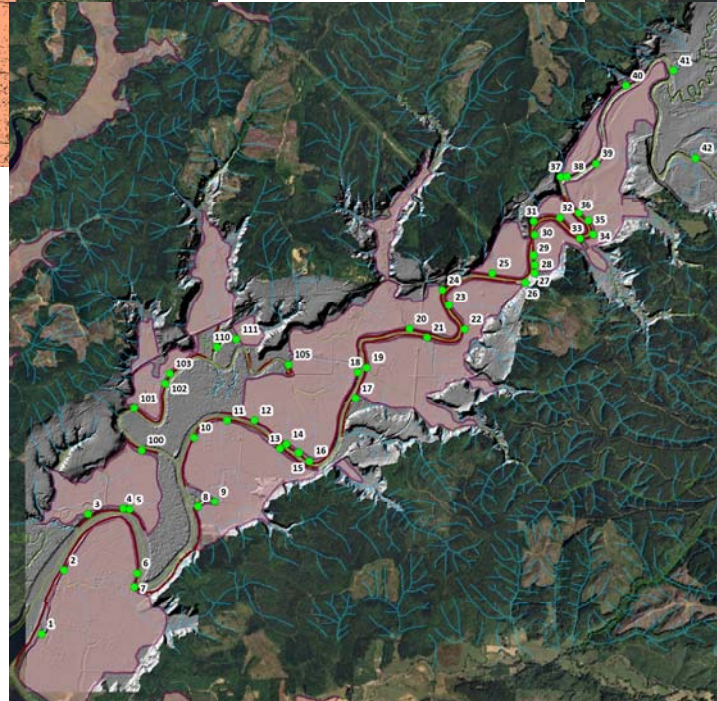
Historical and current
tidal channels identified
on the lower Grays R.;
effects of randomized sets
of dike breaches (scenarios)
were modeled.

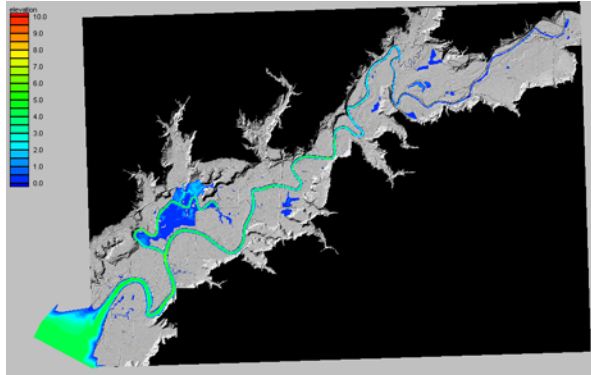
No breaches

Hydrodynamic Modeling of Random Dike Breach Patterns
