US Army Corps  
of Engineers®  
Portland District

# Mount St. Helens Ecosystem Restoration General Reevaluation Study Reconnaissance Report

Sediment Retention Structure on the North Fork Toutle River

July 2007

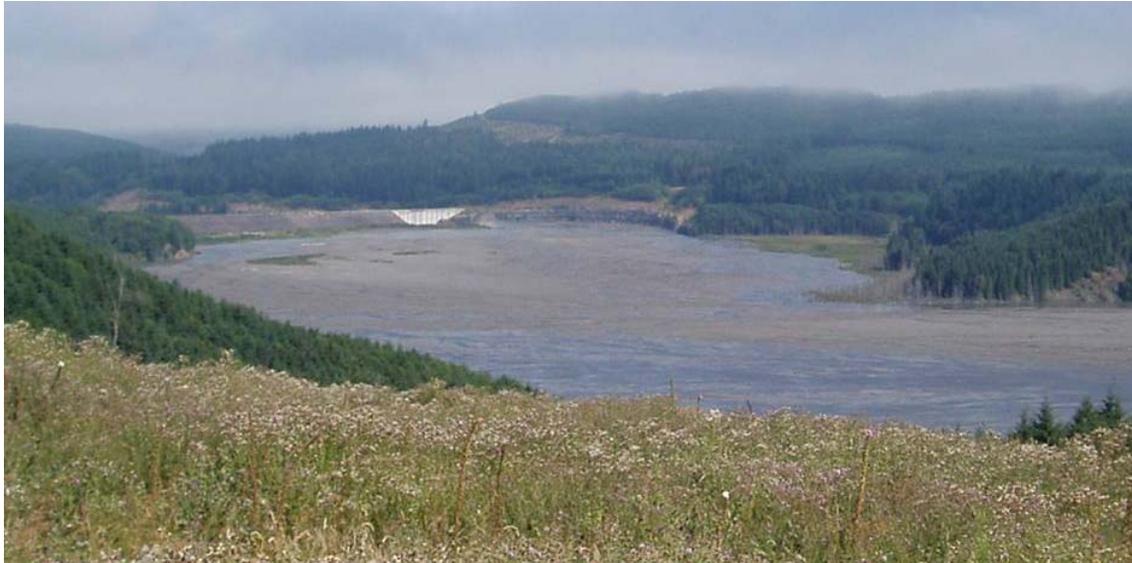
*Figure 1. Sediment Plain Upstream of SRS (seen in the distance)*

valuable upstream habitat and eliminate the problems associated with collecting and trucking the fish to upstream release sites.

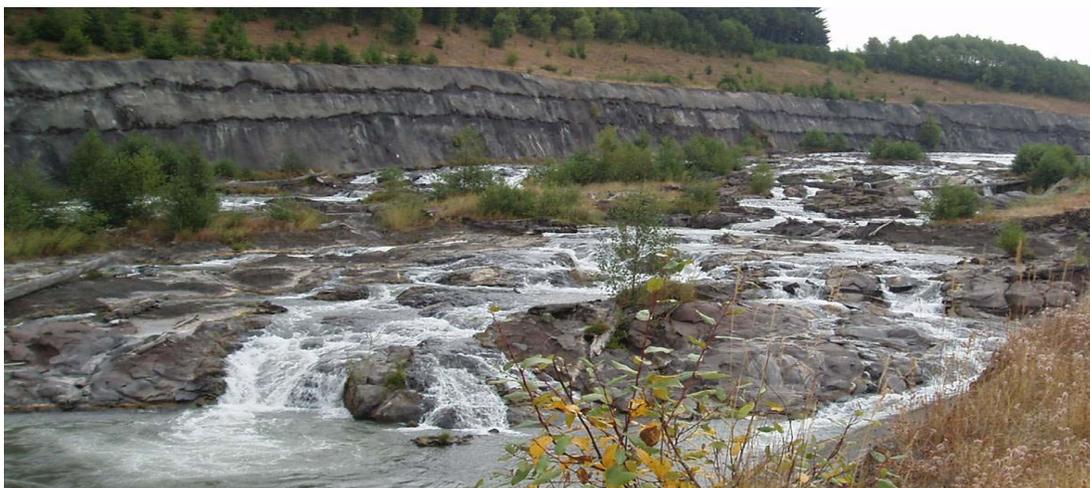
*Figure 2. Middle Section of the Spillway on the North End of SRS at Late Summer Baseflow*

The SRS spillway is a 2,200-foot long, 400-foot wide, unlined, rough-bed channel with a 7% gradient (Figure 2). High flows in 1996 damaged the spillway and caused a 6-foot vertical drop (falls) at the downstream end of the spillway. In response to the damage, the Corps constructed a weir 1,000 feet downstream of the crest to prevent down-cutting, and made minor structural repairs to the spillway. Currently, water flows through a series of high-velocity cascades and depending on flow levels, over shallow sheet-flow areas before ending in the 6-foot vertical drop at the spillway's downstream end. The water continues downstream through a combination of riffles, runs, and cascades and over a concrete velocity barrier at the fish collection facility (FCF) before merging with the Green River.

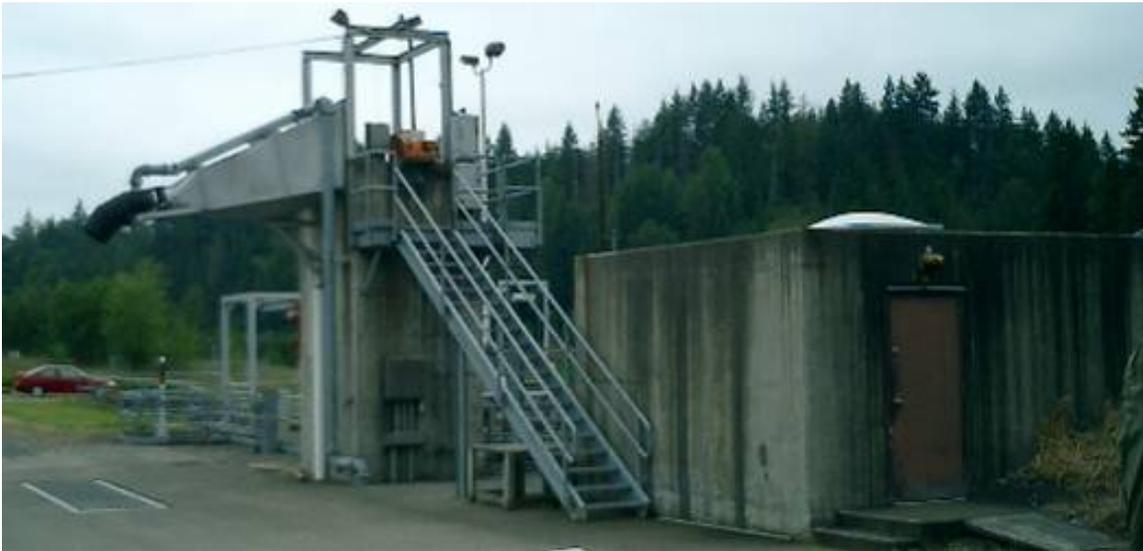
*Figure 3. Fish Collection Facility Downstream from the SRS*

As mitigation for the SRS, a trap-and-haul FCF was funded and constructed by the Corps on the North Fork Toutle River 1.3 miles downstream from the SRS to facilitate fish passage (Figure 3). The FCF was turned over to the State of Washington to operate and maintain. Adult steelhead trout (*Oncorhynchus mykiss*) and coho salmon (*Oncorhynchus kisutch*), both threatened species under the ESA, are collected at the FCF. Fish are collected by diverting a portion of the river above the FCF into a fish ladder. Fish are attracted by this flow into the ladder and move up into a collection pond. Fish are then moved into transport tanks on trucks and taken to two upstream release locations (Hoffstadt and Alder creeks). Transported fish are released randomly in each stream without knowledge of their stream of origin. Large sediment volumes in the North Fork Toutle River have contributed and continue to contribute to FCF operational problems.

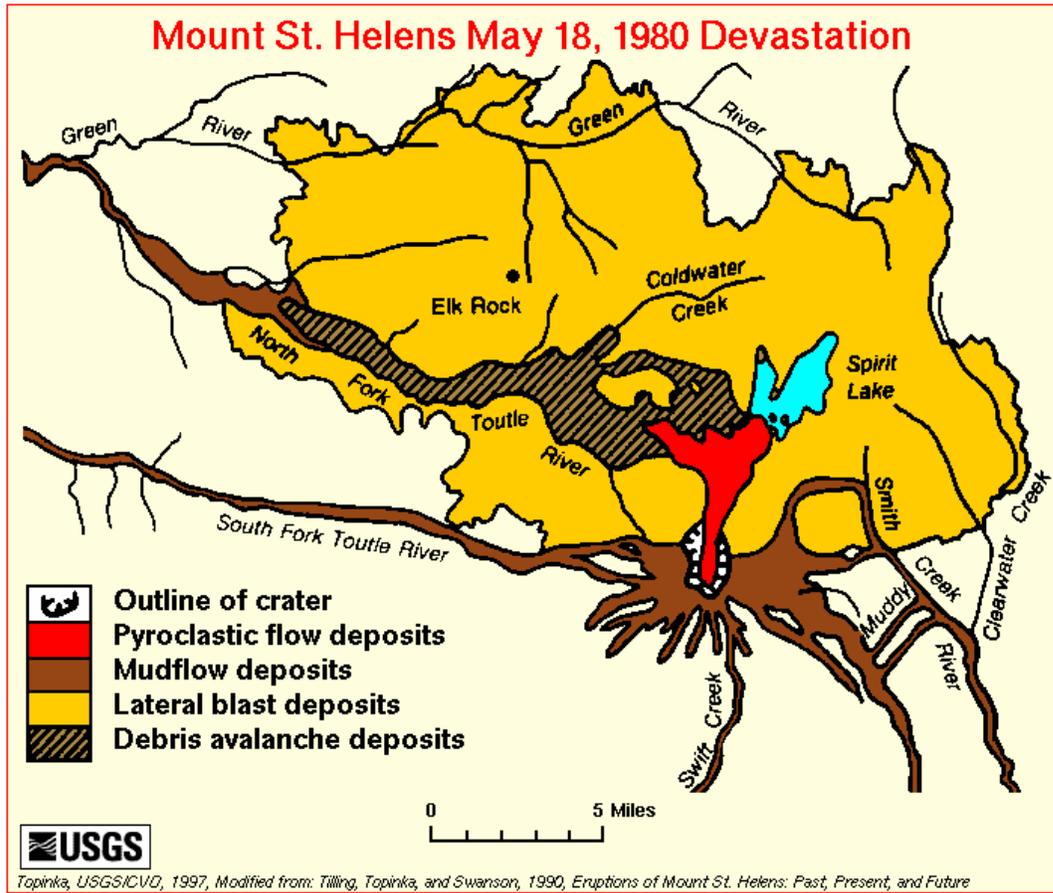
Figure 5. Types of Deposits from the 1980 Mount St. Helens Eruption

The 1980 eruption of Mount St. Helens had the greatest impact on the North Fork Toutle River, which received the majority of the debris avalanche deposit (Figure 5). The Green River and South Fork Toutle River were affected by mudflow deposits. The effects of lateral blast and volcanic deposits altered the landscape characteristics of the three basins and changed the hydrologic characteristics. These effects were seen by increased peak streamflow that affected autumn and winter peaks for a period of 5 years post eruption. The immediate post-eruption changes were driven by modifications to hillslope hydrology (Major and Mark 2006). Table 1 shows the Toutle River drainage areas affected by the lateral blast and volcanic deposits.

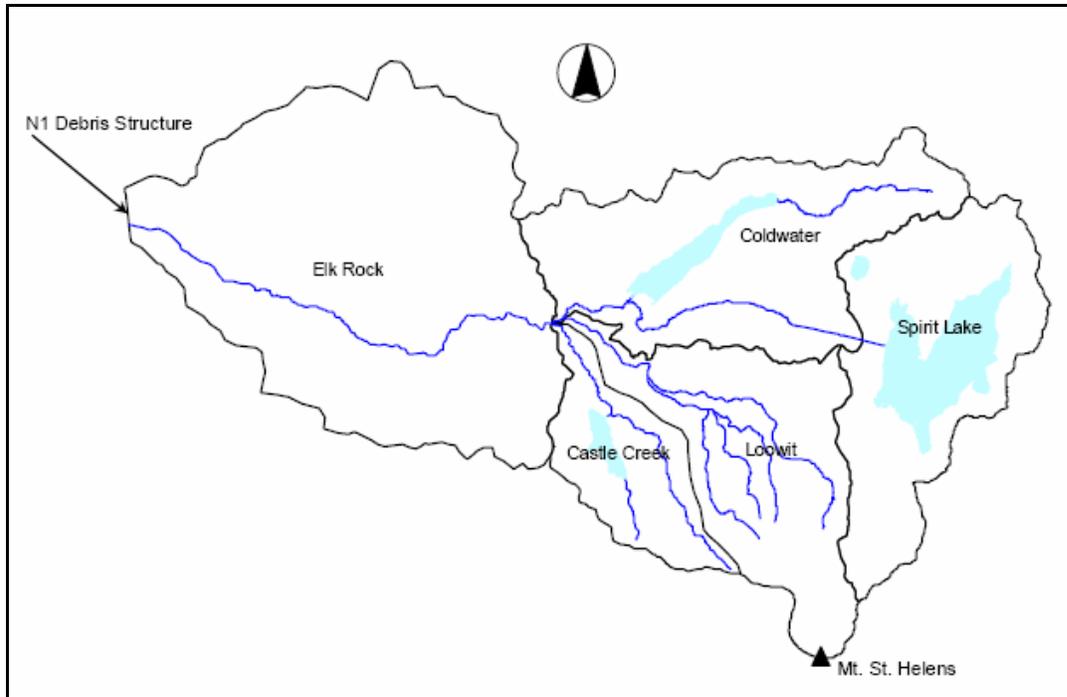
Figure 6. Primary Sediment Source Sub-areas above N-1 Debris Retention Structure

Figure 6 shows the primary sediment sub-areas in the Toutle River watershed. Digital Elevation Models (DEMs) were developed from aerial photography for 1987 (pre-SRS) and 1999 in the form of Triangulated Irregular Networks (TINs) as part of the Corps' 2002 Mount St. Helens Engineering Reanalysis study. The DEMs were used to estimate the total erosion on the debris avalanche upstream of the SRS and the total deposition behind the SRS from 1987-1999 (Figure 7 and Table 2).

Erosion estimates were defined for each of the primary sediment sub-area on the debris avalanche. These sub-areas include Elk Rock, Coldwater, Castle, and Loowit creeks. Deposition estimates were developed for the North Fork Toutle River between the SRS and N-1 debris retention structure. The Elk Rock and Loowit sub-areas accounted for the majority of sediment yield to the SRS and North Fork Toutle below SRS; when combined, these two sub-areas account for 78% of total debris avalanche erosion from 1987 to 1999.

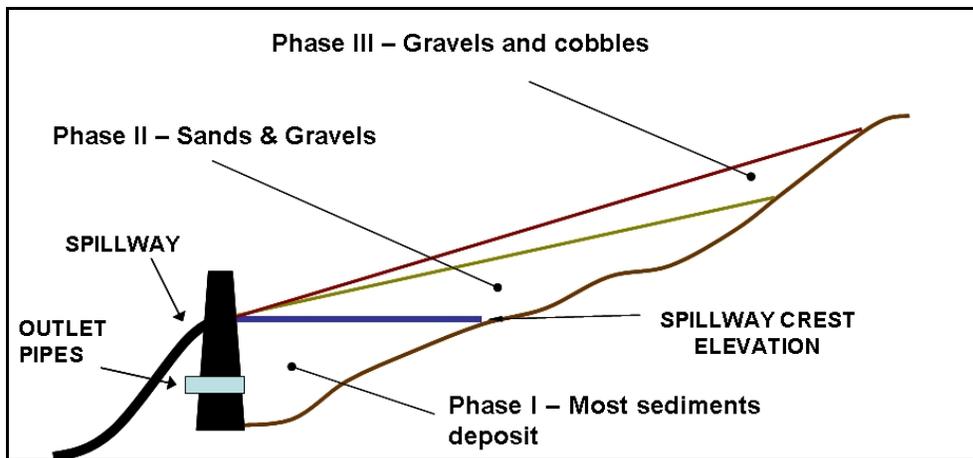
Figure 8. SRS Design and Filling Pattern

The SRS was designed to operate in three general phases (Figure 8). The operational phases were based on the expected pattern of sediment deposition behind the dam and type/grain size of sediment to be trapped. Phase I was initiated when the SRS began trapping sediment behind the structure in November 1987.

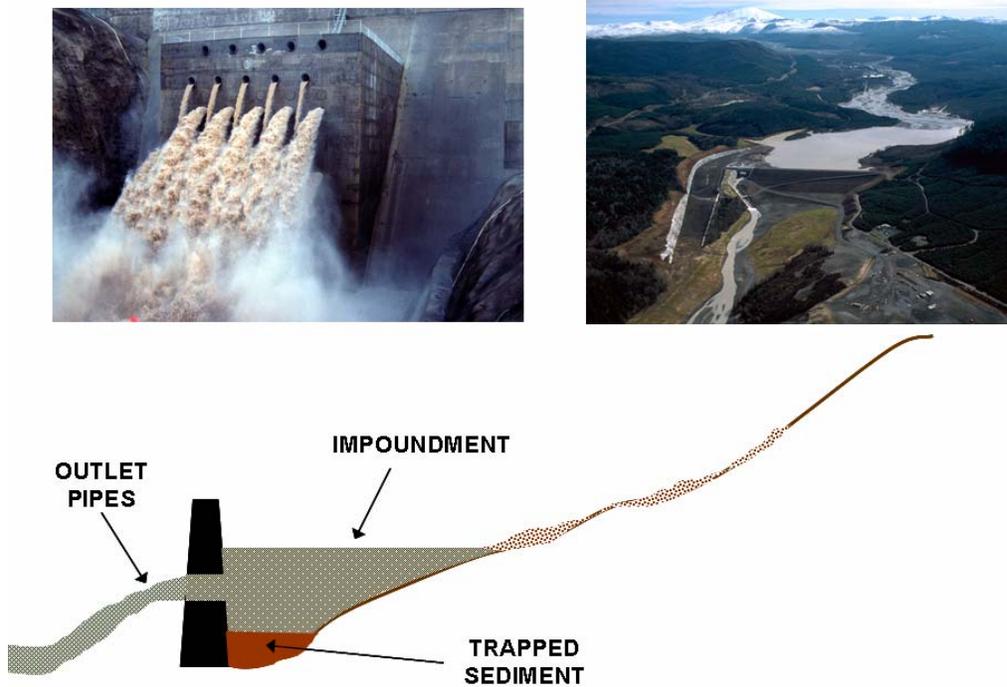
Figure 9. Phase I Operation, Photographs of Outlet Pipes and View Showing SRS

For phase I operation, an impoundment was created by the dam and water was discharged through a series of outlet pipes (Figure 9). During phase I the majority of sediment moving through the system was deposited behind the SRS. Only silts, clays, and some very fine sand passed through the SRS via the outlet pipes. As sediments filled the impoundment, water was discharged through rows of outlet pipes at a higher elevation. Table 3 shows the dates when each row of outlet pipes were closed. By April 1998 the last row of outlet pipes was closed and nearly 90 million cubic yards (mcy) of sediment had filled behind the SRS. The upper row of pipes may be reopened, if necessary.

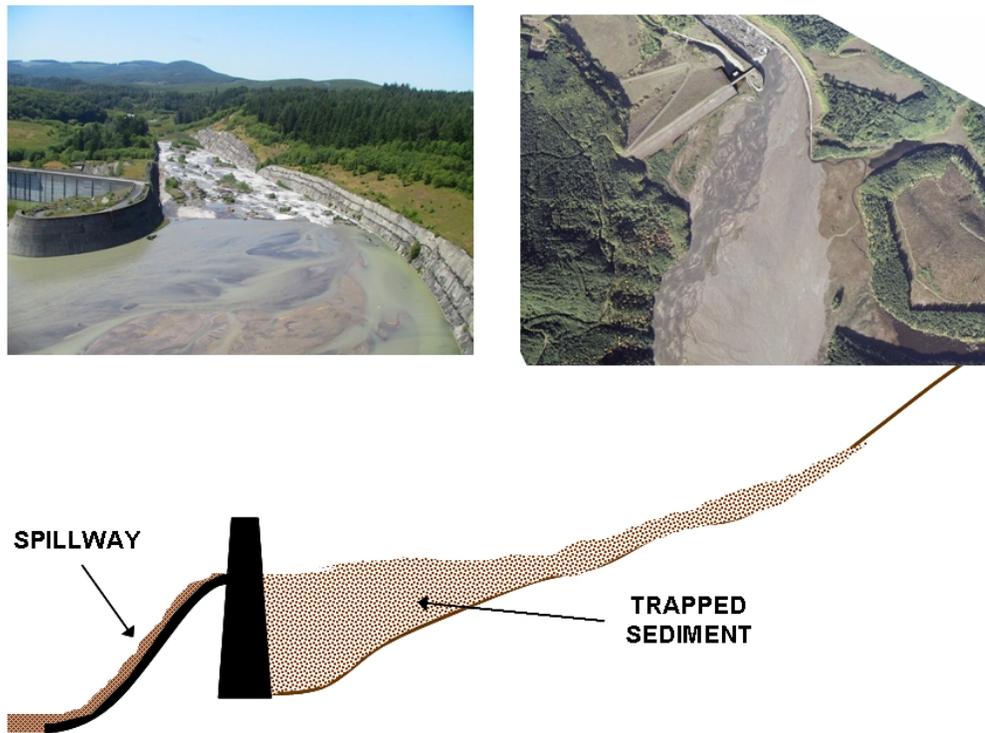
Figure 10. Phase II Operation, Photographs of Outlet Spillway and View of SRS

The second phase of operation began as the sediment reached the level of the spillway in 1998 (Figure 10). Since that date all North Fork Toutle River water flows through the spillway. Cumulative sediment deposition behind the SRS during phase II to date is estimated at 17.6 mcy, which brings the total deposition as of October 2006 to 105.3 mcy. The trap rate for phase II operation to date is 2.2 mcy/year (1998-2006). Data collected since the 2002 Mount St. Helens Engineering Reanalysis Study was used to update performance data on the project.

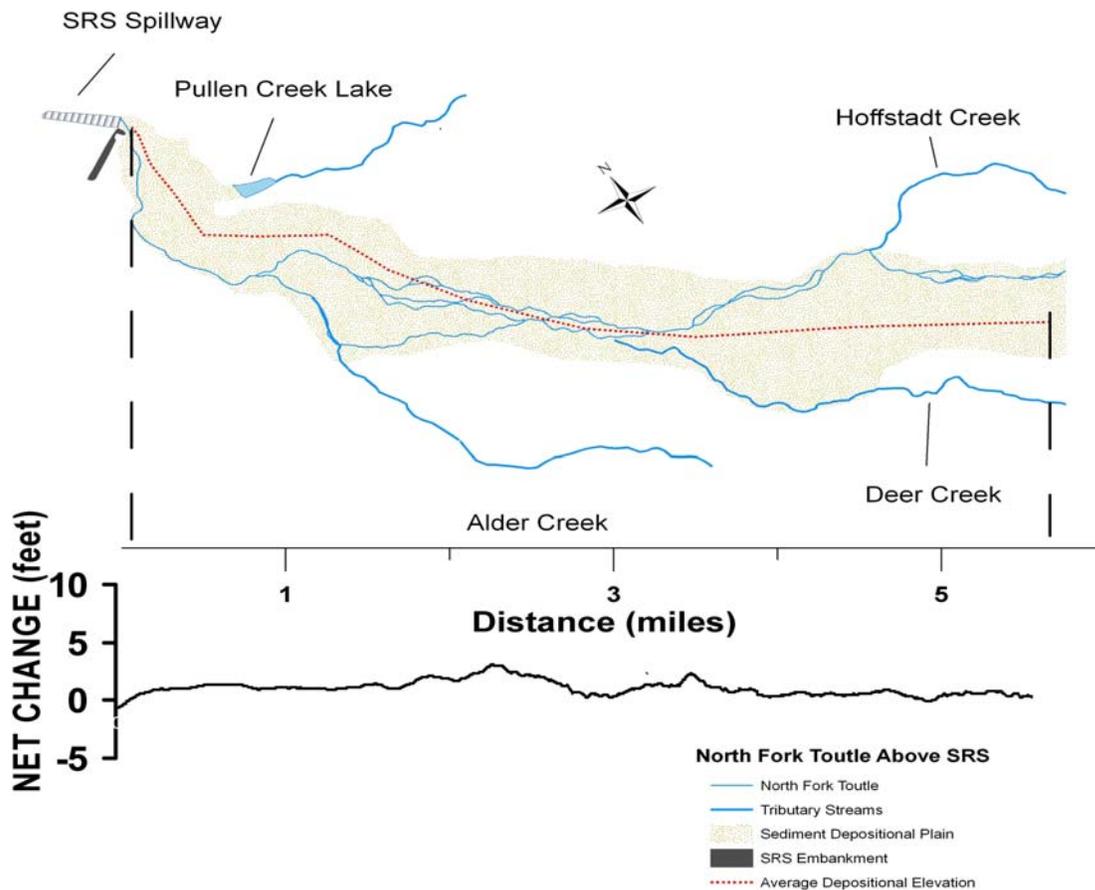
Figure 11. Tributaries to North Fork Toutle above SRS, Net Elevation Change 2005-2006

Figure 11 shows a general schematic of the tributary streams draining the North Fork Toutle through the sediment plain and a relative change in ground elevation (2005-2006) throughout this reach.

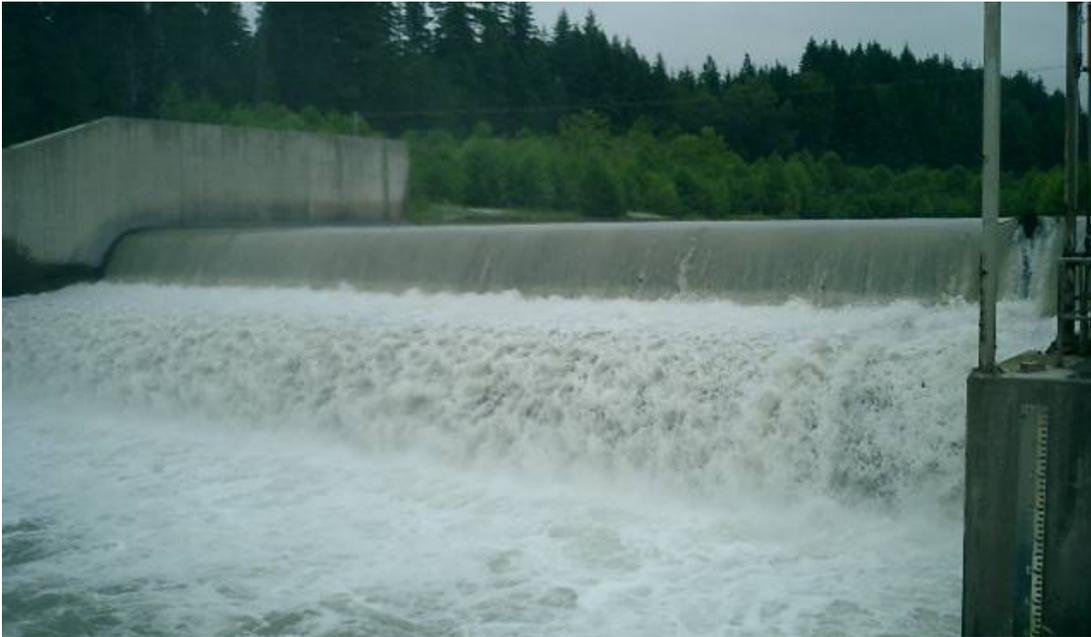
Figure 14. FCF Fish/Velocity Barrier

**Remove FCF Fish/Velocity Barrier.** If the SRS spillway improvements lead to desirable volitional fish passage, the next step could be to modify the FCF itself to allow for volitional passage. Volitional passage at the FCF is prevented by a concrete fish/velocity barrier (Figure 14). The barrier forms a two-tiered falls about 25 to 30 feet in height. To allow for volitional fish passage, the concrete structure would be removed and the upstream river channel would be graded to produce a navigable slope and channel for fish. The total estimated cost for this measure is \$1 million.
