## Joint Aquatic Resources Permit Application (JARPA) Form<sup>1,2</sup>

**Mouth of the Columbia River (MCR) – Jetty A Rehabilitation Project (the "Project")**

PROPOSED JETTY A REHABILITATION  
 PURPOSE: TO STRENGTHEN THE JETTY A STRUCTURE  
 IN: MOUTH OF COLUMBIA RIVER, USCG CAPE DISAPPOINTMENT  
 CITY & COUNTY : NEAR ILWACO, PACIFIC COUNTY  
 STATE : WASHINGTON  
 APPLICATION BY: U.S. ARMY CORPS OF ENGINEERS, PORTLAND DISTRICT  
 SHEET 1 OF 9 DATE: APR 17, 2015

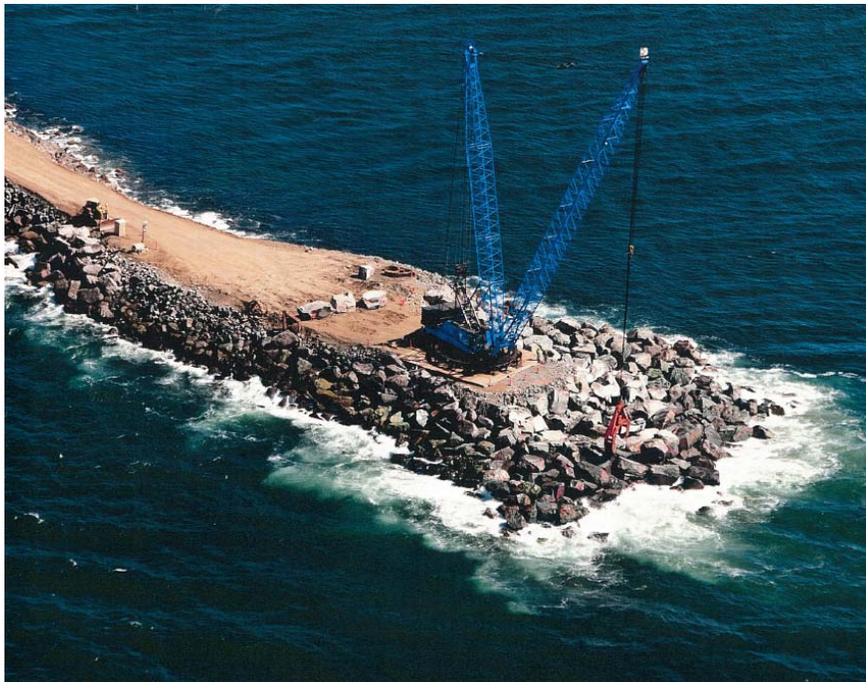
The below photographs shows construction during recent repairs at the Tillamook Bay North Jetty in 2010, specifically, one example of an access pathway on top of the jetty, placement of stone on the jetty and the staging area north of

the jetty root. At Tillamook Bay, a MOF was not required nor constructed to transport stone to the site. A MOF is currently an option for the MCR Jetty A Project.

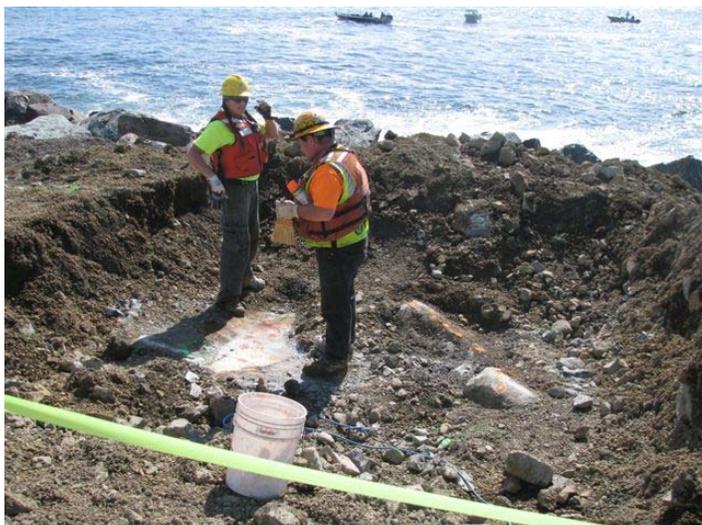
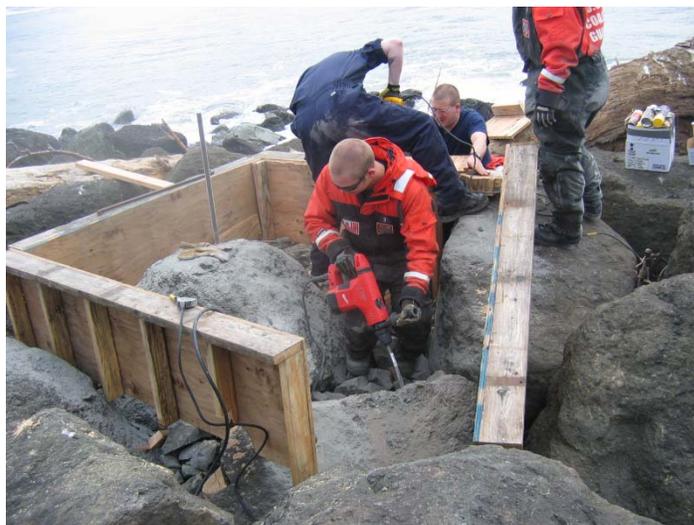
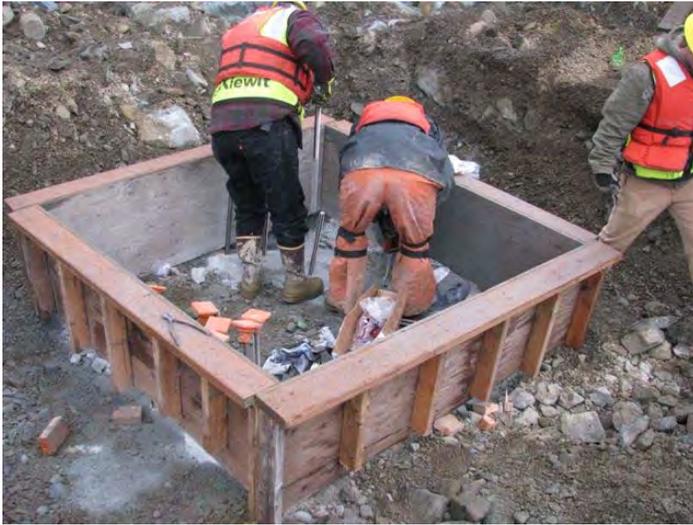
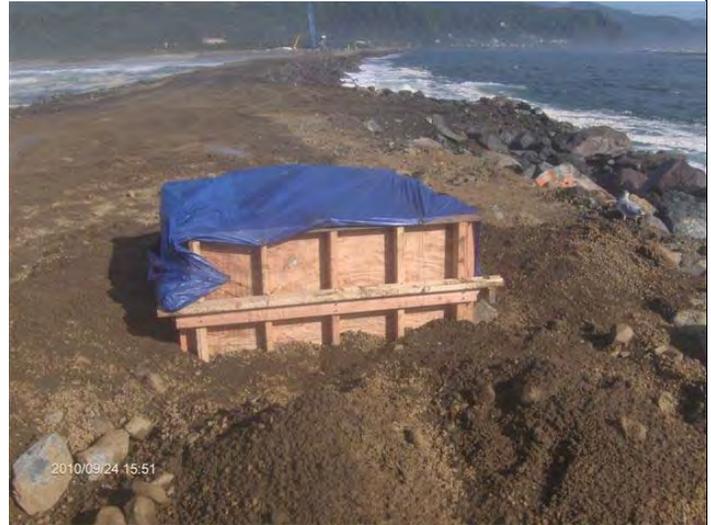
If the existing USCG navigational tower structure at Station 78+00 is to be replaced, the USACE will do using similar construction methods used at the Tillamook Bay North Jetty in 2010. First, the existing base, in need of replacement is removed and the armor stone exposed. Then, anchors are drilled, the bottom graded with finer stone so that any concrete will not seep through cracks in the jetty stone, and a frame used to contain the new concrete base. The bellow photographs provide examples of a very similar tower replaced on one of the Tillamook jetties.

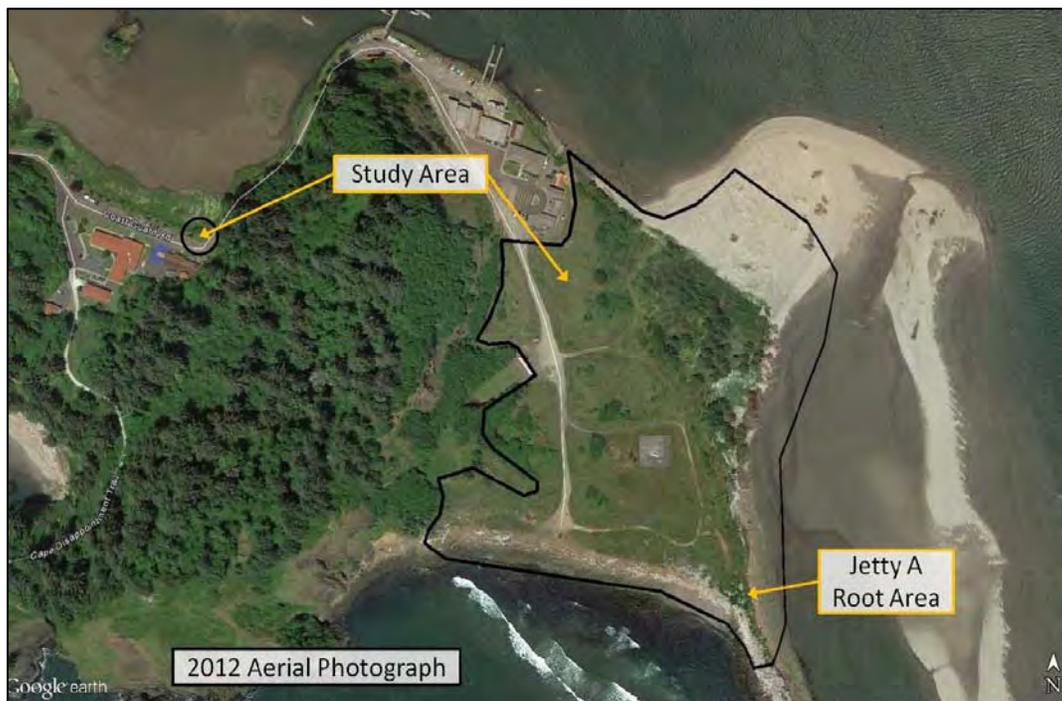
**Figure 2. Jetty A study area (Source: USACE 2015)**

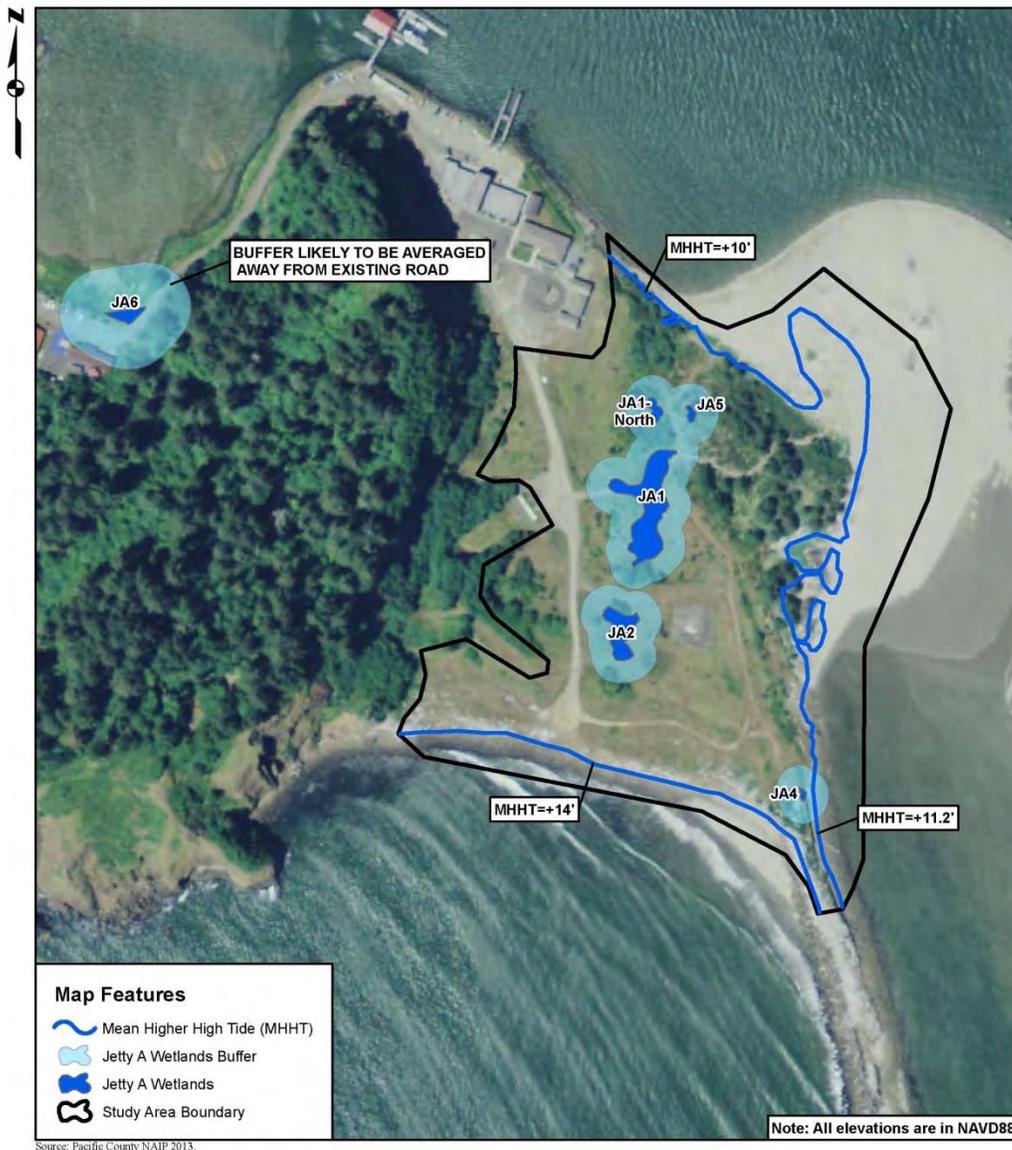
**Figure 3. Jetty A wetland delineation map**

Six wetlands were delineated within the Jetty A project limits during a site visit conducted by the USACE in December 2014. These wetlands are summarized in Table 1 and described briefly below.

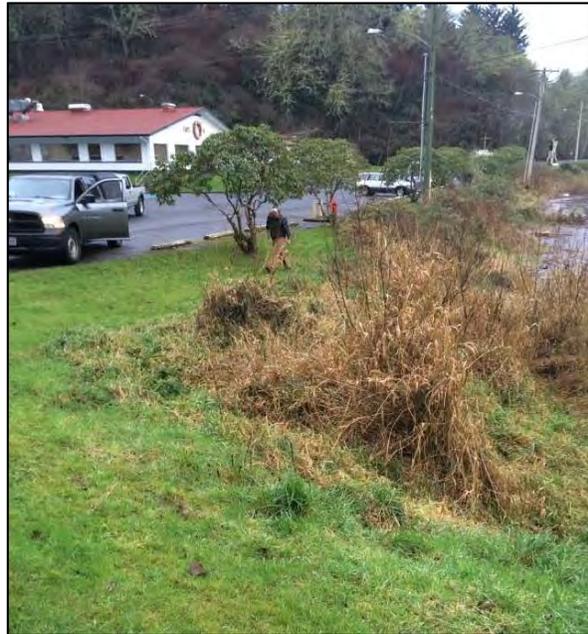
**Figure 4. Looking northwest at Wetland JA6 (Source: USACE 2015)**

Wetland JA6 was outside the 2011 wetland study area. The wetland is classified by the USFWS as Estuarine Intertidal Emergent, persistent (E2EM1). The portion of tidal fringe wetland area that is within the study area is approximately 1,650 ft<sup>2</sup> and is located waterward of the USCG access road and main buildings and downslope of the mowed and maintained road right-of-way (Figure 4). Wetland JA6 is hydrologically fed by a 24-inch concrete culvert under the road and by tidal fluctuations in Baker Bay. The upper fringe of the wetland that will be affected by road widening is dominated by reed canary grass (*Phalaris arundinaceae*). The wetland is a part of much larger tidal fringe wetland that extends to the northwest. Further from shore, the wetland vegetation shifts to intertidal mudflats.

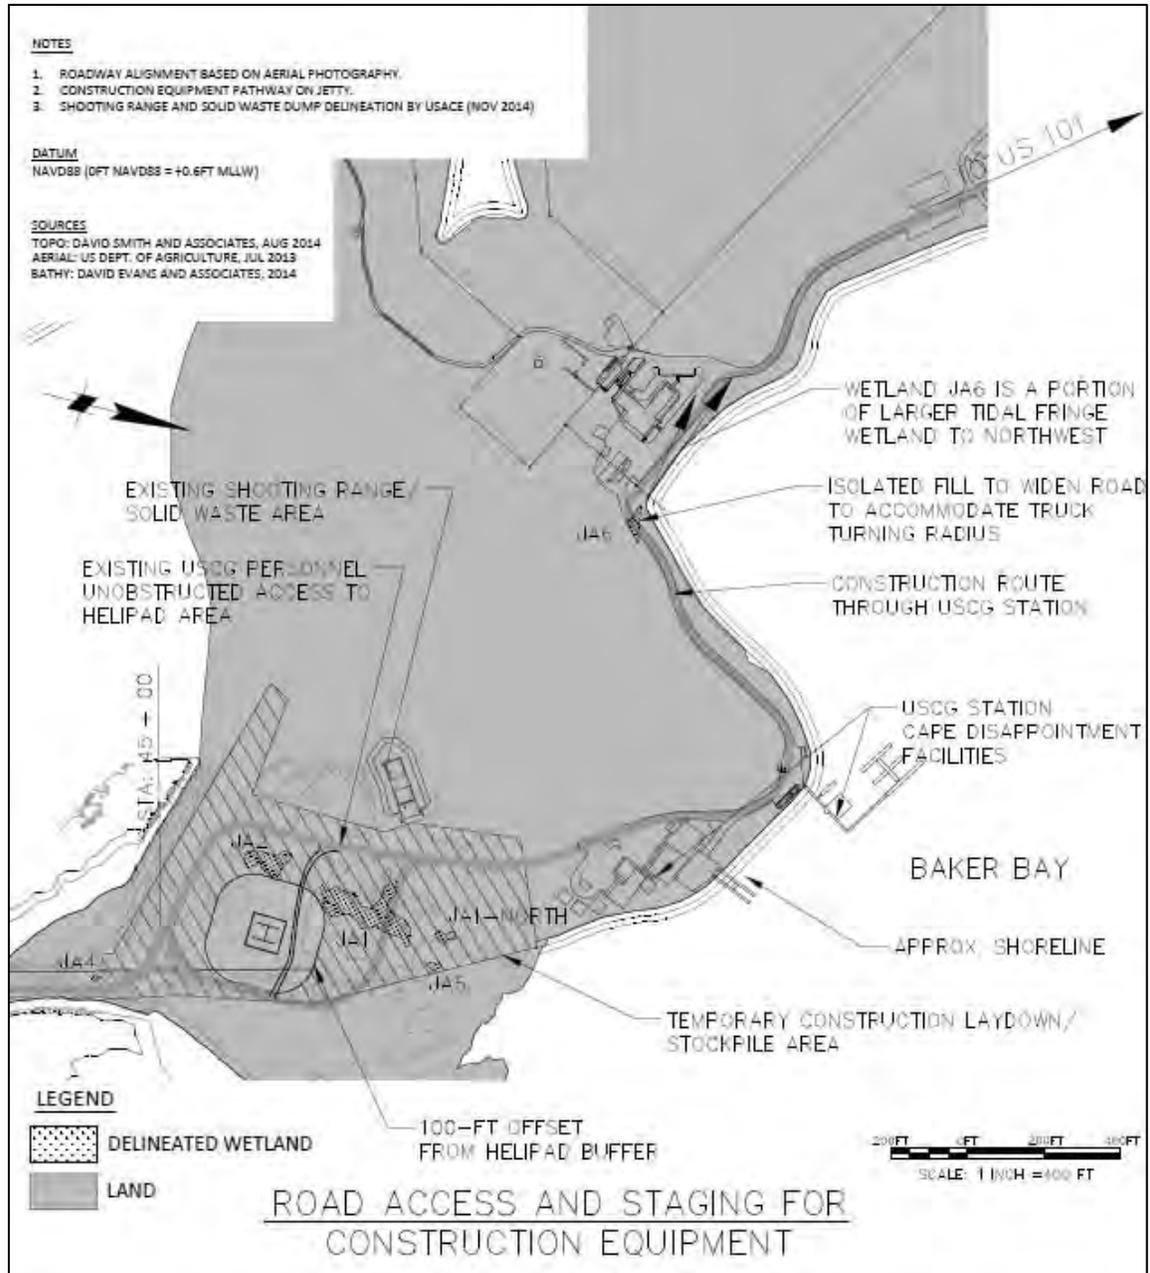
Figure 3. Jetty A Access and Staging Area Draft Plan

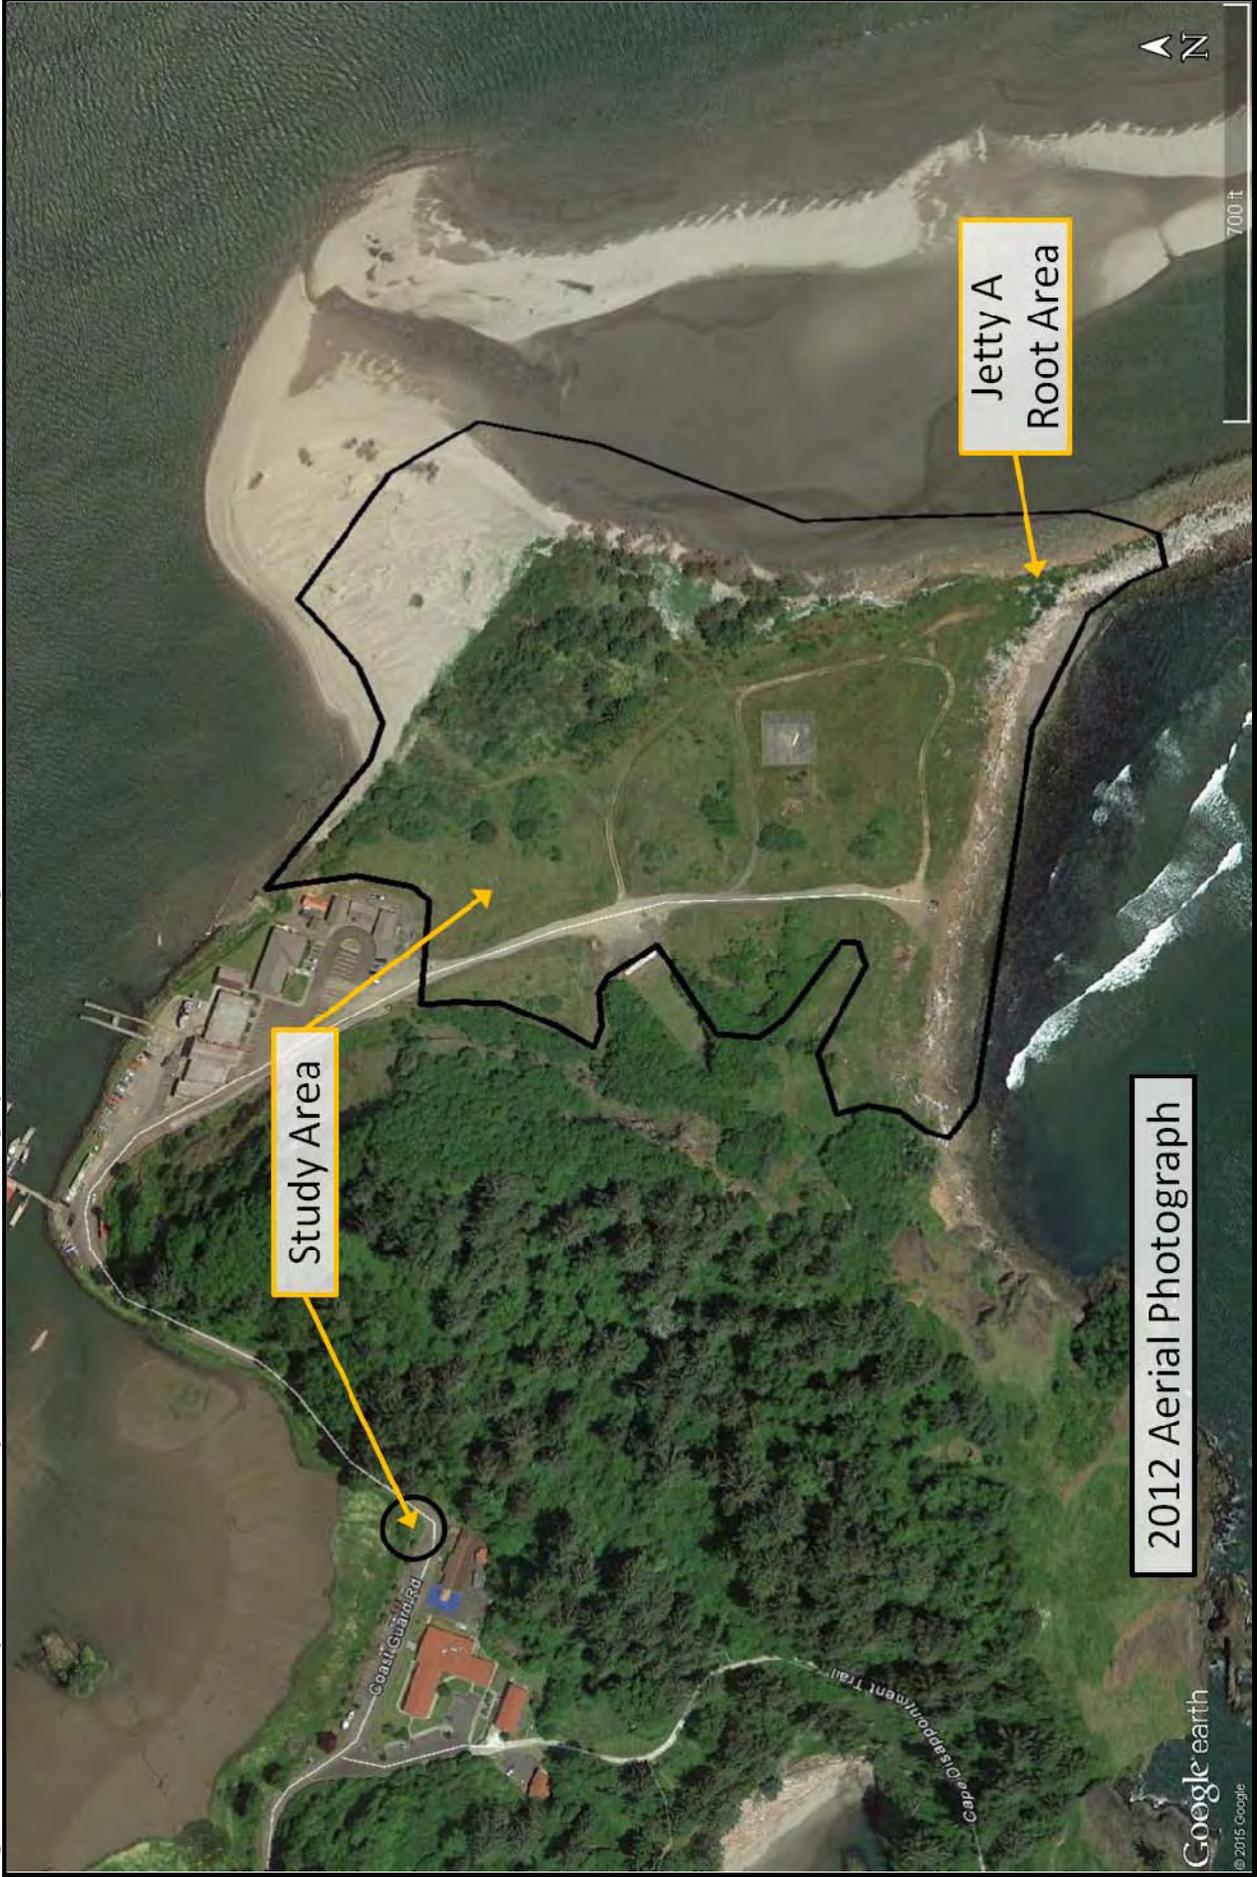
Figure 3: 1996 Aerial Photograph of MCR Jetty A (Source: Google Maps).

The southwestern bank that is directly exposed to ocean storm events and strong river currents has receded approximately 90 feet since 1996. This erosion is lesser due to armoring by large diameter basalt boulders and the compacted nature of the upper terrace.

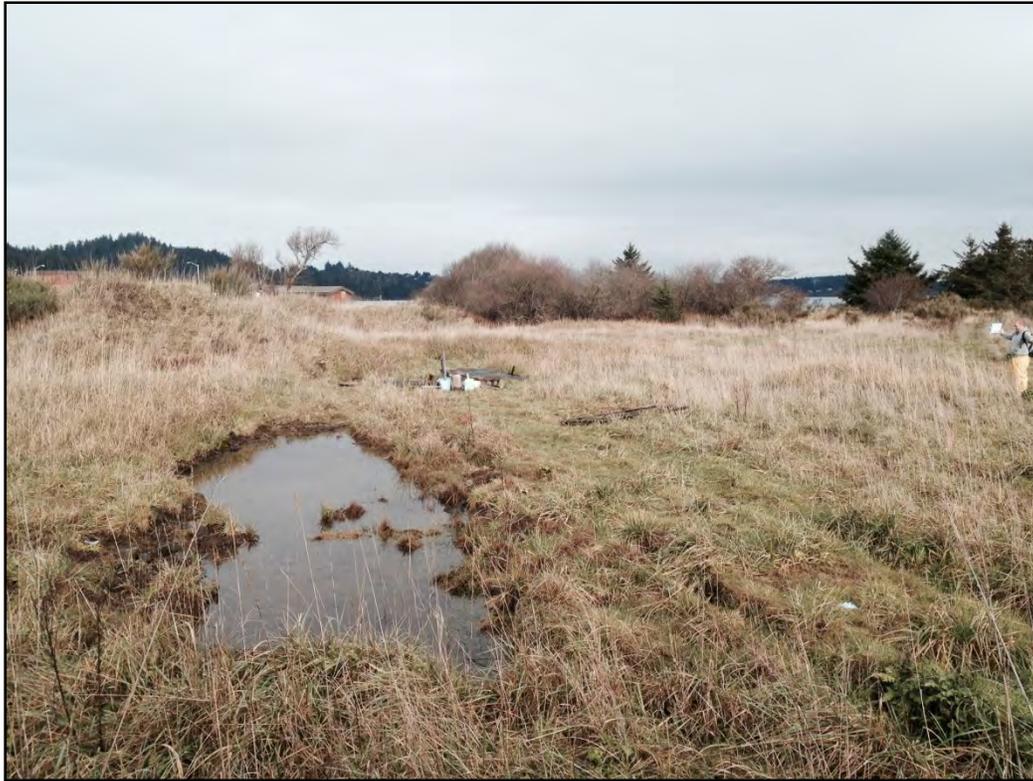
**Photograph 1.** Facing north, a view of Wetland JA1.

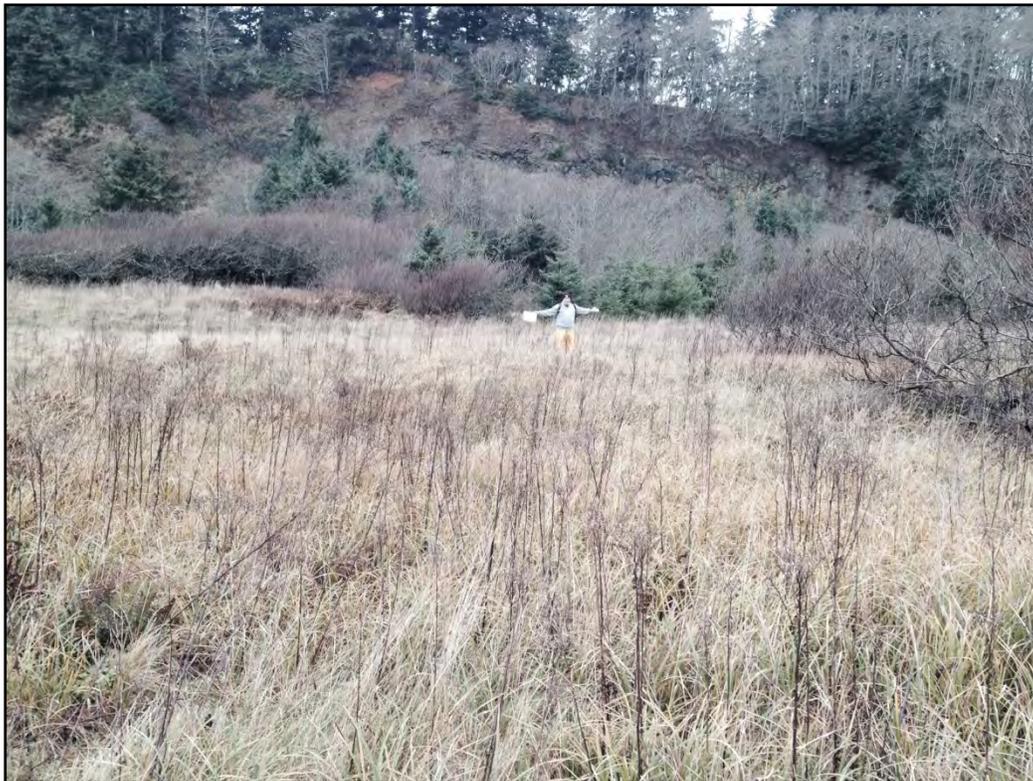
**Photograph 2.** Facing west, a view of Wetland JA2.

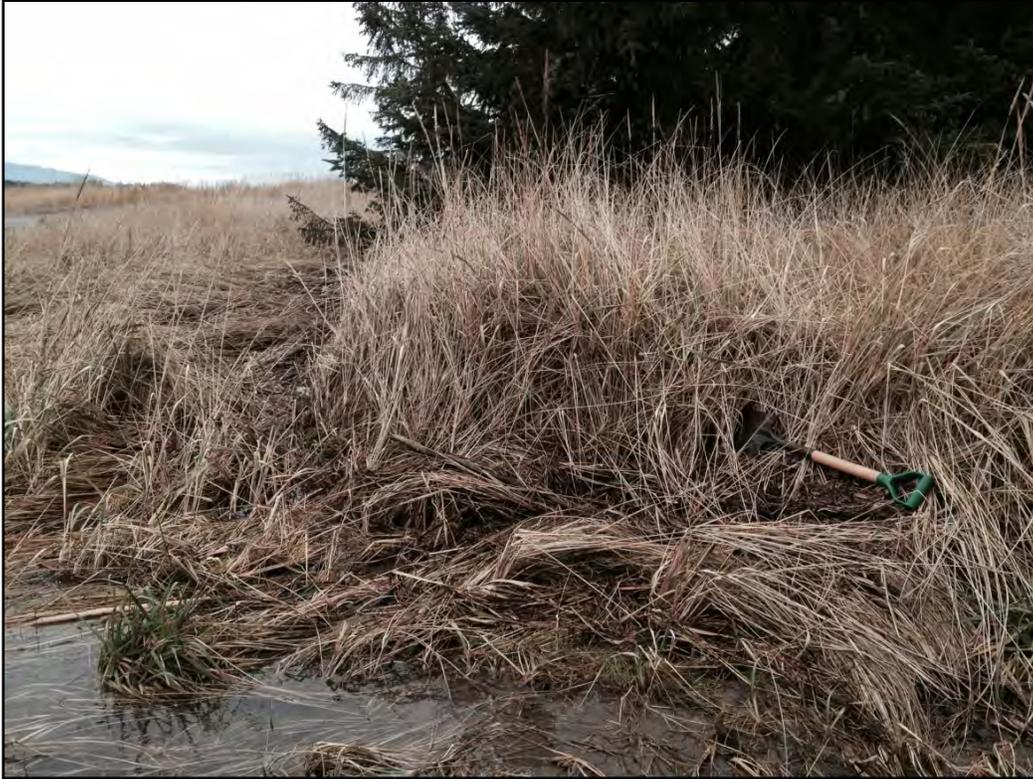
**Photograph 3.** Facing southeast, a view of the MHT on the northern boundary.

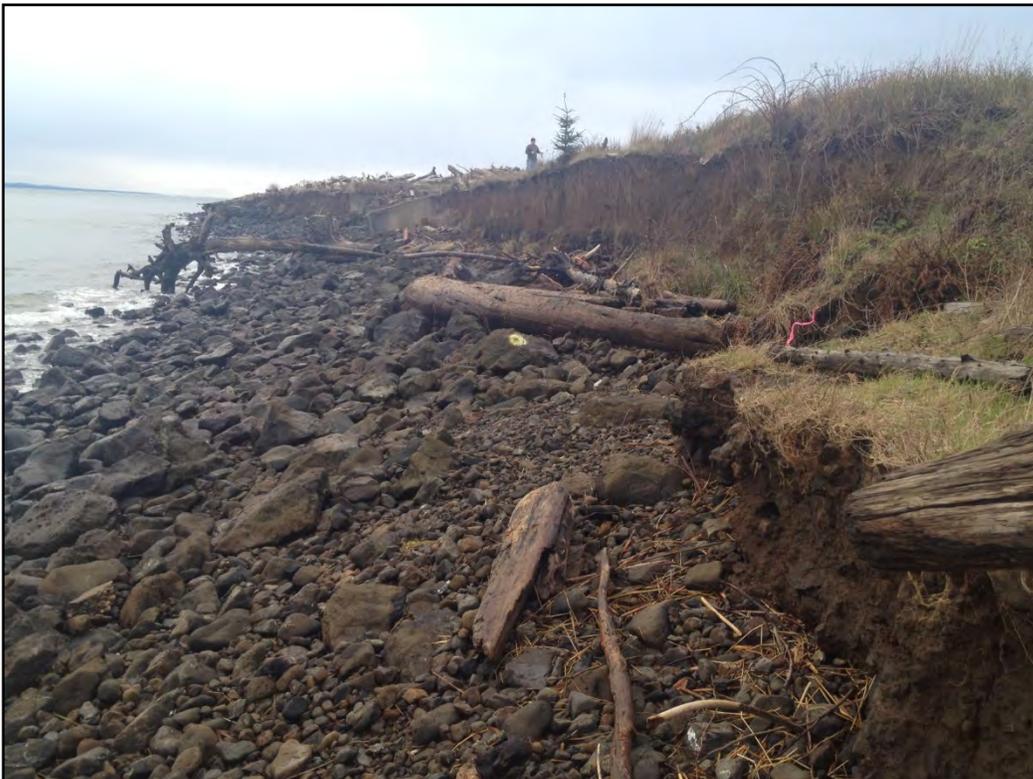
**Photograph 4.** Facing south, a view of the MHT along the eroding eastern bank of Jetty A.

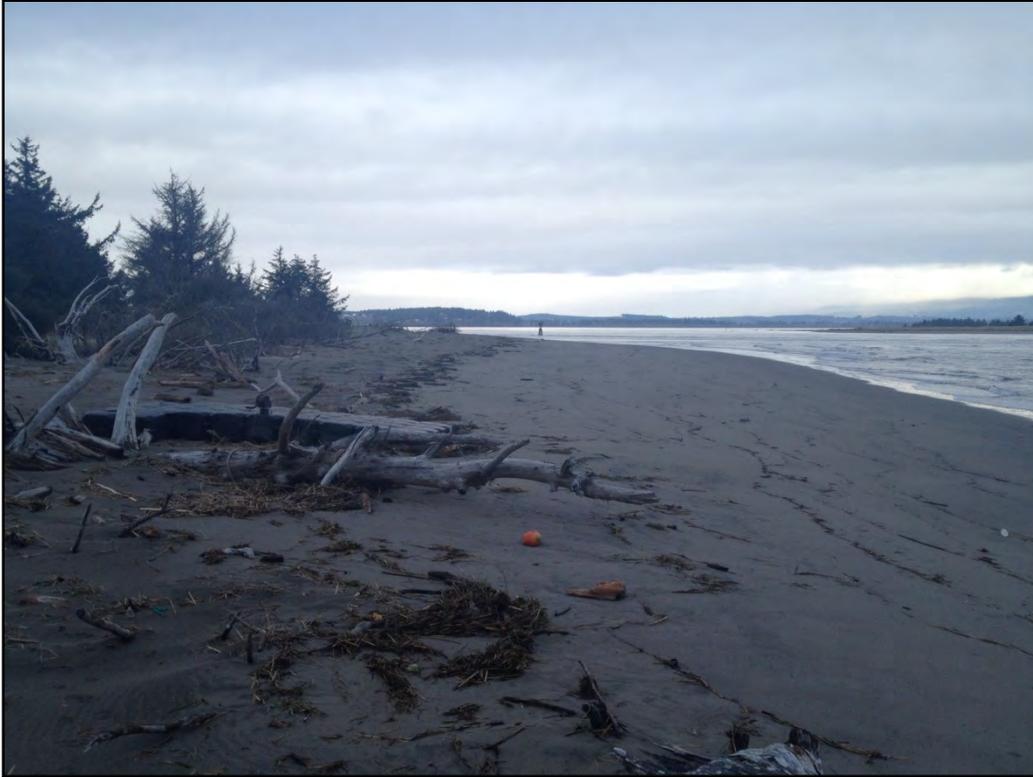
**Photograph 5.** Facing north, a view of the beach area on the eastern site boundary.

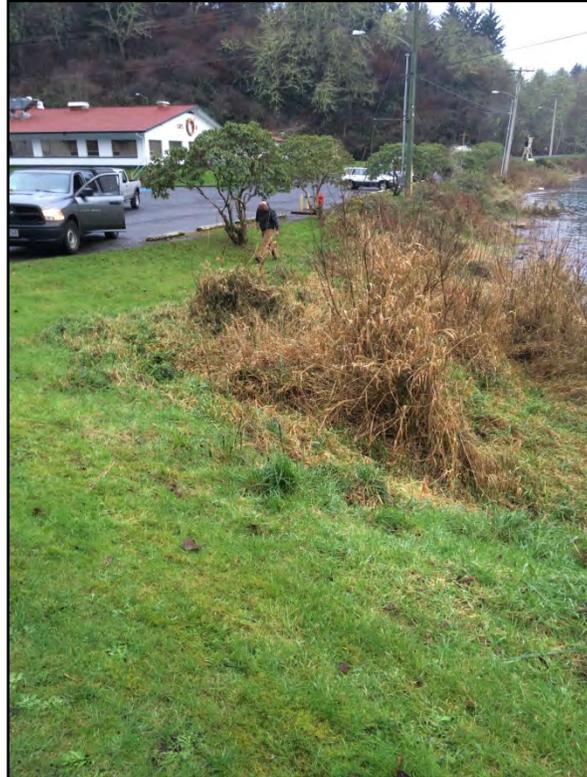
**Photograph 6.** Facing northwest, a view of Wetland JA6 on the fringe of the cove.

Wetland JA6. Wetland JA6 (Photograph 6) was outside the 2011 wetland study area. The portion of tidal fringe wetland area that is within the study area is approximately 1,650 sq. ft. The fringe wetland is located water ward of the USCG access road and main buildings (Figure 4). It is located down slope of the mowed and maintained road right-of-way and it is hydrologically feed by a 24-inch concrete culvert under the road and by tidal fluctuations. The upslope portion of the wetland to be affected by road widening is dominated by reed canary grass. It is a part of much larger tidal fringe wetland that extends to the northwest along the sheltered cove. Further from shore, the wetland vegetation shifts to salt-tolerant species and intertidal mudflats. This larger estuarine, intertidal, emergent (E2EM1) wetland was evaluated using the Special Characteristics section of the updated 2014 Washington State protocol. It is considered a Category I wetland because it is an estuarine wetland that is partially with a state park.

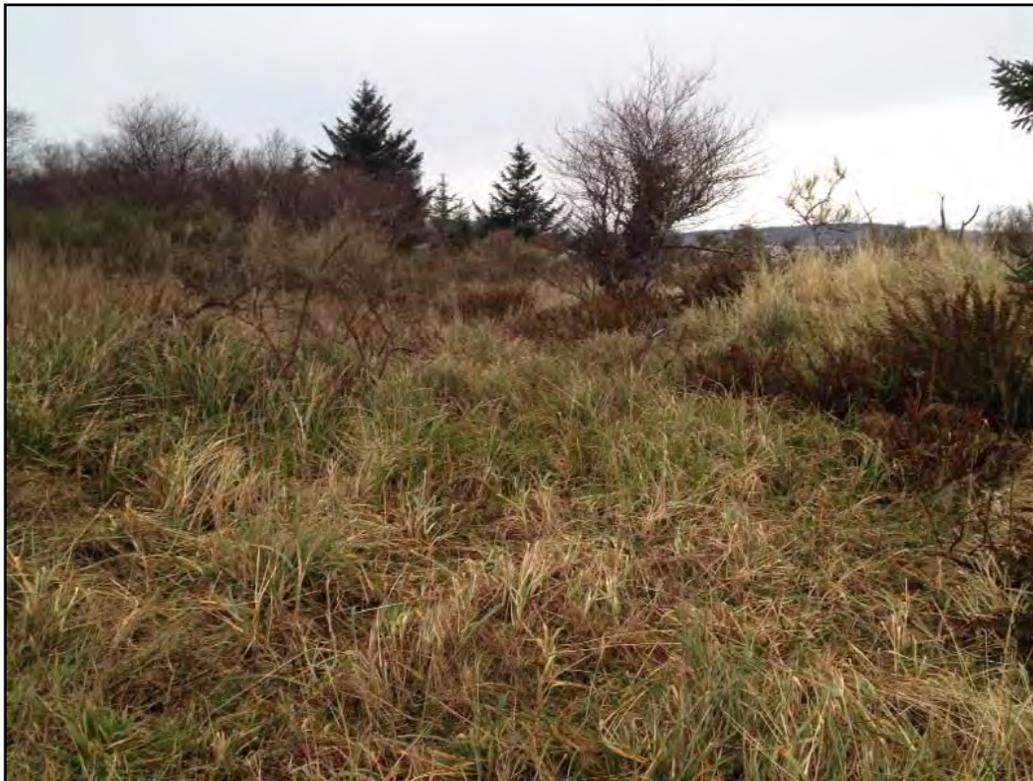
**Photograph 8.** Facing east, a view of Wetland JA5.

Wetland JA5. Wetland JA5 (Photograph 8) was not previously delineated in 2011. Its area is only 500 sq. ft. and it is located on the upper terrace, east of the USCG two-track path (Figure 4). Even though it is very small, the palustrine emergent (PEM) wetland was rated using the updated 2014 Washington State protocol. It received a score of 19 and is considered a Category III wetland based on its functions.

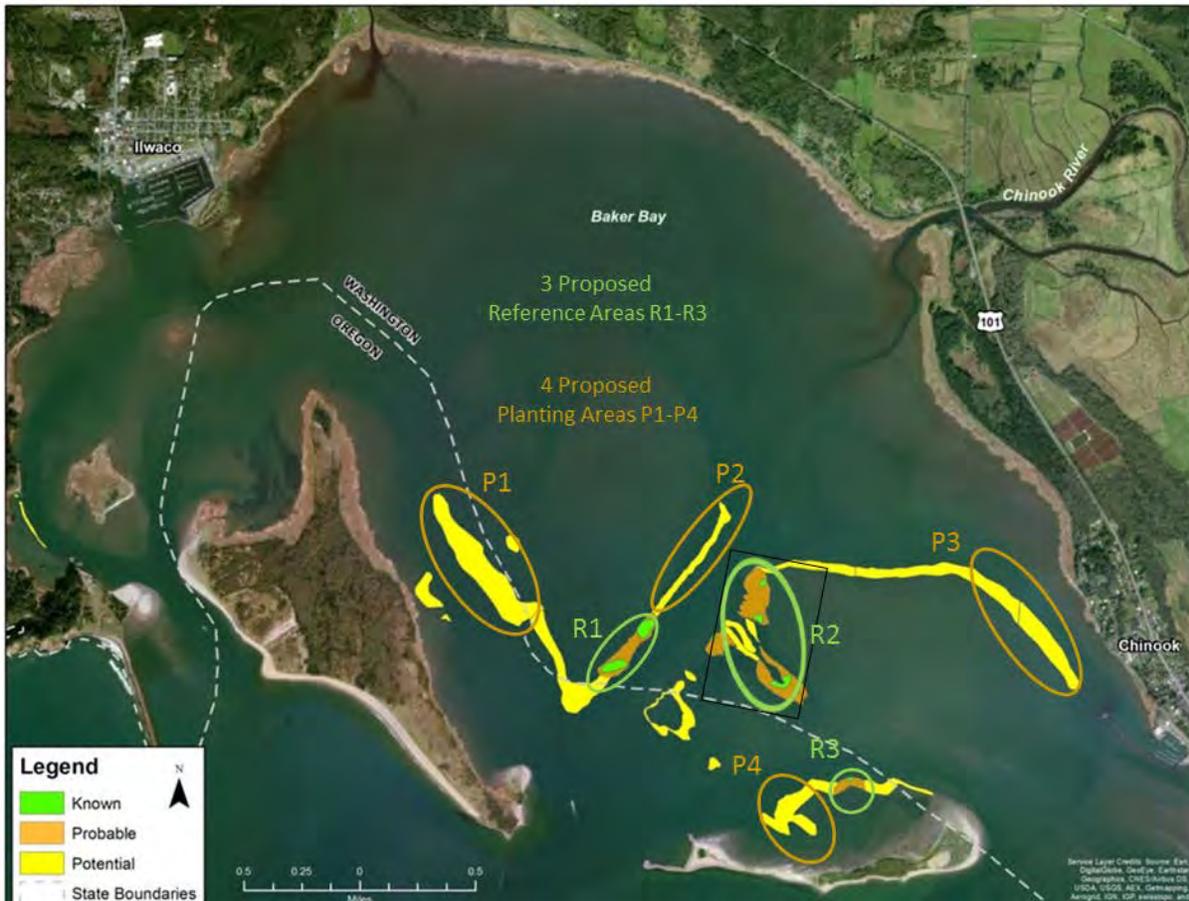
**Figure 3. Four potential eelgrass mitigation planting sites (P1-P4) and three potential reference areas (R1-R3) based on areas of known, probable, and potential eelgrass in Baker Bay as of 2008 (Figure created using data provided by A. Borde).**
