Mouth of the Columbia River Jetties Three-Phase Construction Plan

Project Overview

October 9, 2012

MCR Jetties Major Rehabilitation

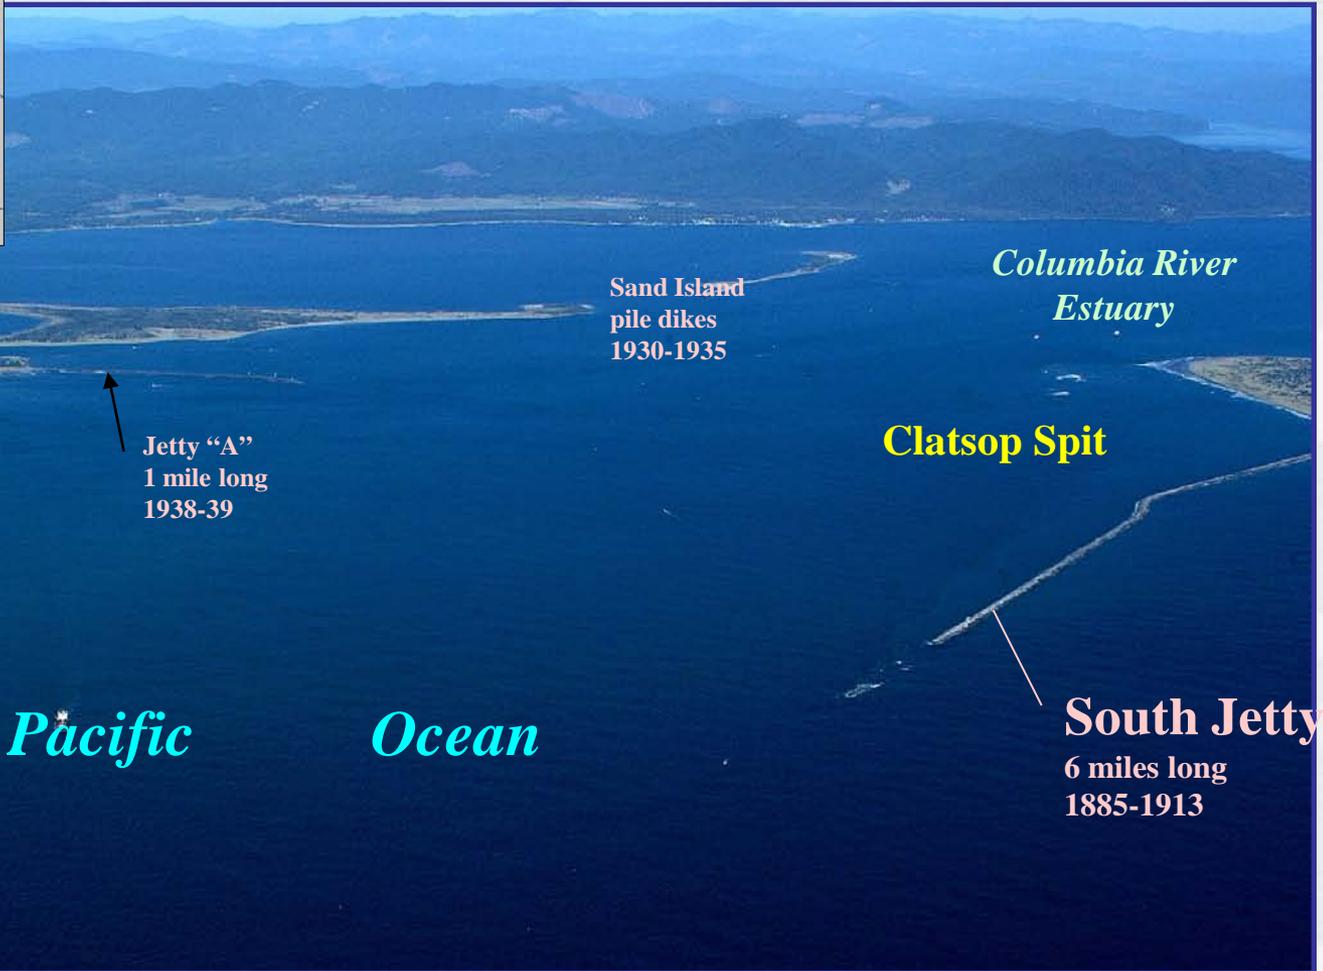
North Jetty 2.5 miles long 1914-1917

Jetty "A" 1 mile long 1938-39

Sand Island pile dikes 1930-1935

South Jetty 6 miles long 1885-1913

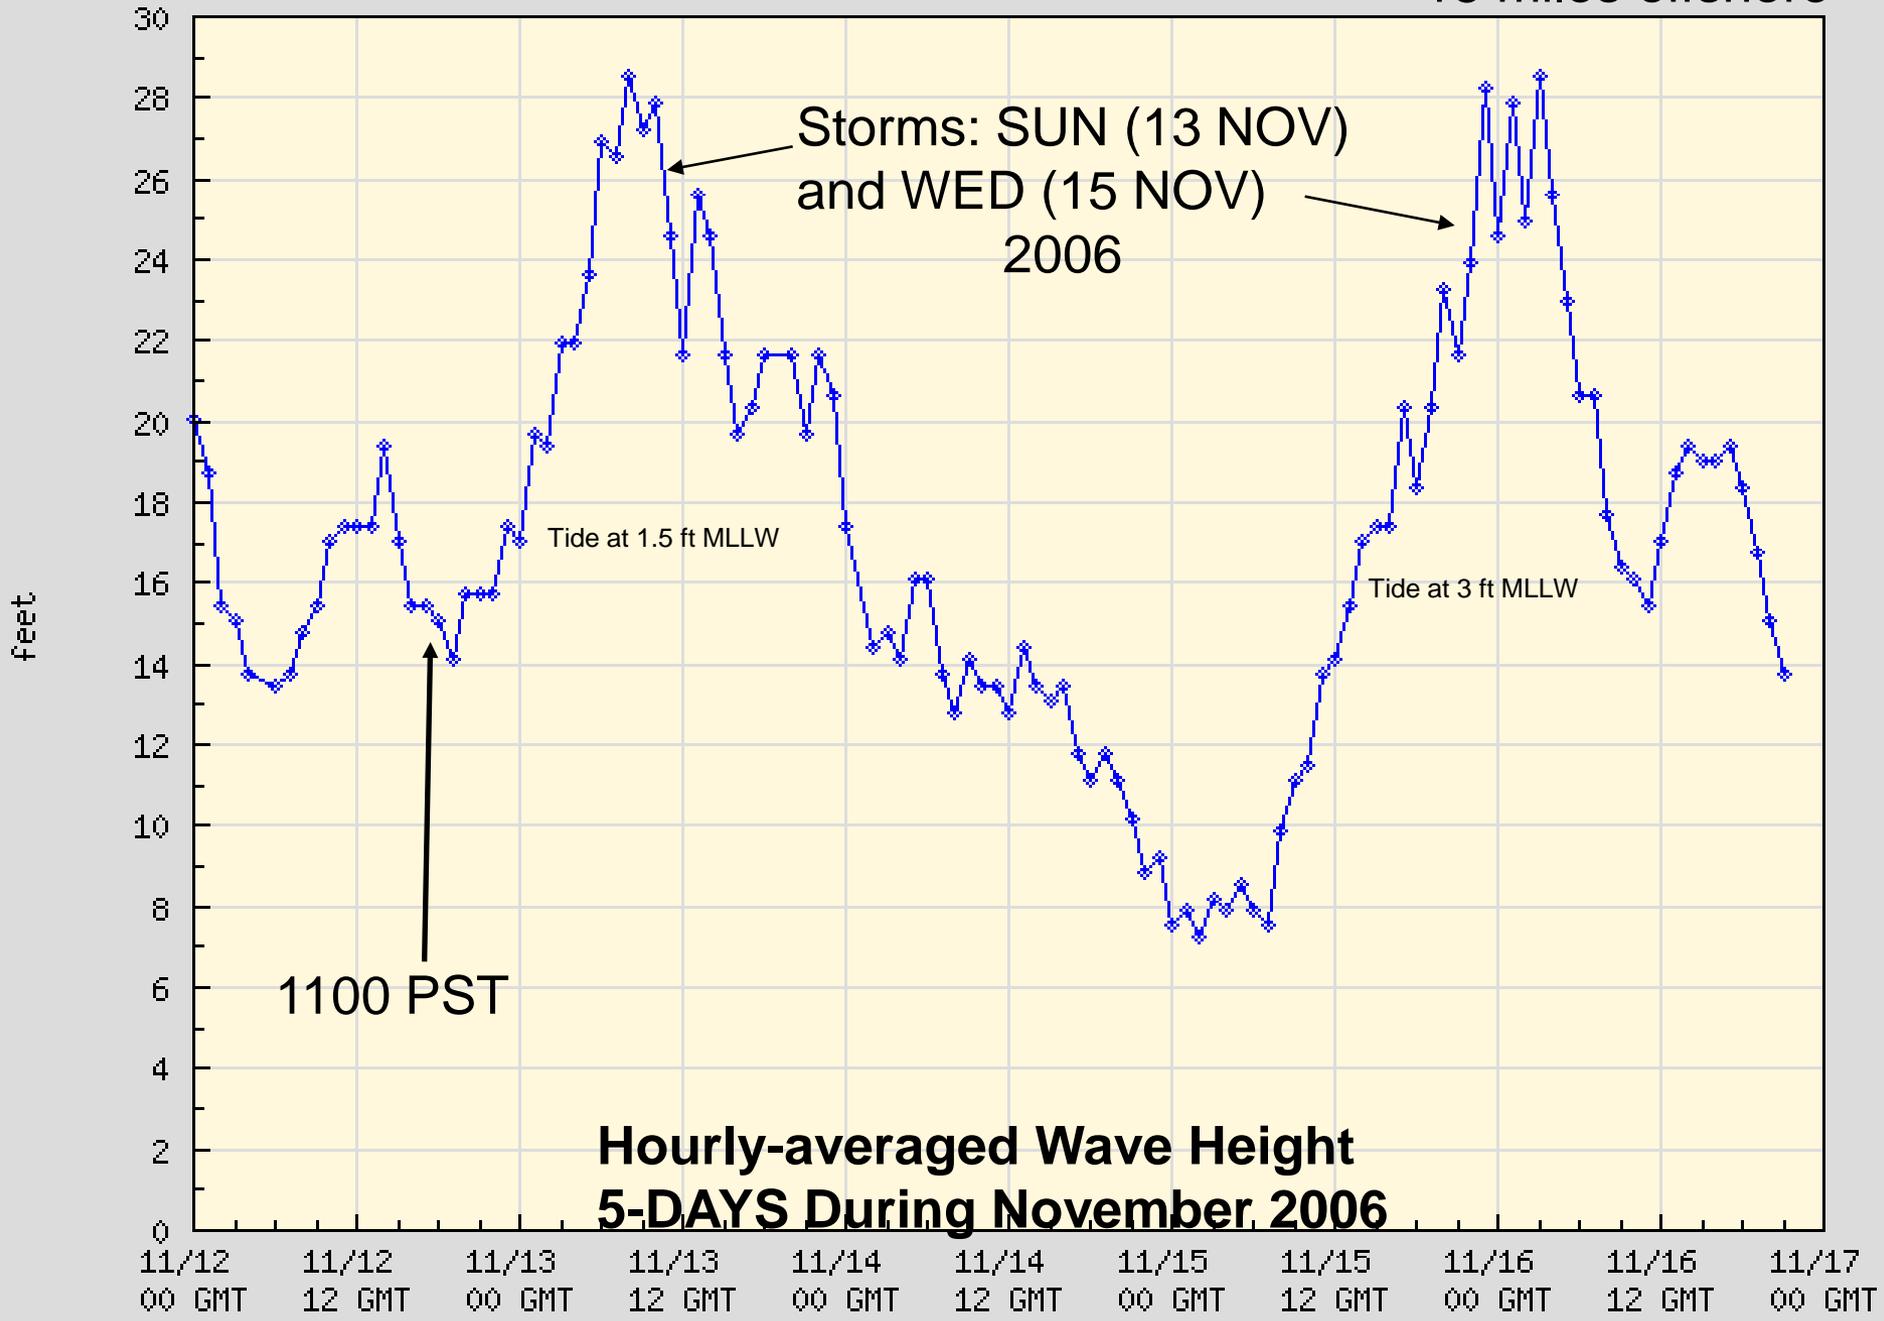
Significant Wave Height at 46029 15 miles offshore

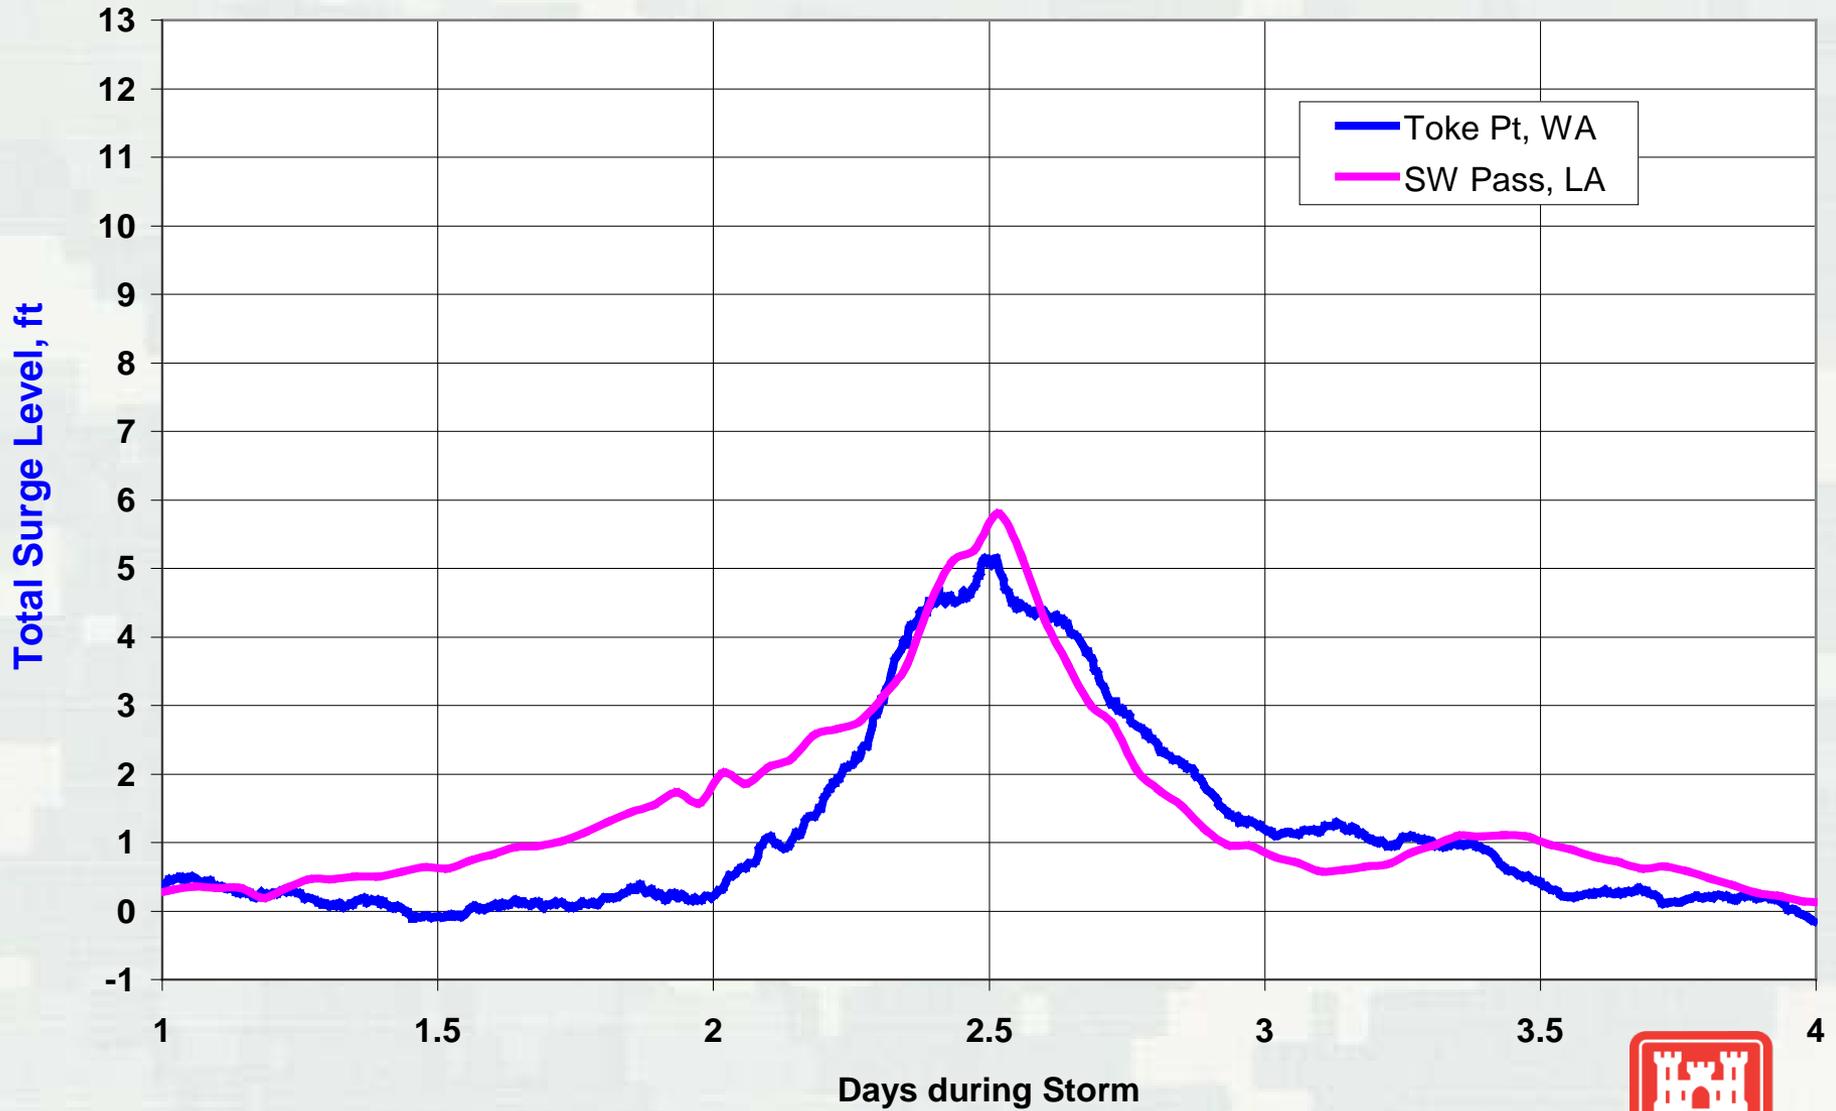
"Open" Coast Storm Surge Comparison Hurricane (GOM) vs. Extr. Low (PacNW)

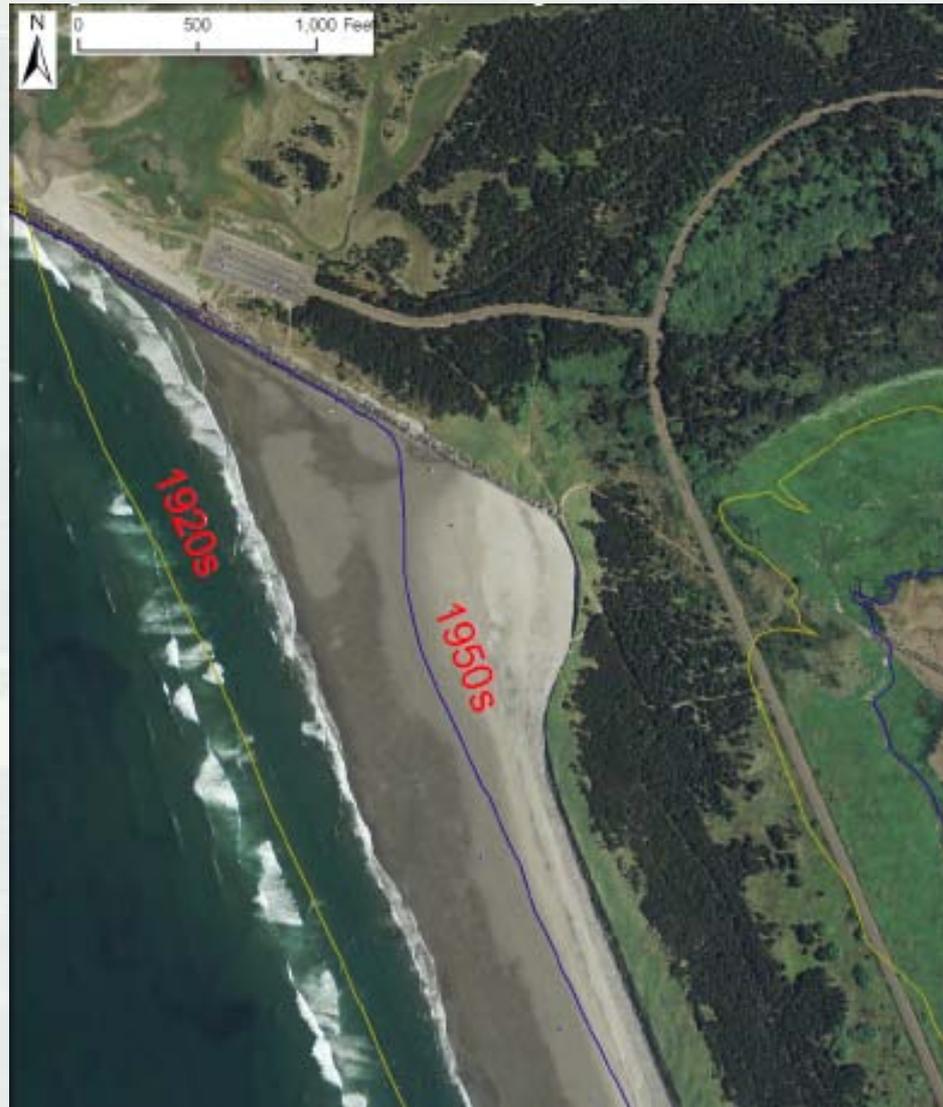
South Jetty: **The Observed Historic Movement of the Shoreline**

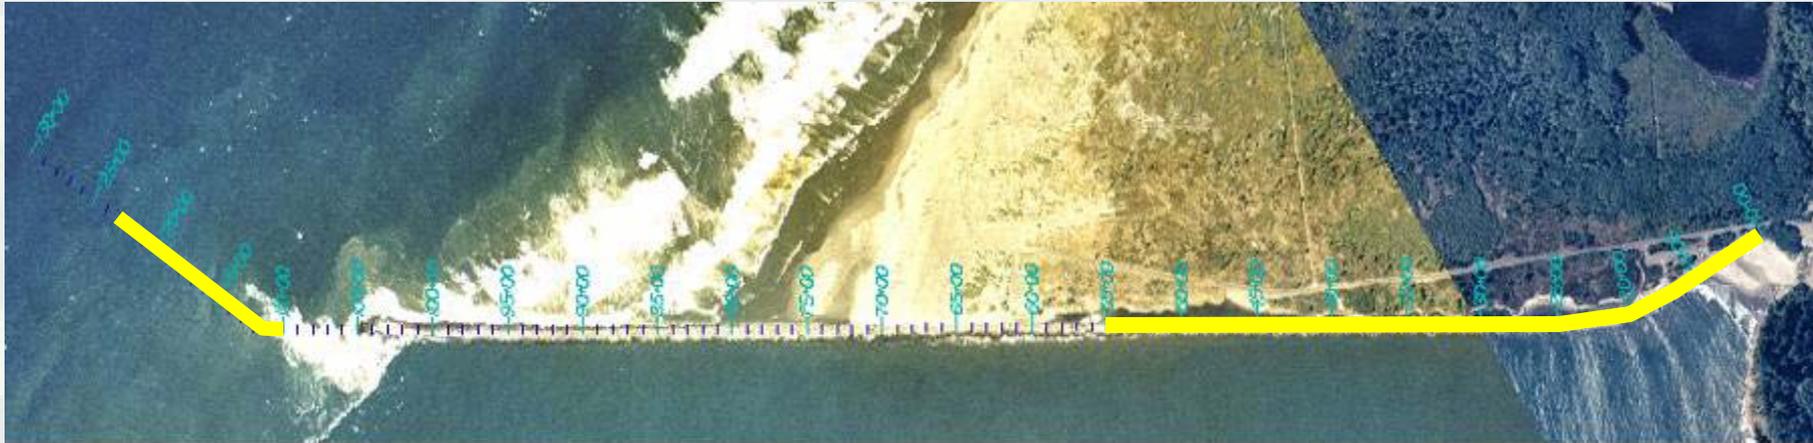
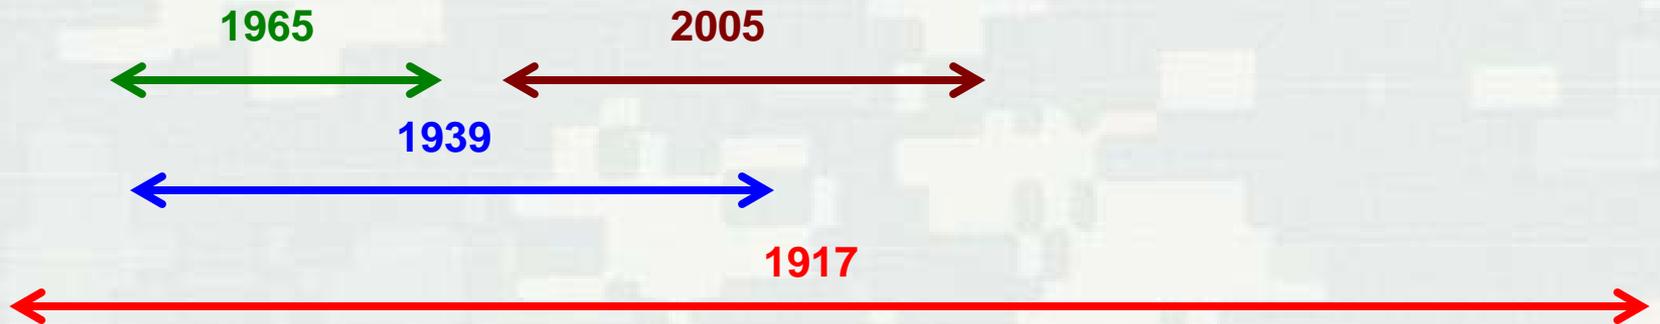
MCR North Jetty - Construction and Repair History

(Has receded approximately 1800' in length since 1916.)

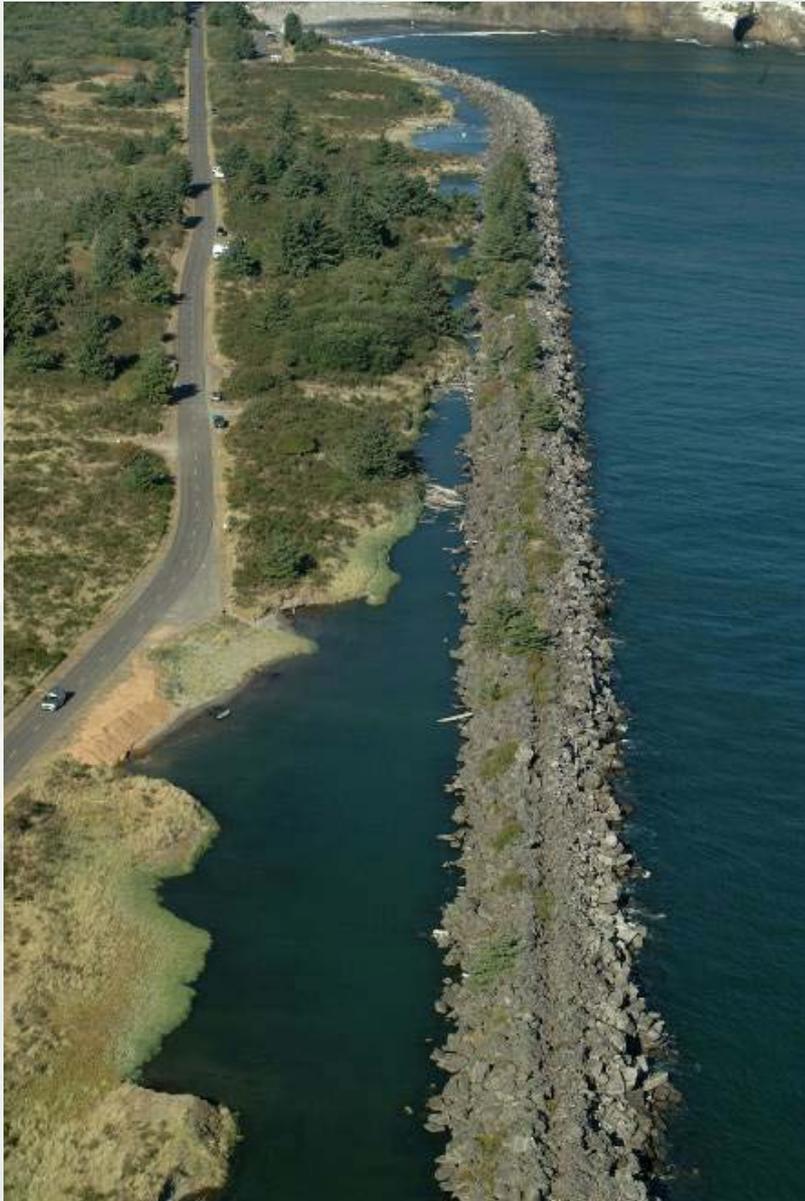
North Jetty Lagoon Fill

- Losing:
 - 1.14 acres of wetlands
 - 4.71 acres of waters of the U.S.
- Locating, developing mitigation site
- Replacing jetty road culvert
- Redirect stream away from lagoon wetlands
- Redirect overland flow away from jetty root; stabilize foundation

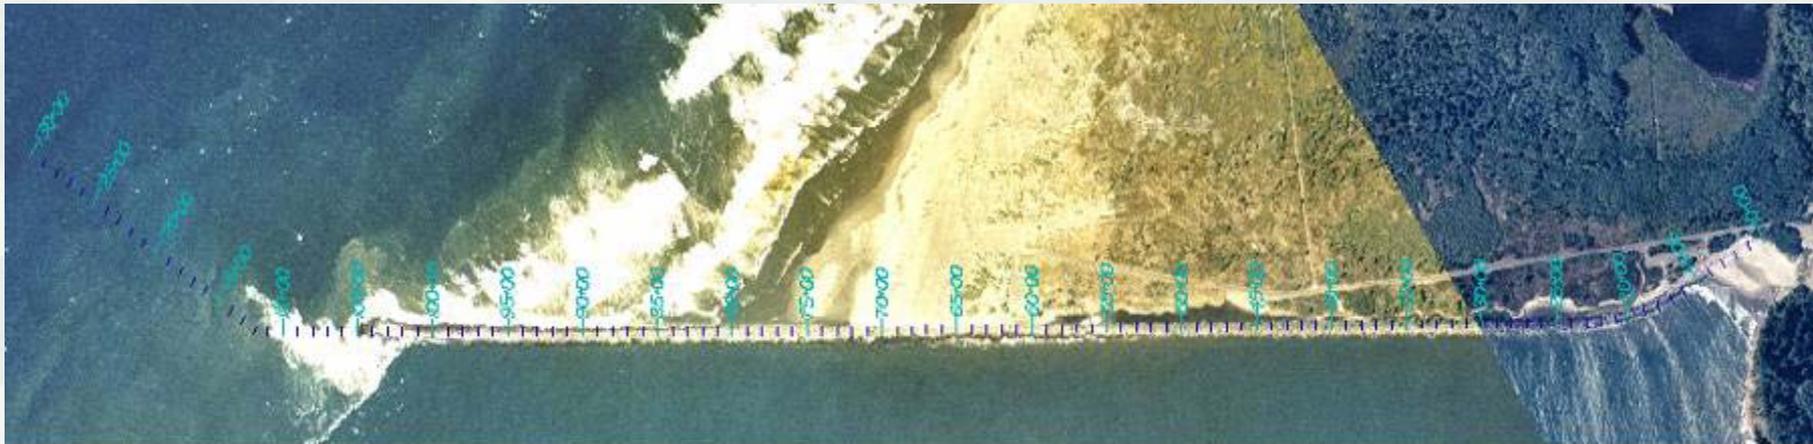
Critical Repairs
STA 86-99
↔

Lagoon Fill
↔

- (1) Lagoon Fill: \$10.84M → stabilizes jetty's foundation
- (2) Critical Repairs: \$14.15M → rehabs degraded reach

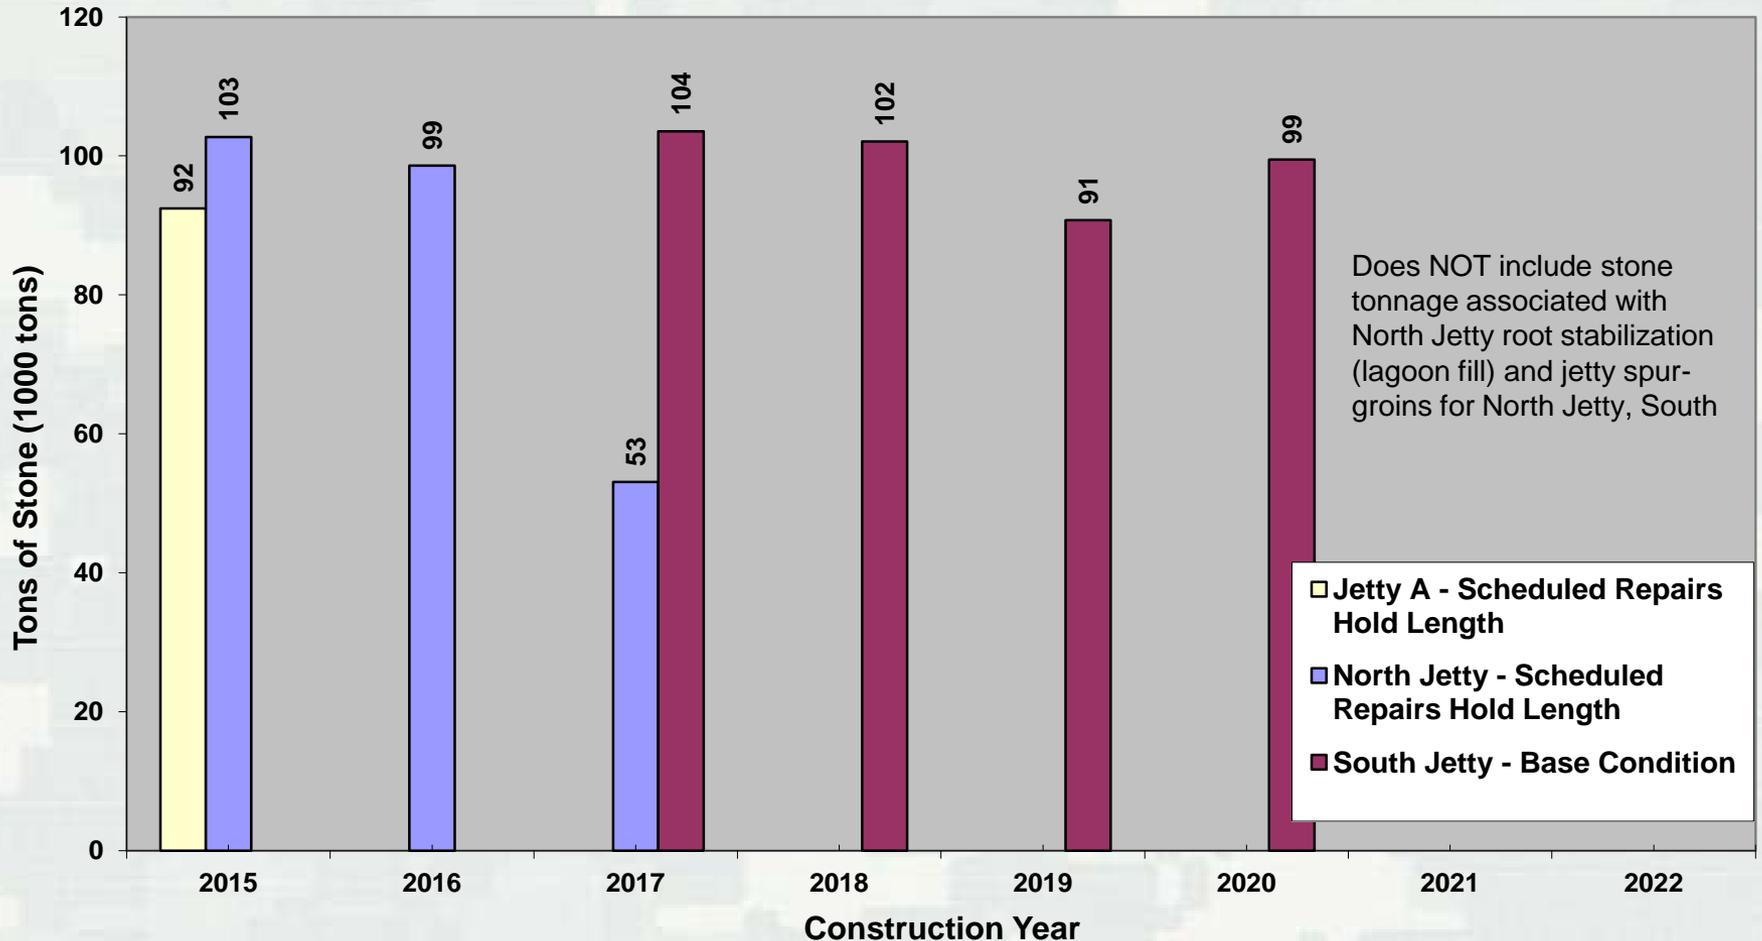
Mouth of the Columbia River Jetty System Rehabilitation - Selected Plan (Construction Schedule: For stone placement on Jetties and existing stone re-work)

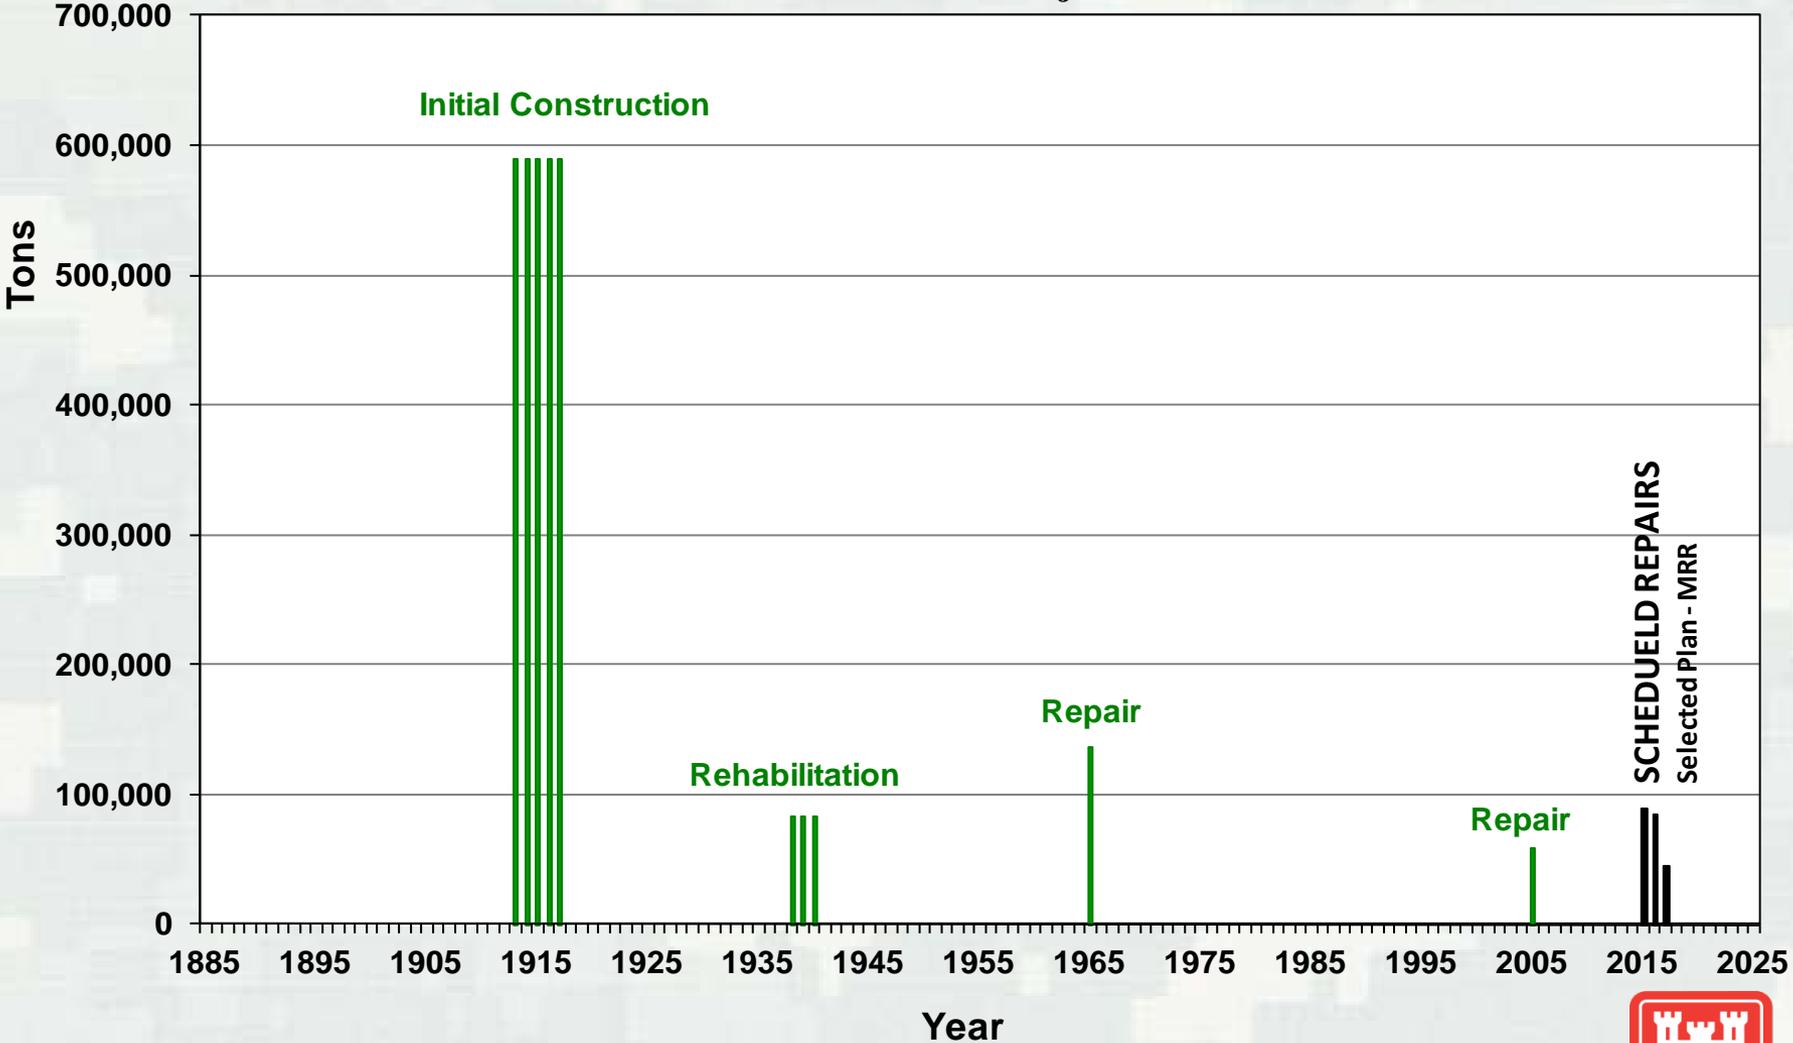
NORTH Jetty
Actual Year by Tons Placed
Previous and Future Project Conditions

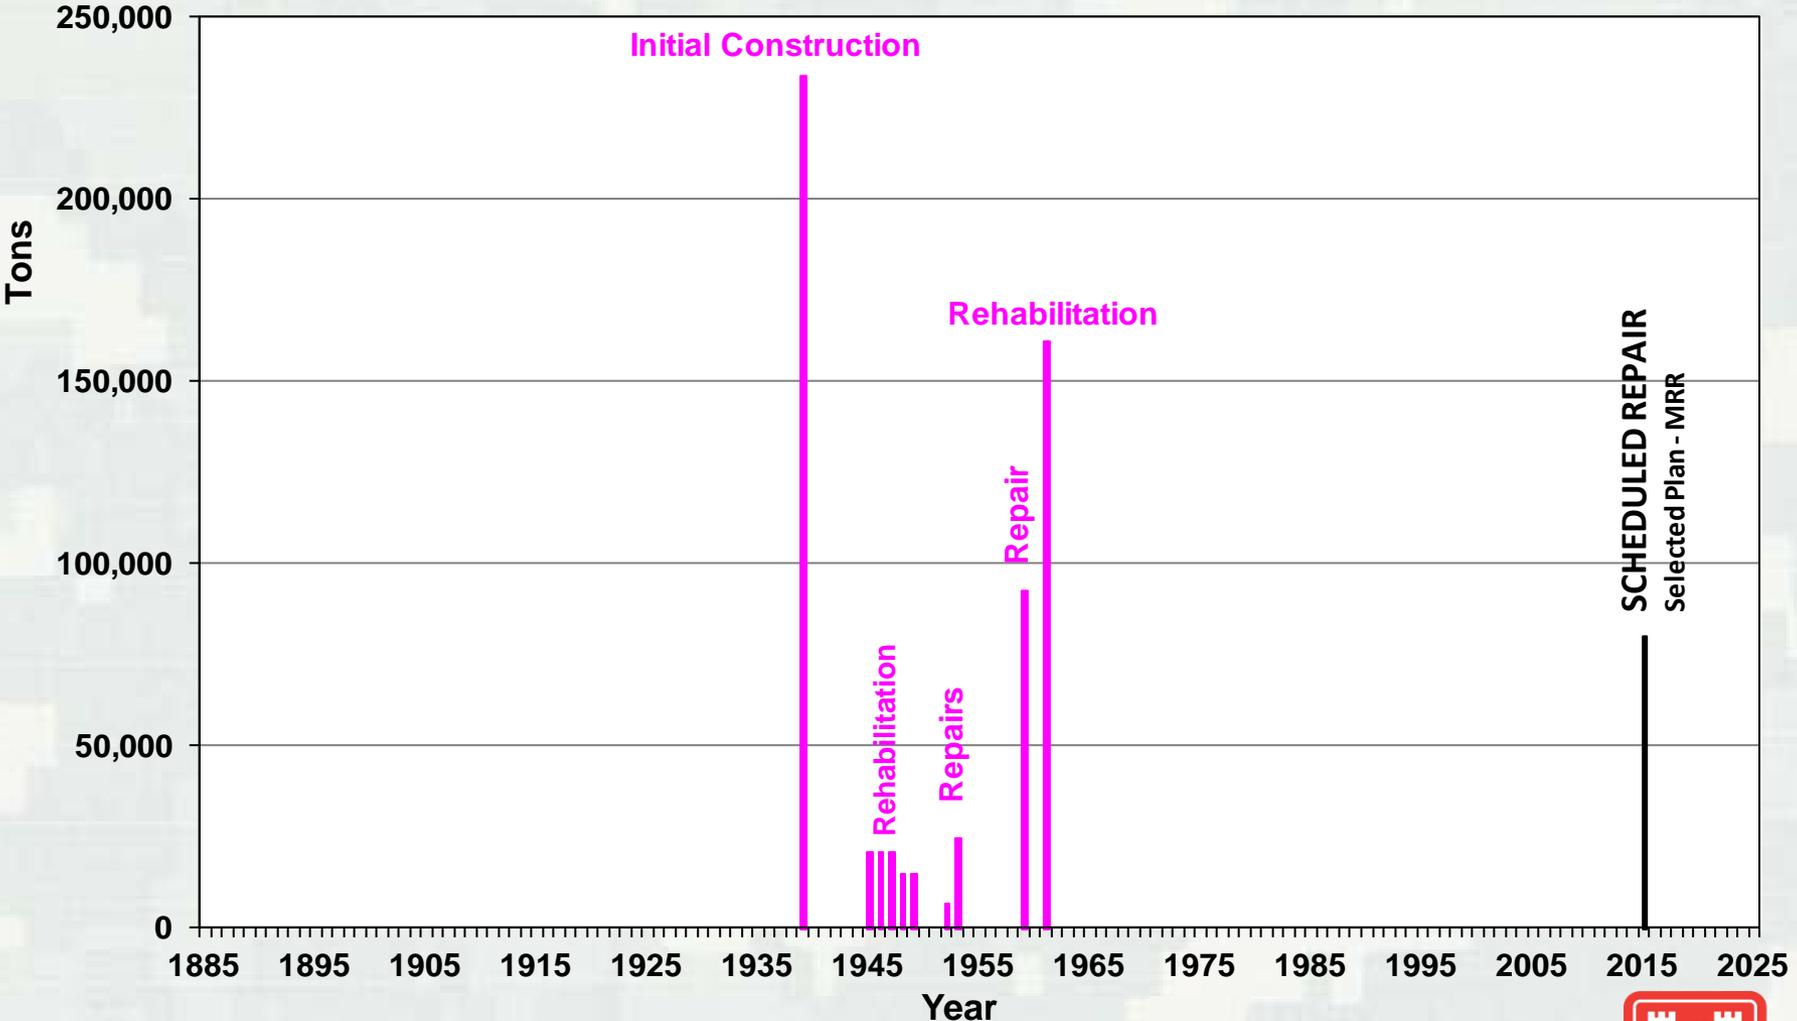
JETTY "A"

Actual Year by Year Tons Placed

Previous and Future Project Conditions

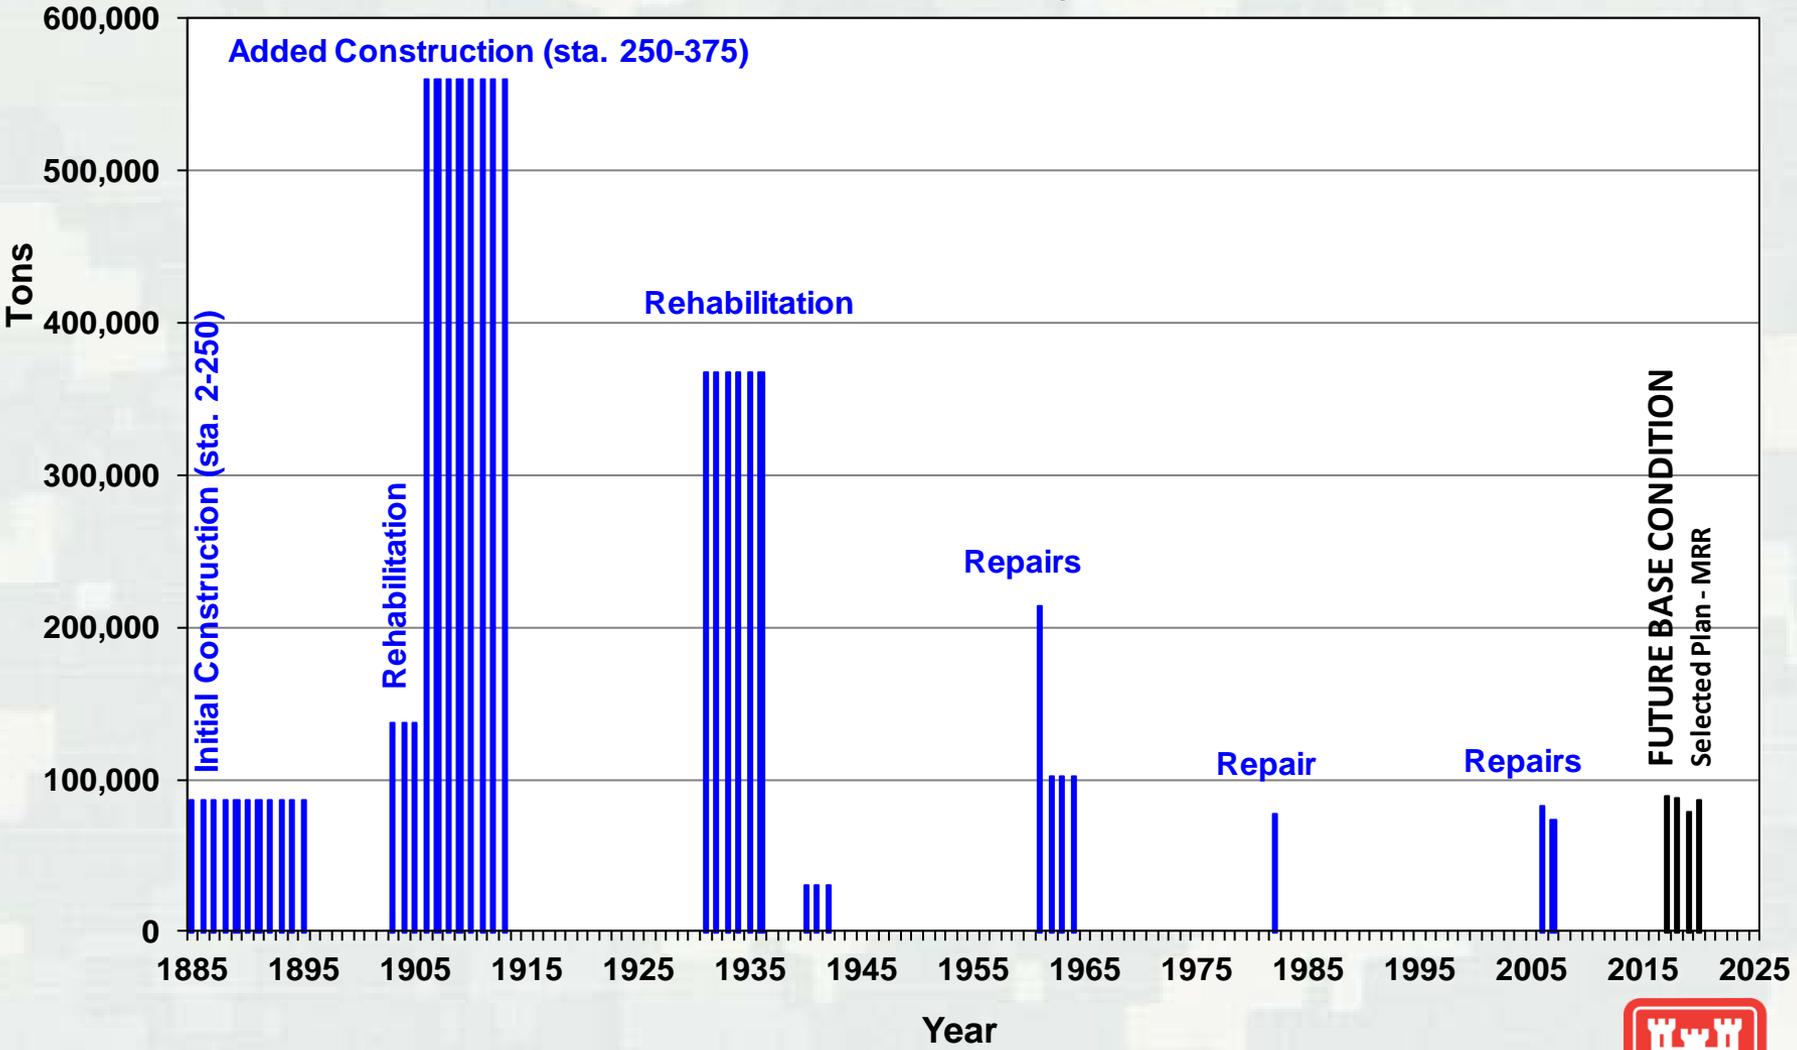
SOUTH Jetty

Actual Year by Year Tons Placed

Previous and Future Project Conditions

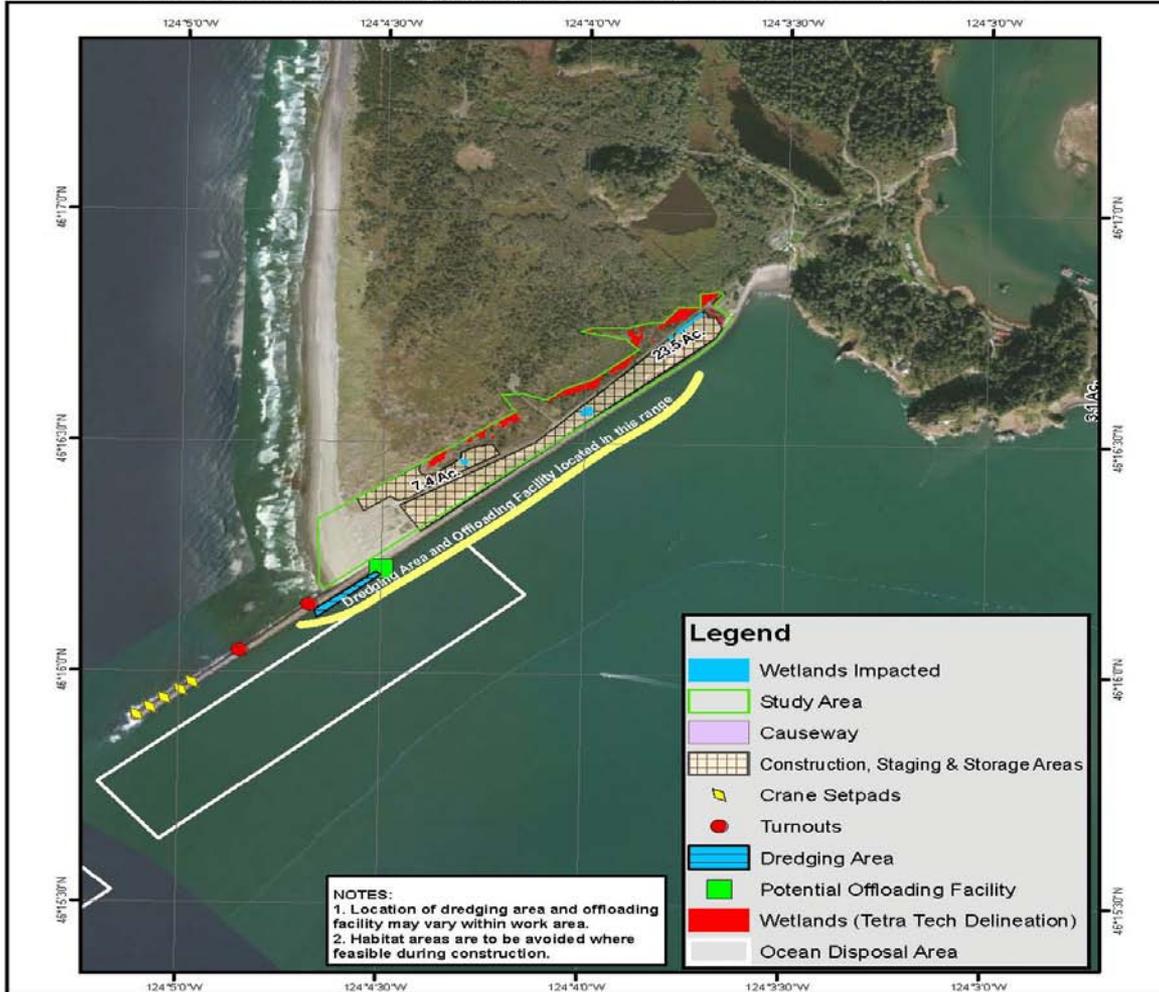
MCR Major Rehab North Jetty, Pacific County, Washington Potential Offloading, Staging, Storage & Causeway Facilities

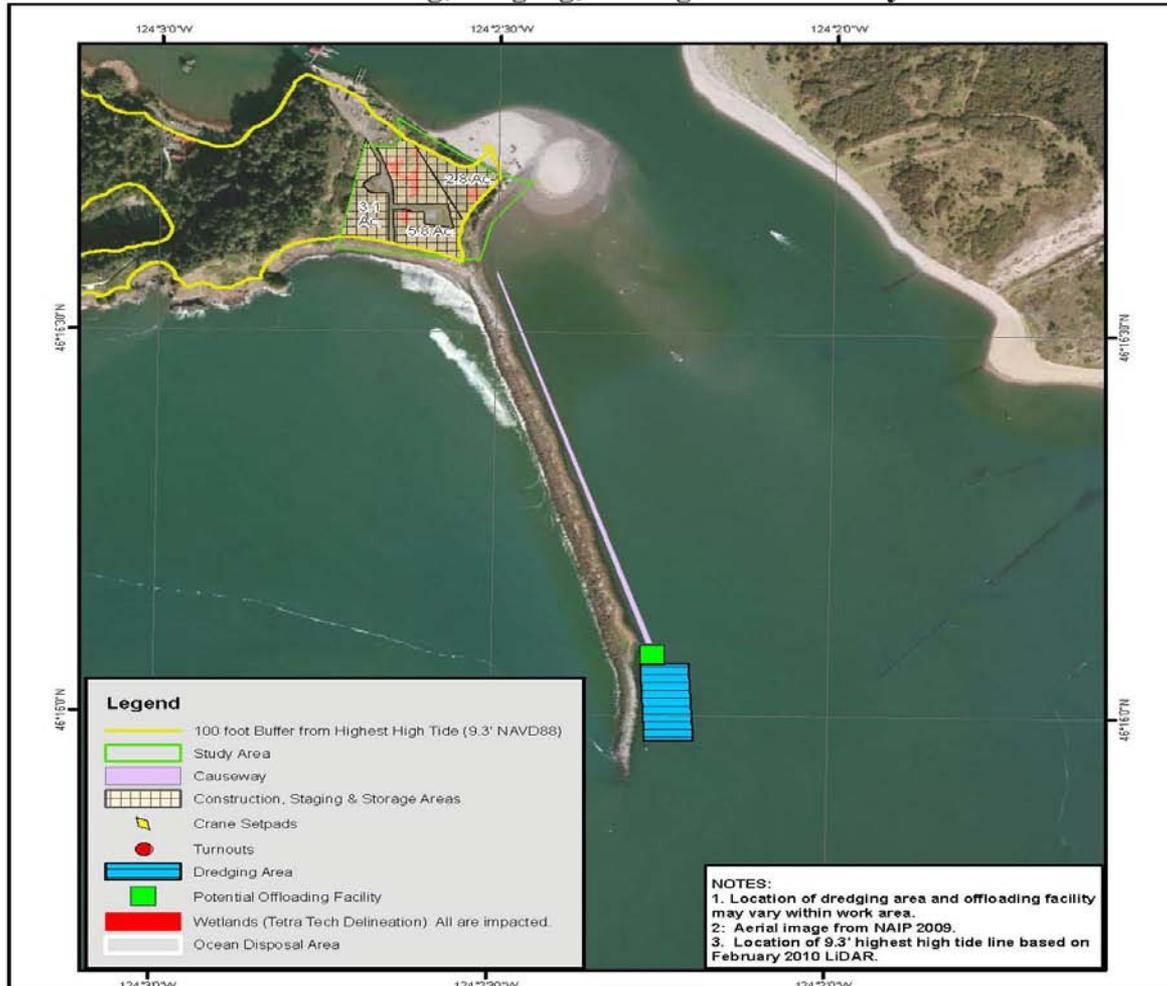
MCR Major Rehab Jetty A, Pacific County, Washington Potential Offloading, Staging, Storage & Causeway Facilities

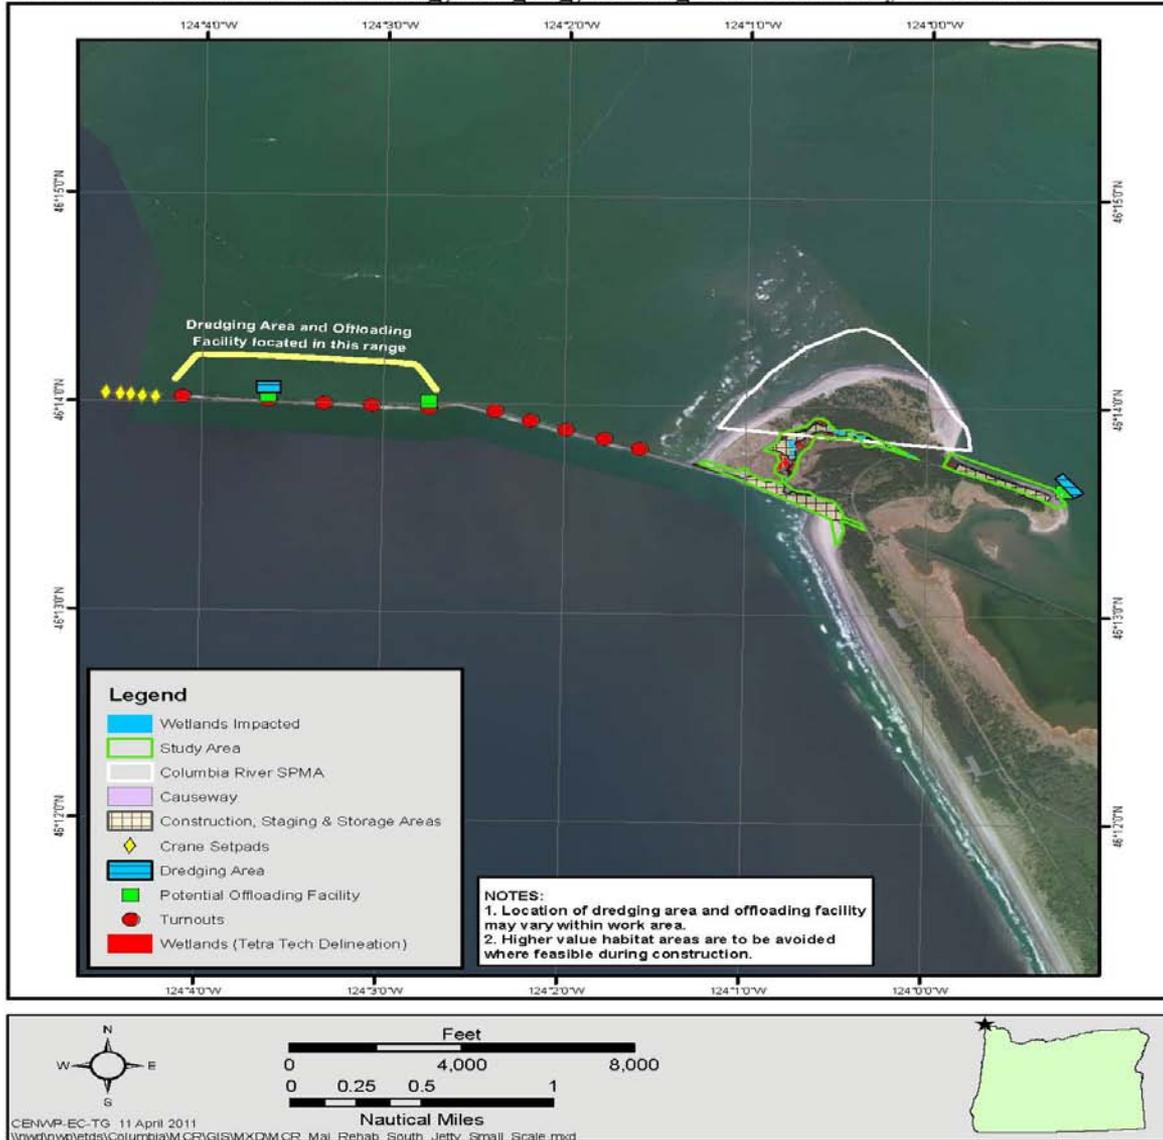
MCR Major Rehab South Jetty, Clatsop County, Oregon Potential Offloading, Staging, Storage & Causeway Facilities

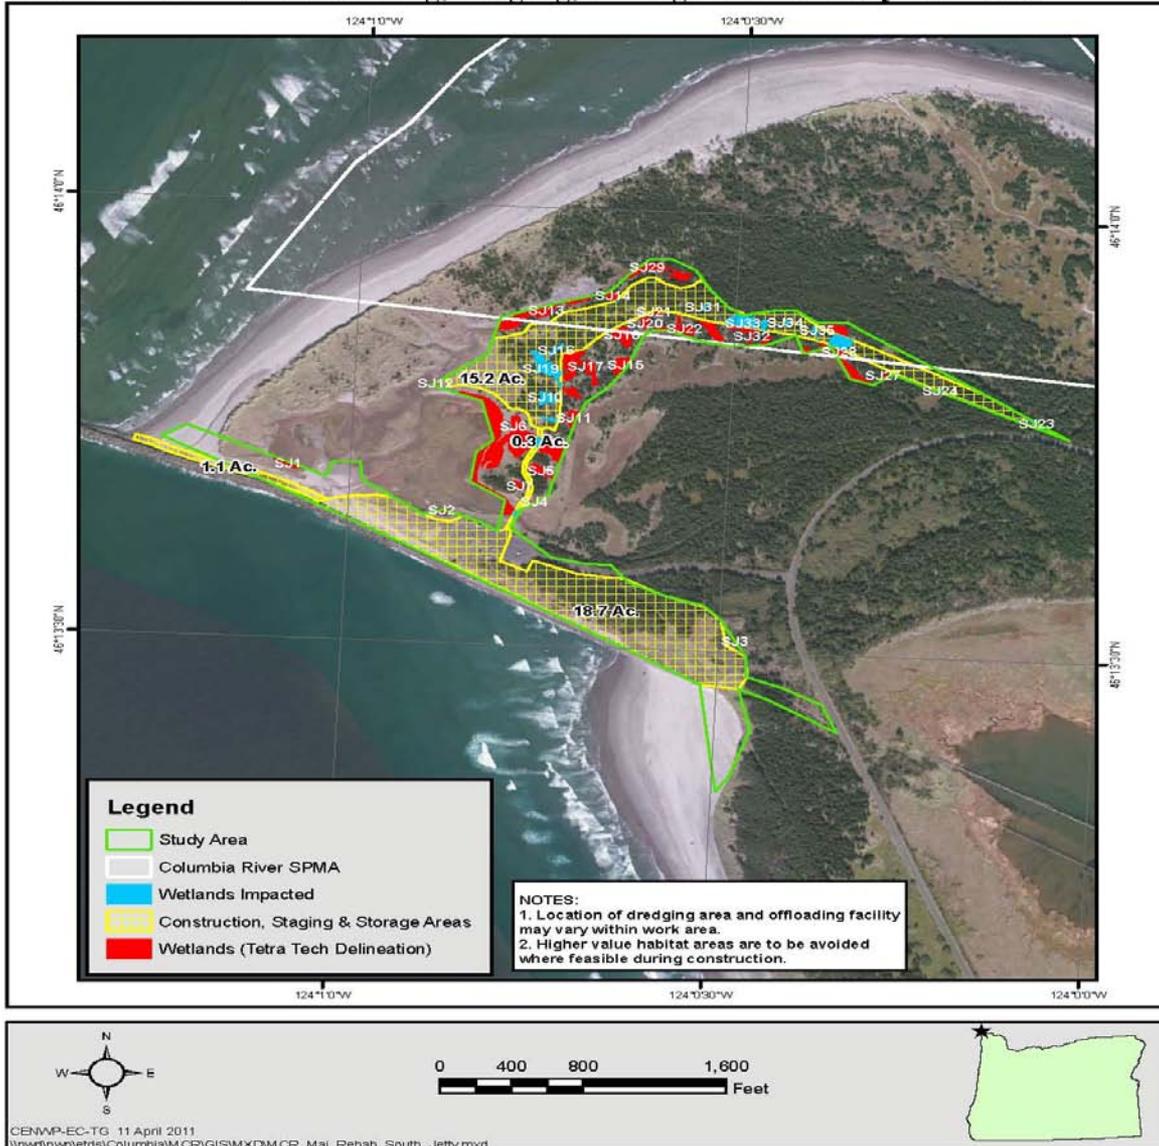
MCR Major Rehab

South Jetty, Clatsop County, Oregon

Potential Offloading, Staging, Storage & Causeway Facilities
