Mouth of the Columbia River Jetties Three-Phase Construction Plan

Project Overview

October 9, 2012

MCR Jetties Major Rehabilitation

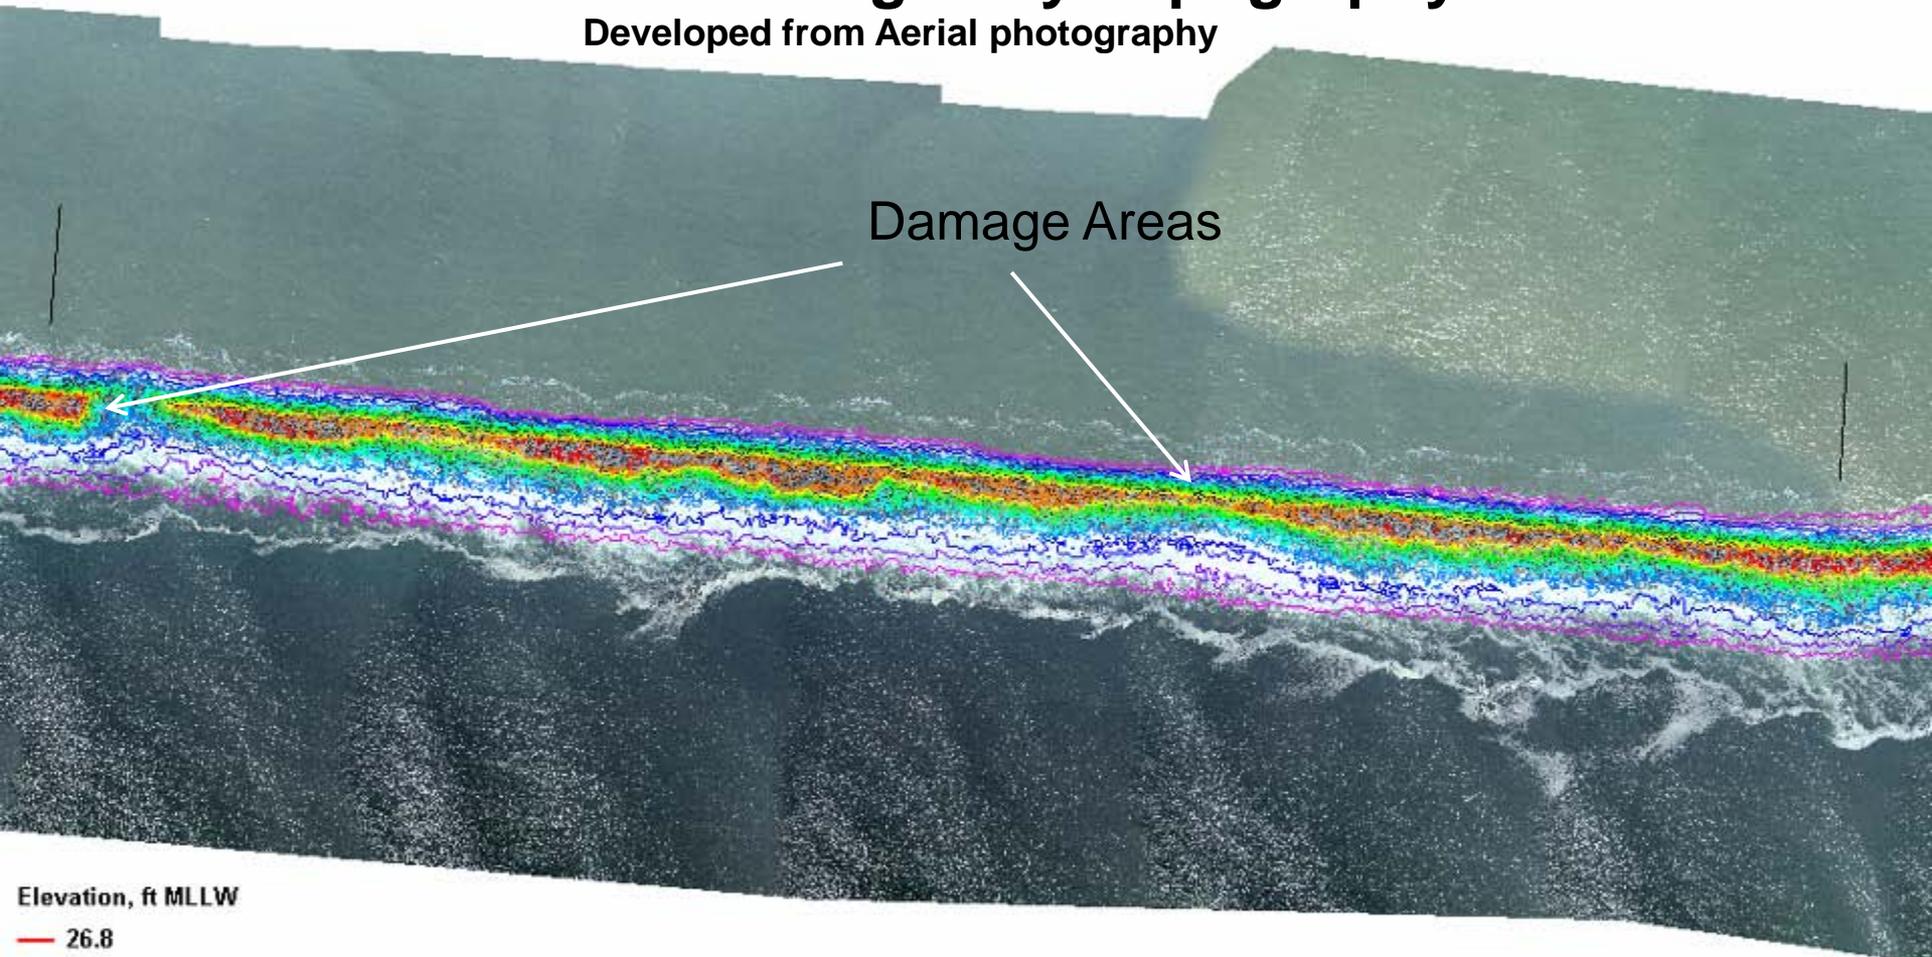
Jetty Cross-Section Damage Documented Using Jetty Topography

Developed from Aerial photography

Damage Areas

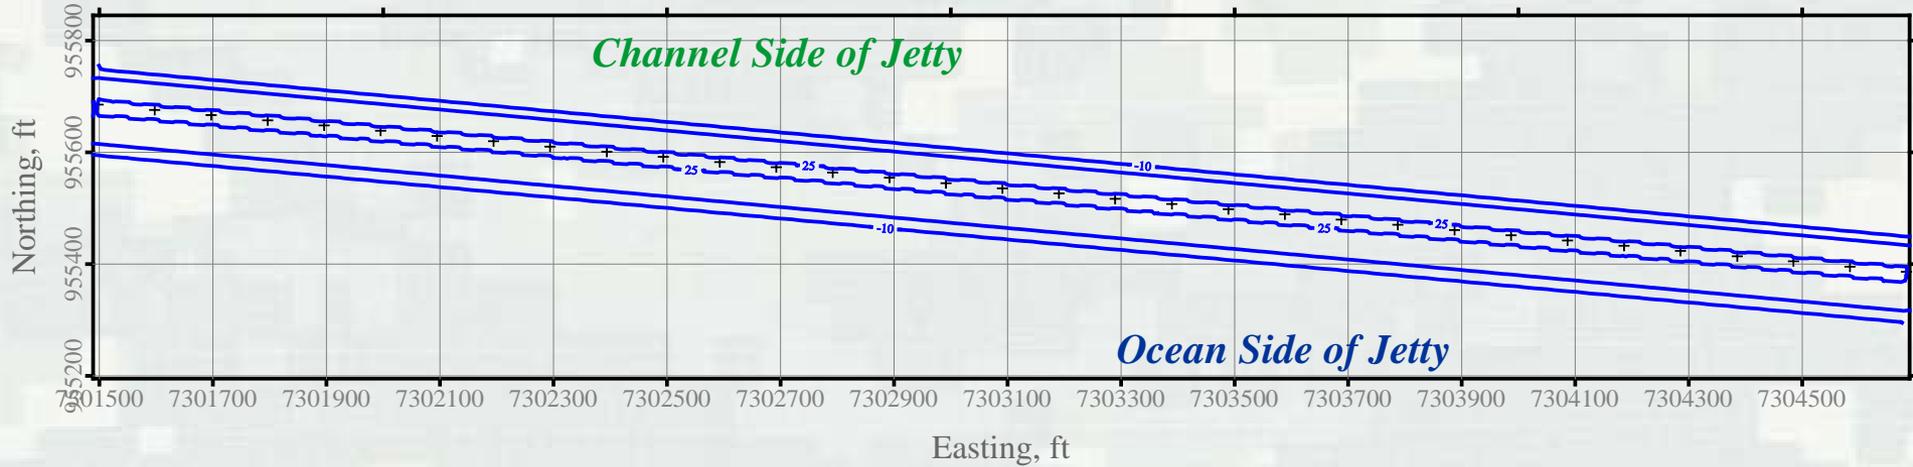
Example of Undamaged Jetty Surface (design template) - Contour Lines Plan View

— BLUE Lines indicate surface elevation of FULL Undamaged Jetty Template for -10 ft, 0 ft, and 25 ft elevation

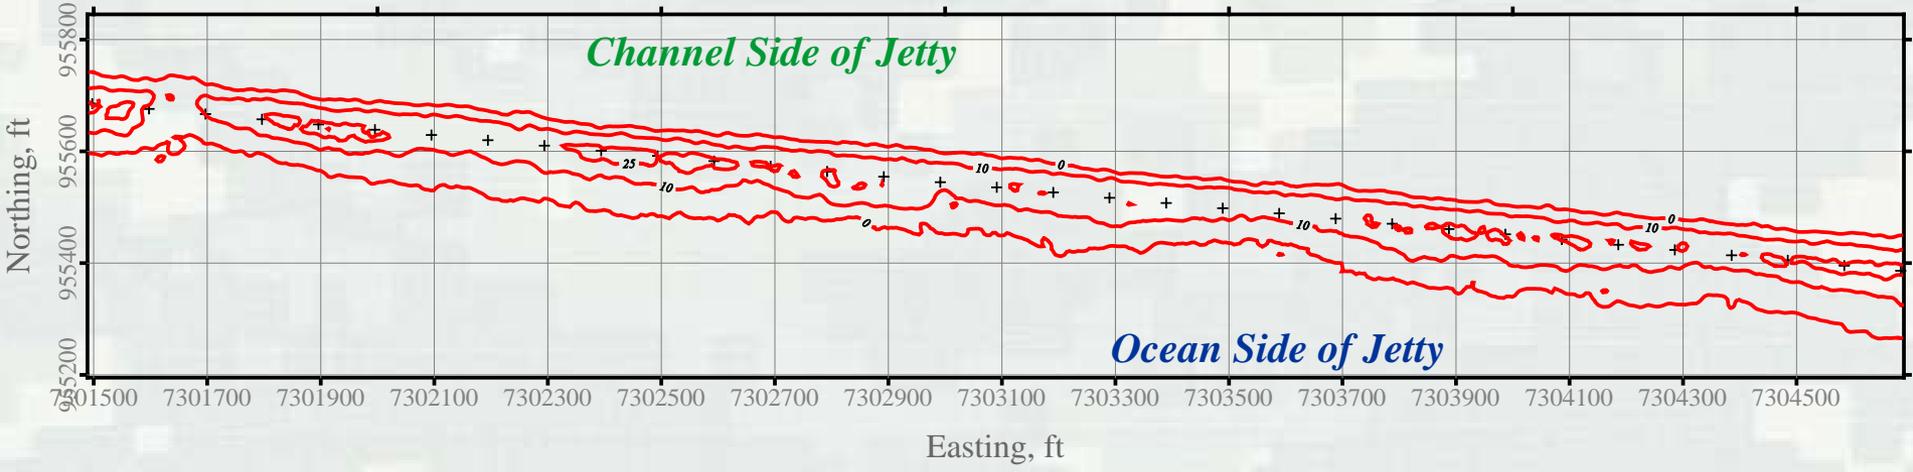
Example of Damaged Jetty Surface - Contour Lines Plan View

— RED Lines indicate elevation of DAMAGED jetty surface for 0 ft, 10 ft, and 25 ft elevations

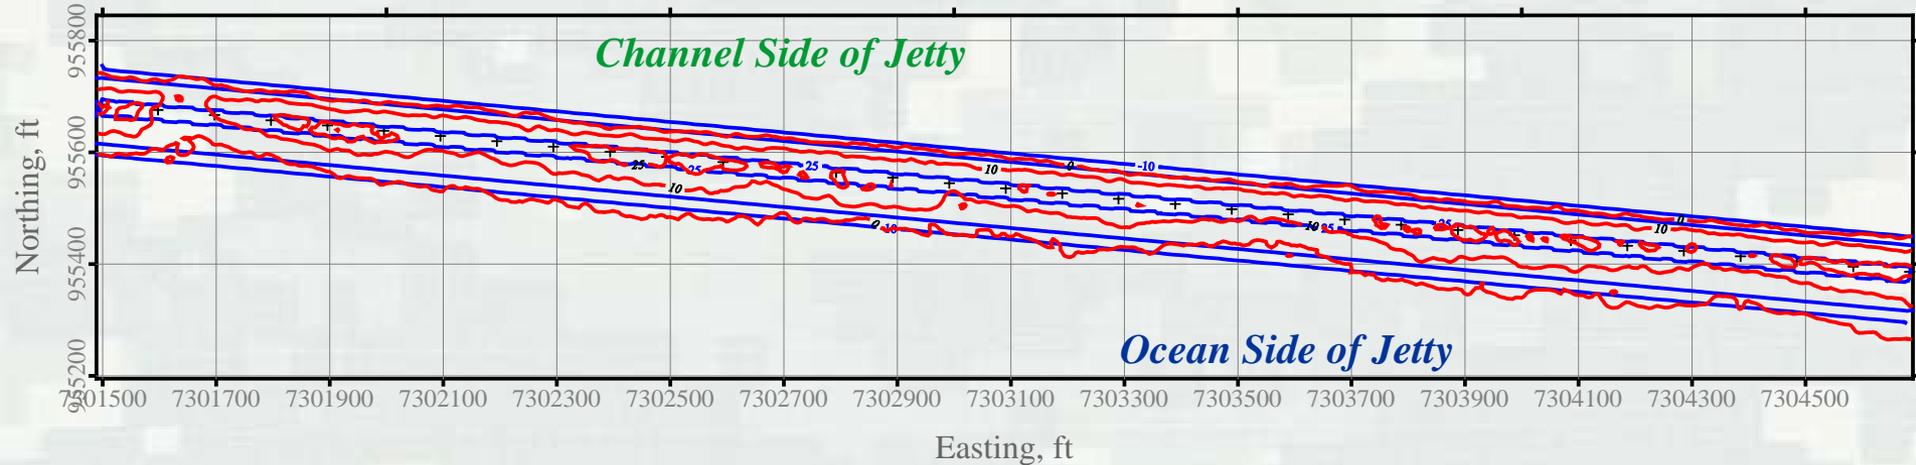
Example of Comparing Undamaged Jetty Surface to Damaged Jetty Surface Contour Lines Plan View

BLUE Lines indicate surface elevation of FULL Undamaged Jetty Template for -10 ft, 0 ft, and 25 ft elevation

RED Lines indicate elevation of DAMAGED jetty surface for 0 ft, 10 ft, and 25 ft elevations

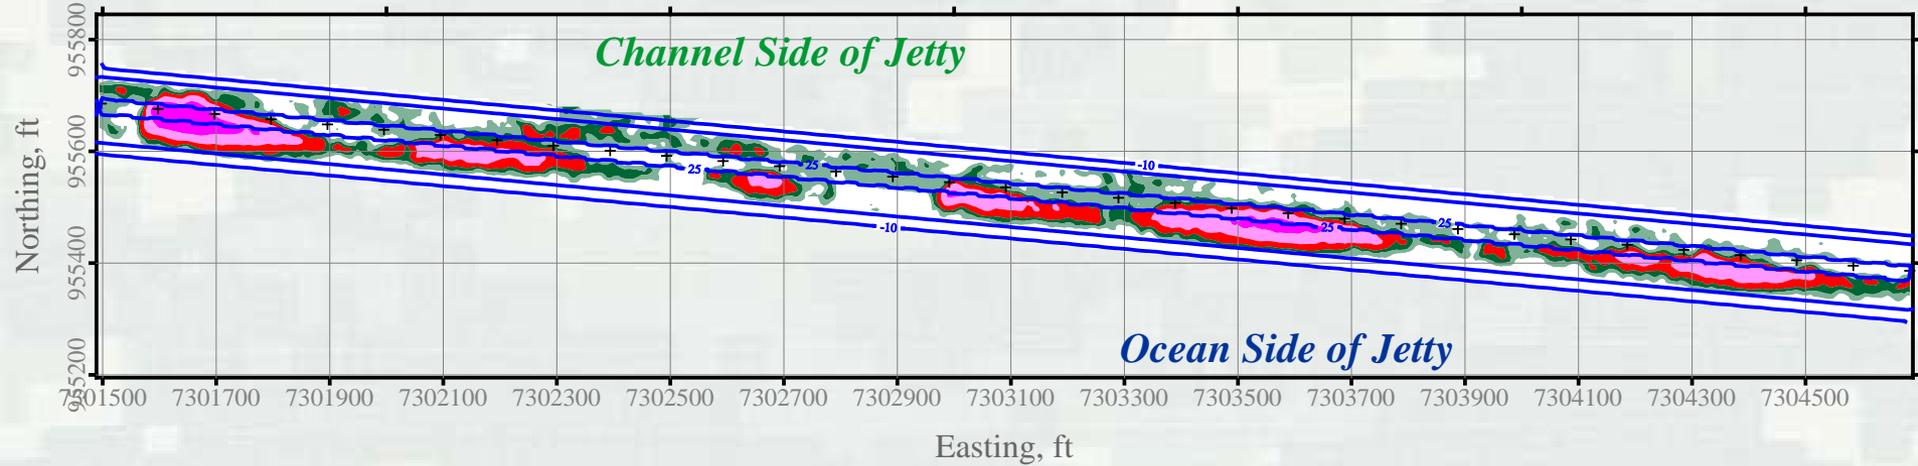
Example of Calculating Damage to Jetty

By subtracting the **Damaged** Jetty Surface from the **Undamaged Condition**
Plan View

— BLUE Lines indicate surface elevation of FULL Undamaged Jetty Template for -10 ft, 0 ft, and 25 ft elevation

FT Below
FULL Undamaged Template
(damage to repair)

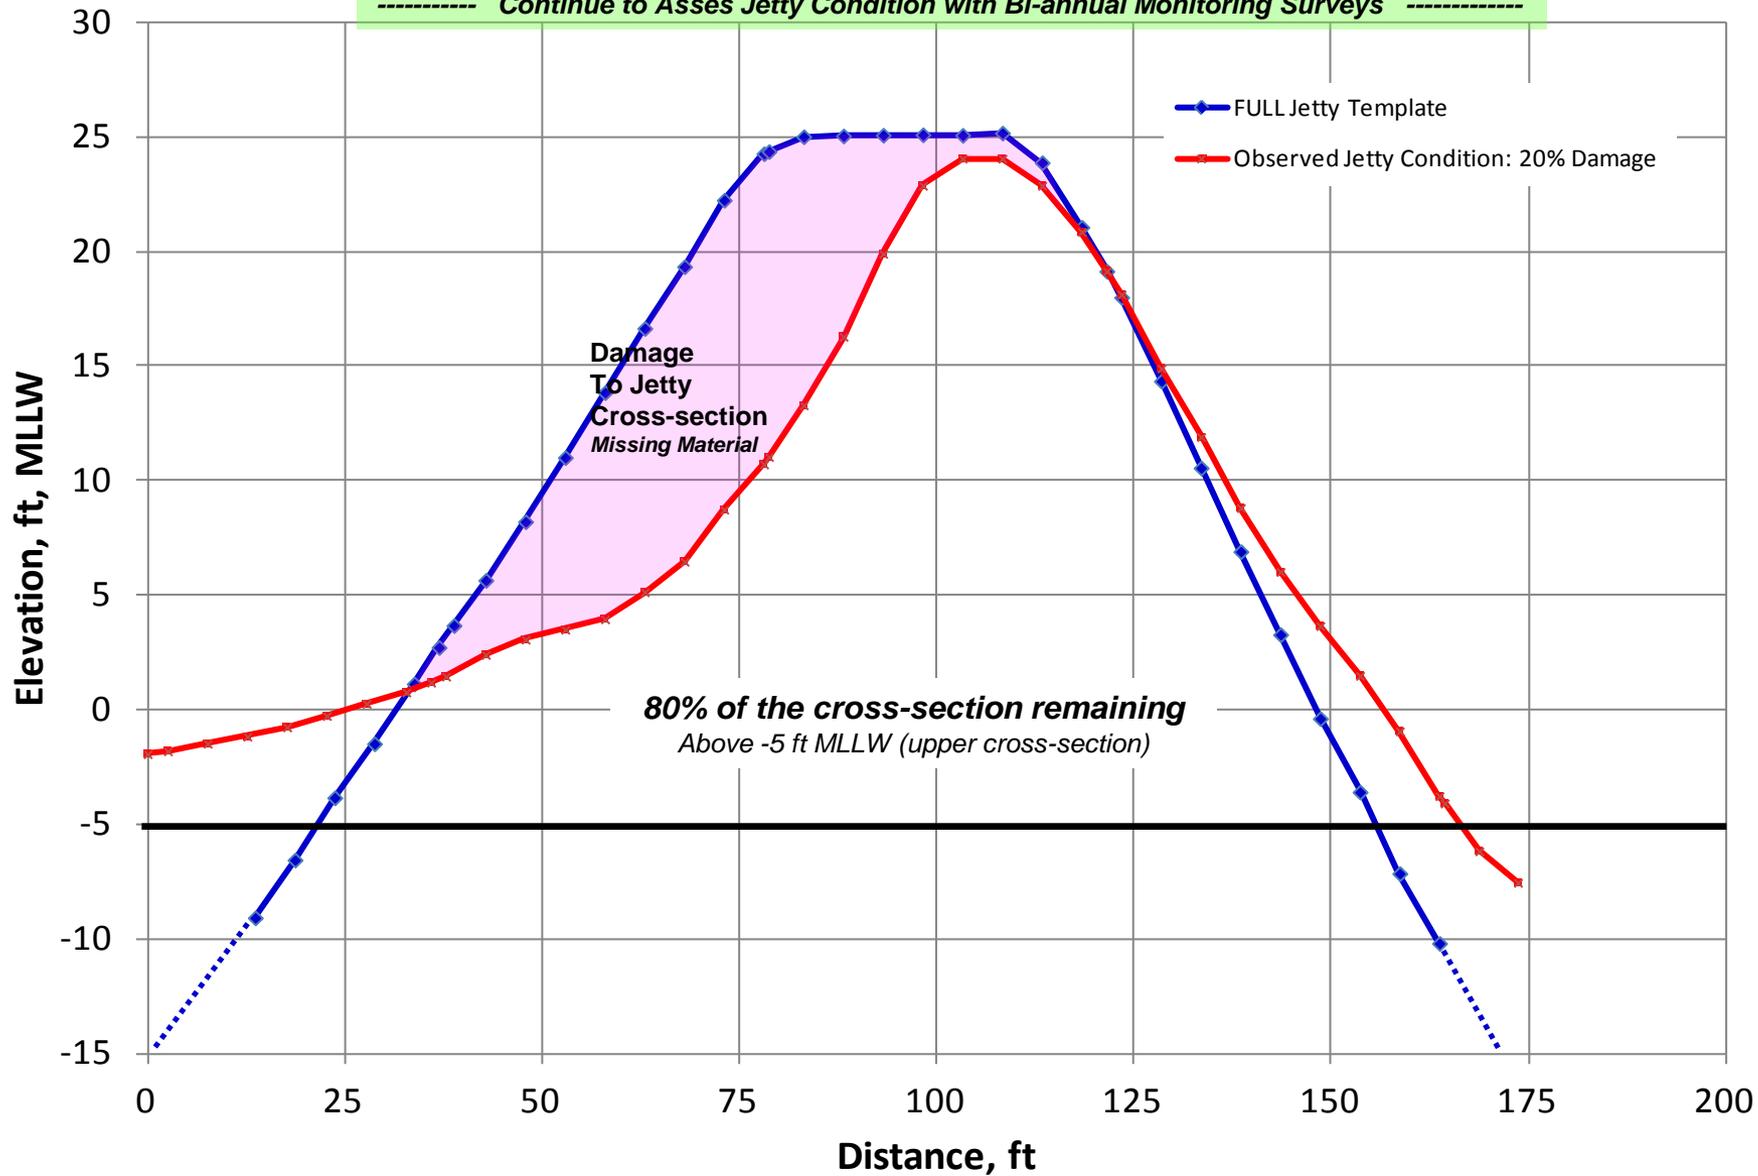
Jetty Cross Section Status **GREEN**

----- Continue to Assess Jetty Condition with Bi-annual Monitoring Surveys -----

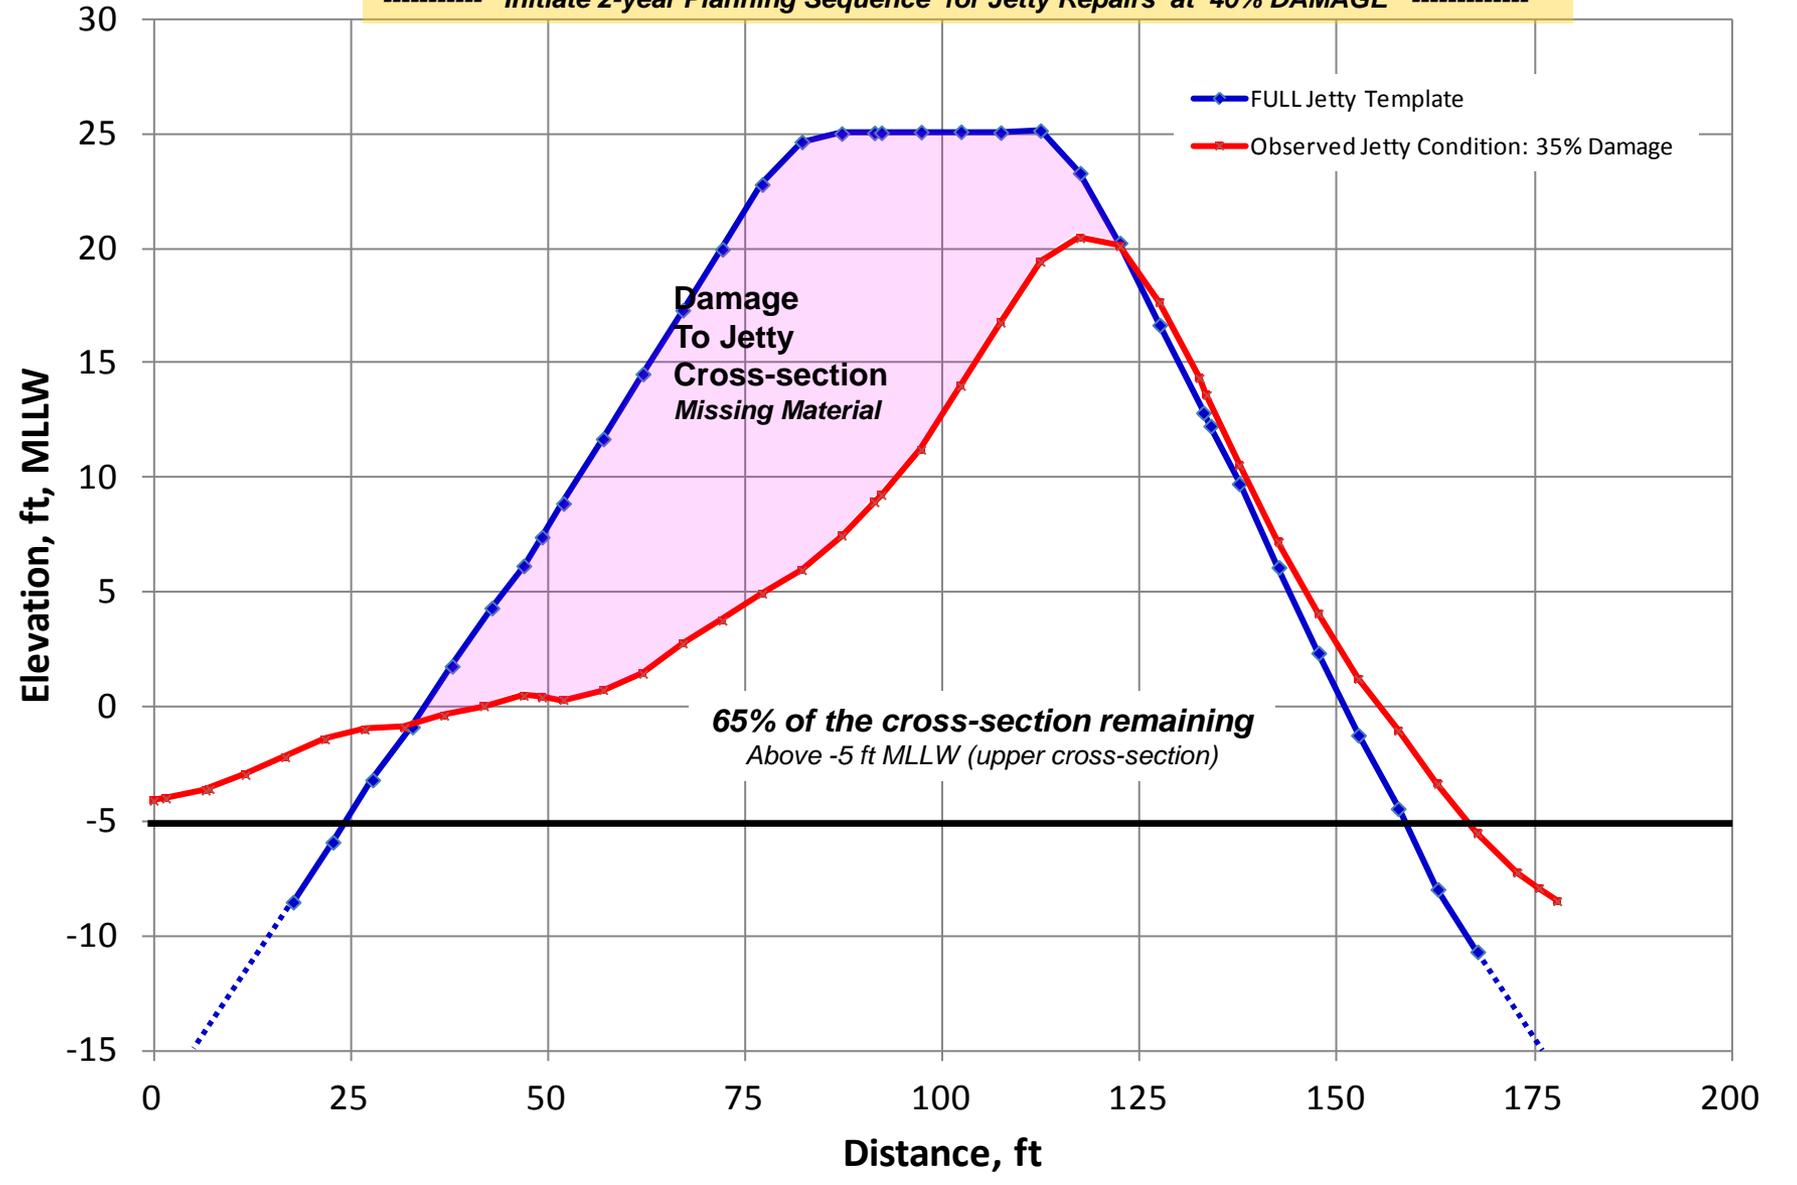
Jetty Cross Section Status **AMBER**

----- Initiate 2-year Planning Sequence for Jetty Repairs at 40% DAMAGE -----

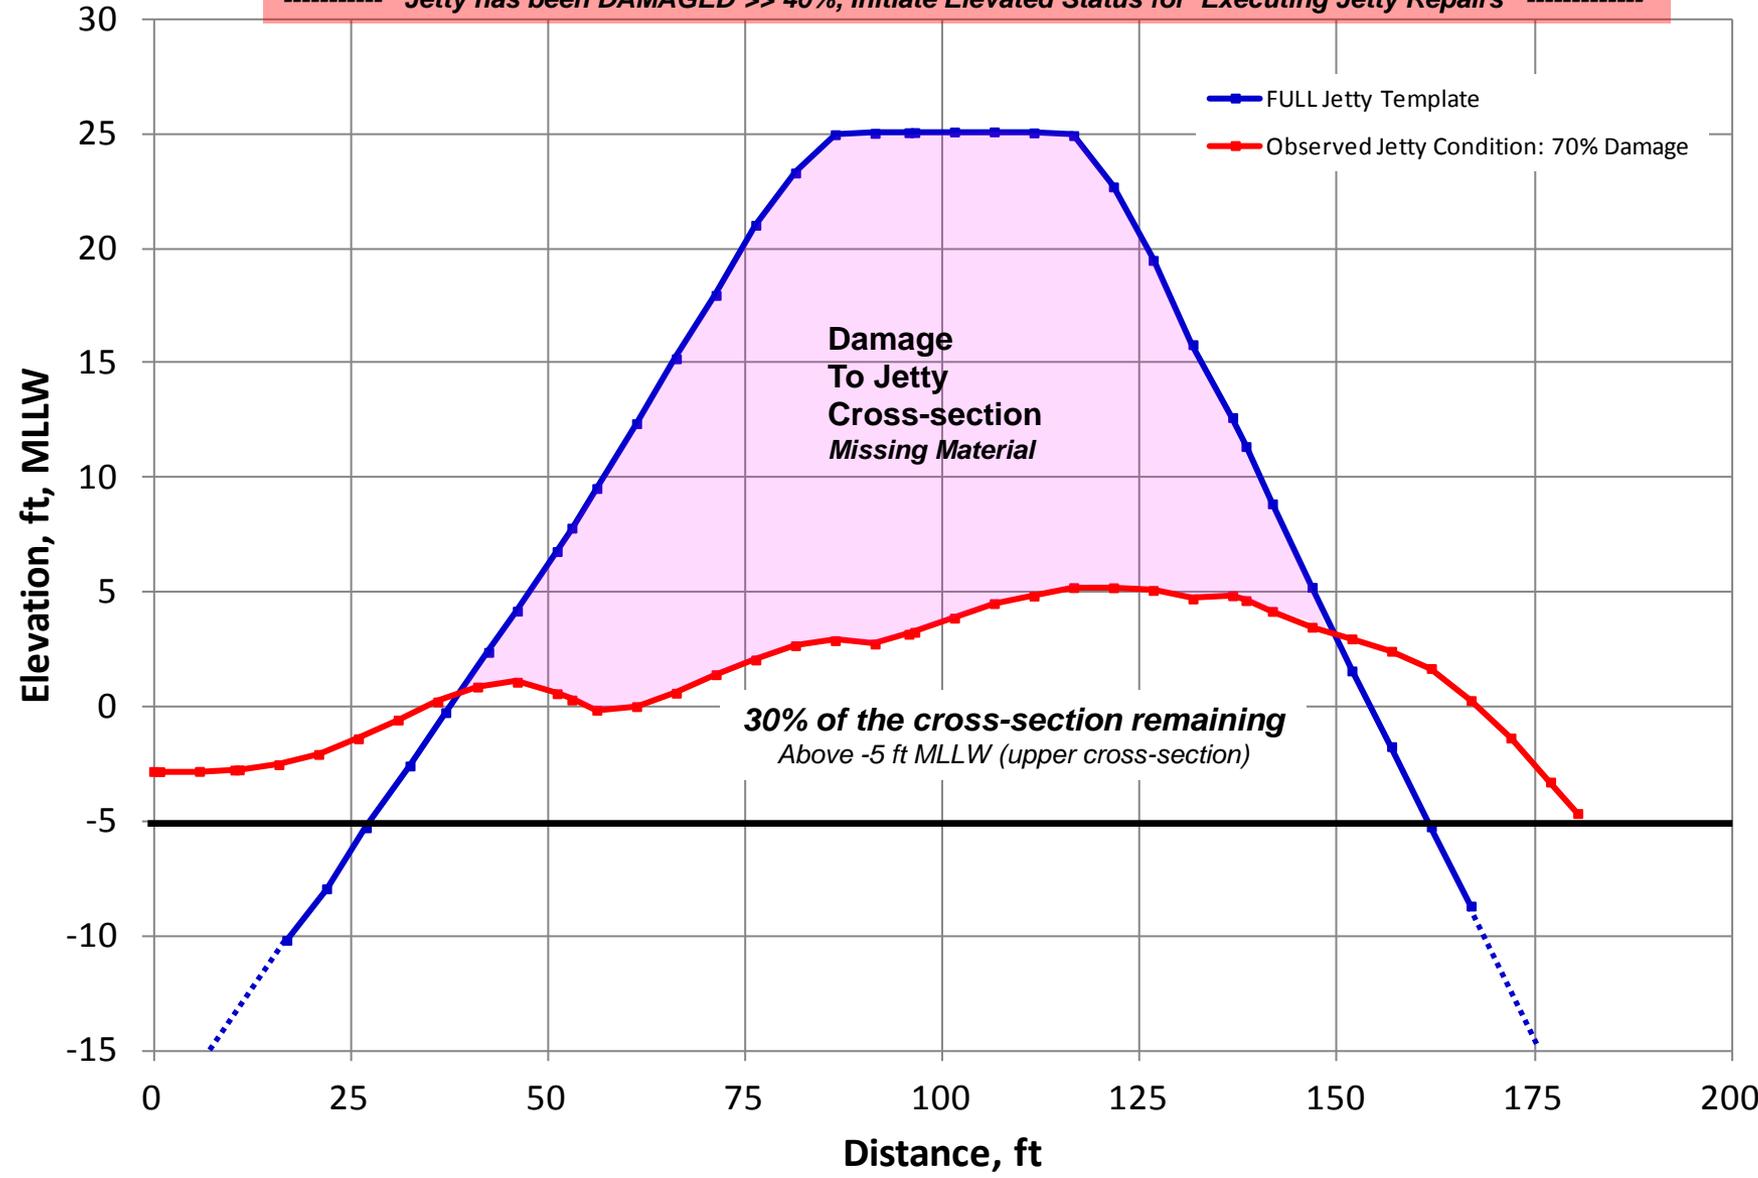
Jetty Cross Section Status **RED**

----- *Jetty has been DAMAGED >> 40%, Initiate Elevated Status for Executing Jetty Repairs* -----

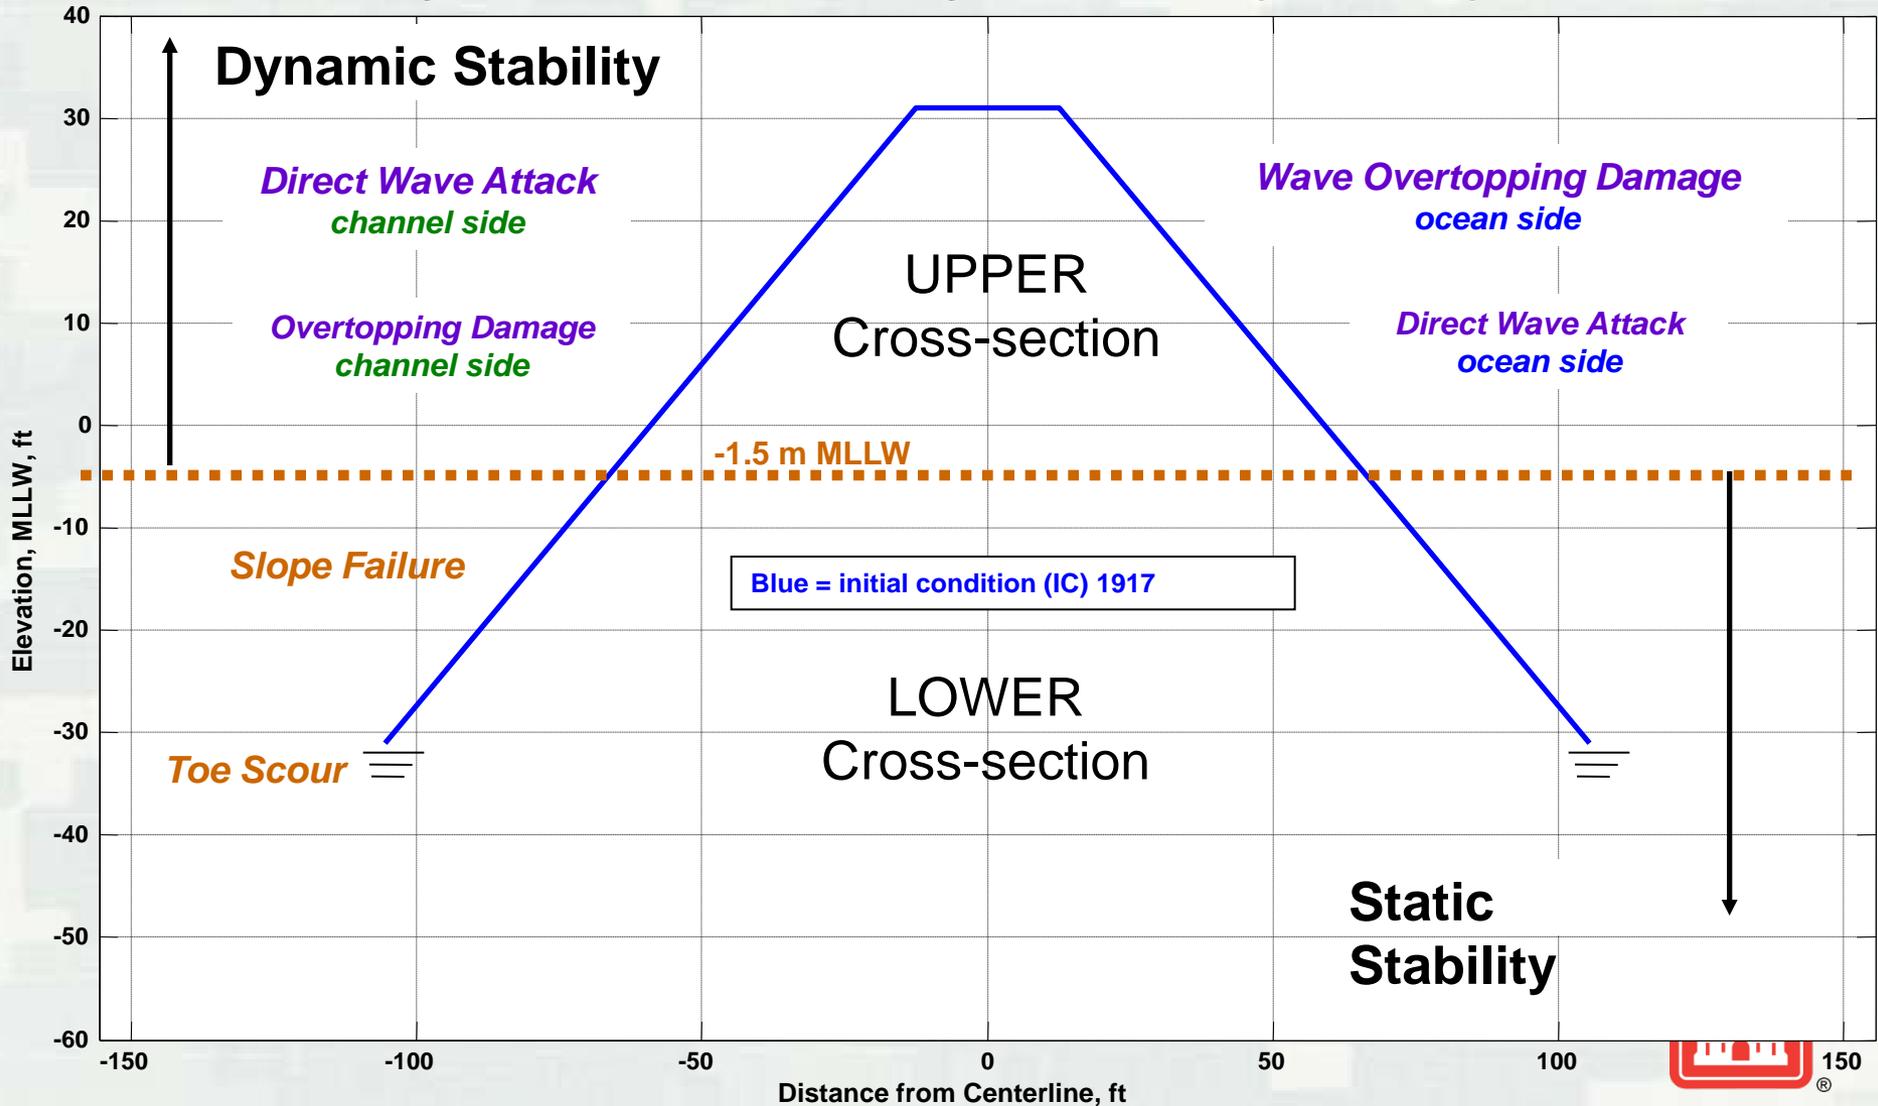
North Jetty CROSS SECTION Life-Cycle Evolution (1917-2006) for STA =84.5

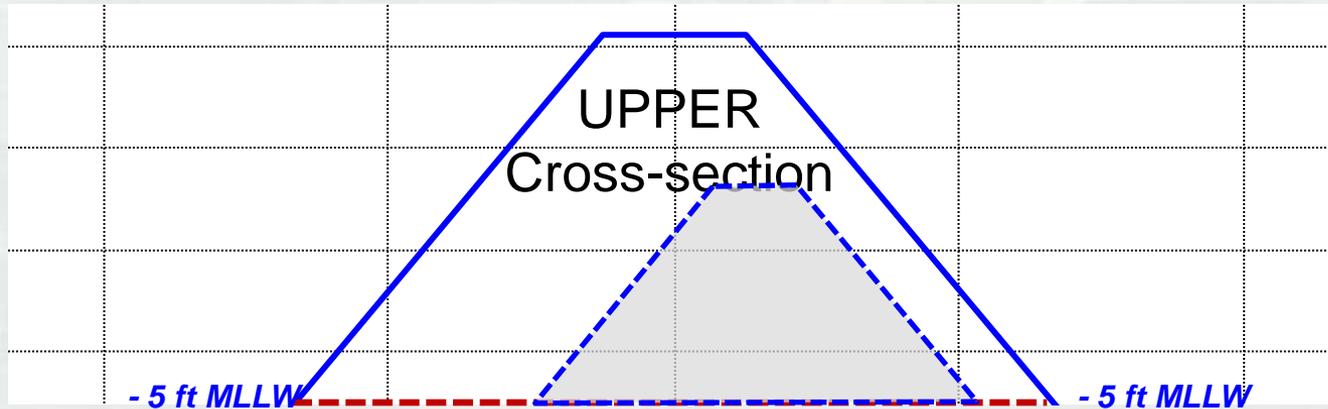
Jetty	Template Area* ft ² , above WAV EL = -5 ft	WAV_EL, ft MLLW	Crest Elevation, ft MLLW	Crest Width, ft	Side slope (rise,v : run,h) Channel / Ocean
North Jetty	2250	max(-5 , TE+2)	25	30	1:1.5 / 1:1.5
South Jetty	2475	max(-5 , TE+2)	25	30	1:2 / 1:1.5
Jetty A	1687	max(-5 , TE+2)	20	30	1:1.5 / 1:1.5
