APPROVED JURISDICTIONAL DETERMINATION FORM
U.S. Army Corps of Engineers

A. REPORT COMPLETION DATE FOR APPROVED JURISDICTIONAL DETERMINATION (JD): 27 April 2015

B. DISTRICT OFFICE, FILE NAME, AND NUMBER: Portland Office, Dutch Canyon, NWP-2015-92

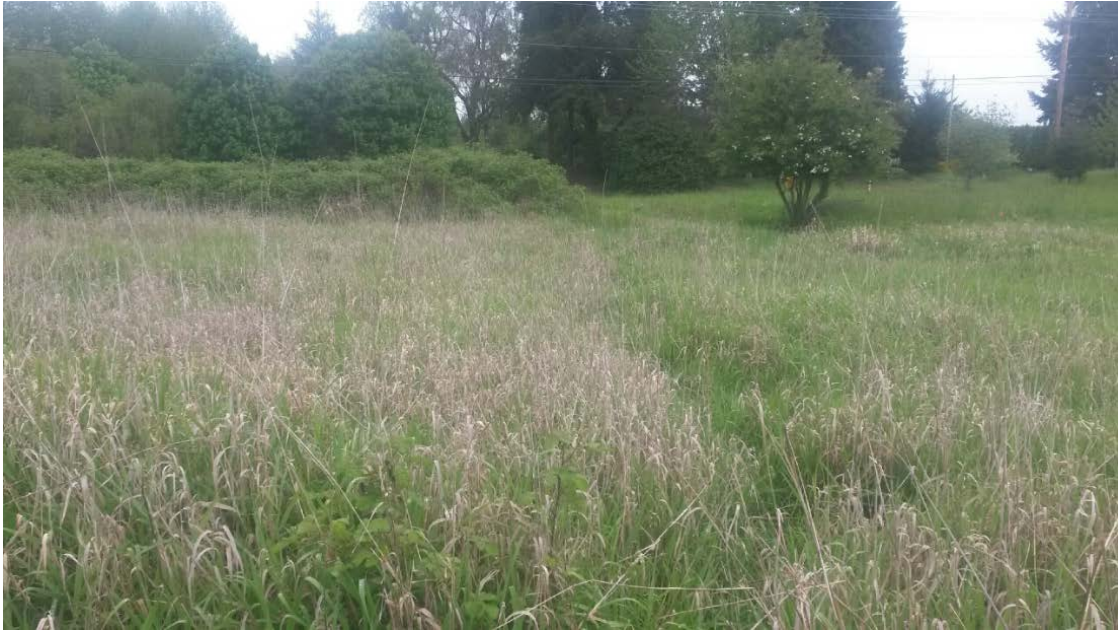
accordance with the Corps 1987 Wetland Delineation Manual. During the 24 April 2015 site visit, the depressional wetland was dominated completely by reed canarygrass (FACW 2014); meeting the requirements for hydric vegetation. The environmental consultant reported surface water 12-inches above the soil surface during their 11 February 2015 site visit. During the Corps site visit, the depressional wetland meet Secondary indicator for geomorphic position and contained saturated soils up to the soil surface; meeting the requirements for wetland hydrology. Soils within the wetland were fine soils of 10YR 3/2 (low value/ low chroma) within the upper six inches (no redox features,). Beneath this layer were fine, depleted soils of 10YR 4/2 containing a 5% redox matrix – meeting USDA hydric soil indicators.

Figure 1. Within isolated wetland, camera facing northeast.

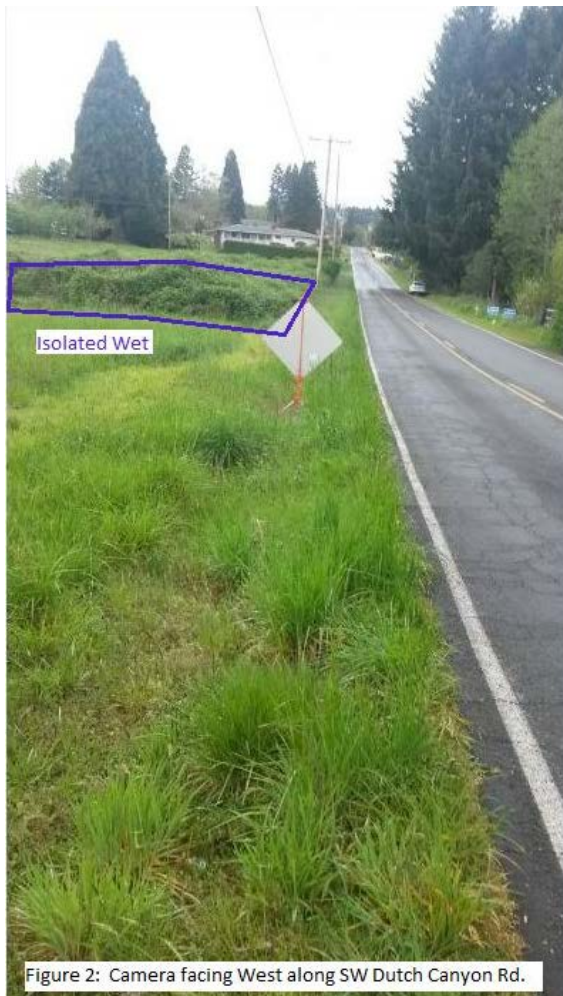
Figure 2: Camera facing West along SW Dutch Canyon Rd.

Corps employee viewed the entire perimeter of the isolated wetland during the site visit. No unbroken surface or clear shallow sub-surface connections were identified around the wetland, with the exception of a small swale located along Dutch Canyon Road. The topography of the wetland resembles a bowl - where the elevation rises outward of the wetland. The topographic shift is strongest to the east and west of the wetland (Dutch Canyon Road), as the elevation rises at an approximate 1:1 slope. This can be seen in the above Figures 2 and Figures 3.

A small swale was identified abutting the south side of SW Dutch Canyon Road (shown Figures 2 and 3 above). This swale extends a few feet from either direction of the wetland, along the roadway, and then ends (flattens out) a few feet as the elevation increases. In the two pictures above, I am standing at the location of where the ditch ends. The white car seen in both pictures is the same vehicle, and acts as a point of references. I am standing on the south side of the roadway in both photographs, so the photographs only show the south side swale along Dutch Canyon Road. The north side of the road has a swale as well, but the north side swale along Dutch Canyon Road also dissipates at approximately the same distance of the wetland. No culverts extend underneath this section of Dutch Canyon Road. These swales do not lead to any tributary.

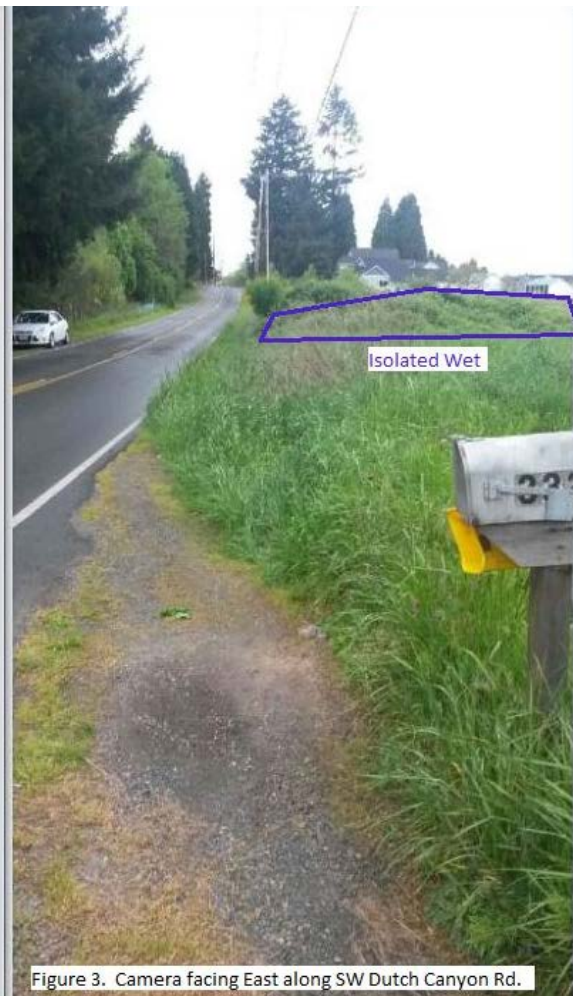
Figure 3: Camera facing East along SW Dutch Canyon Rd.

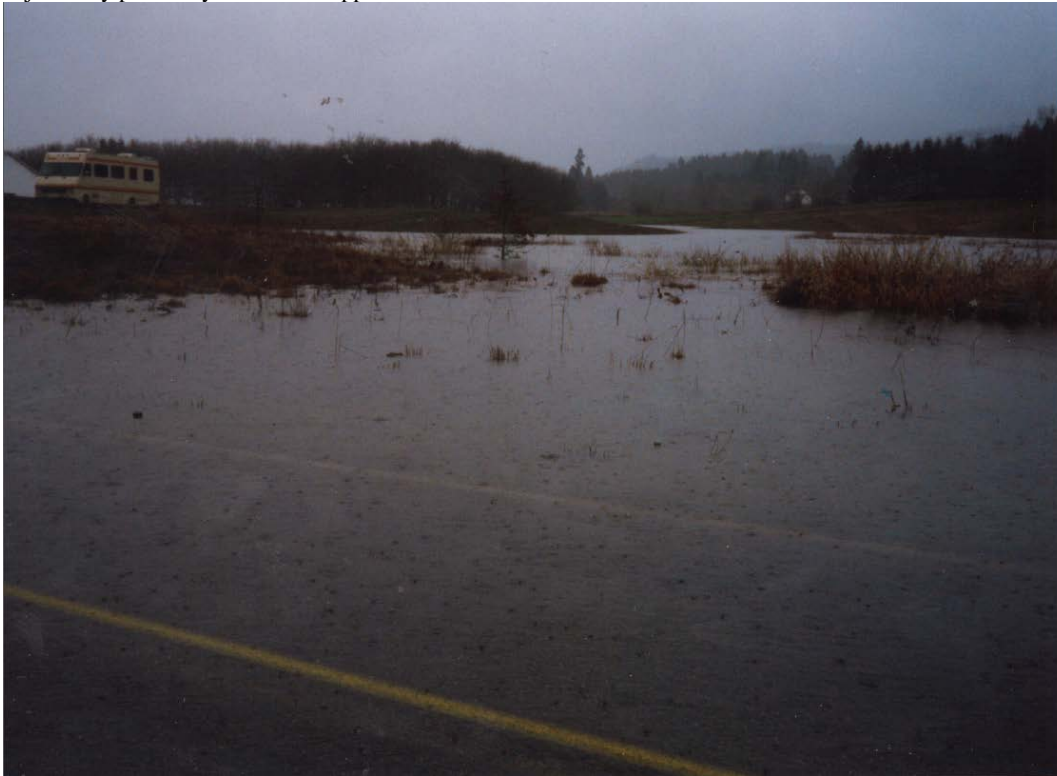
During flood events, water from within the wetland is expected to spill northward across Dutch Canyon Road (as shown in Figure 4 below). The Corps did not access the property just north of Dutch Canyon Road, where this water flows to. The Corps parked at Dutch Canyon Road and were able to see into the property just north of Dutch Canyon Road. We did not identify any swale or hydrological conveyance. If you look at the aerial photography, no hydrological connection could be identified from the roadway or aerials that would allow flood waters to travel to the nearest tributary (South Scappoose Creek). The nearest tributary is located 0.23 linear miles to the northwest. Between our subject wetland and the tributary is

Figure 4. 1999 Flood event; camera facing south into the property. From Dutch Canyon Road. Water is flooding across Dutch Canyon road from the isolated wetland. We found no evidence that this wetland flows into a tributary.

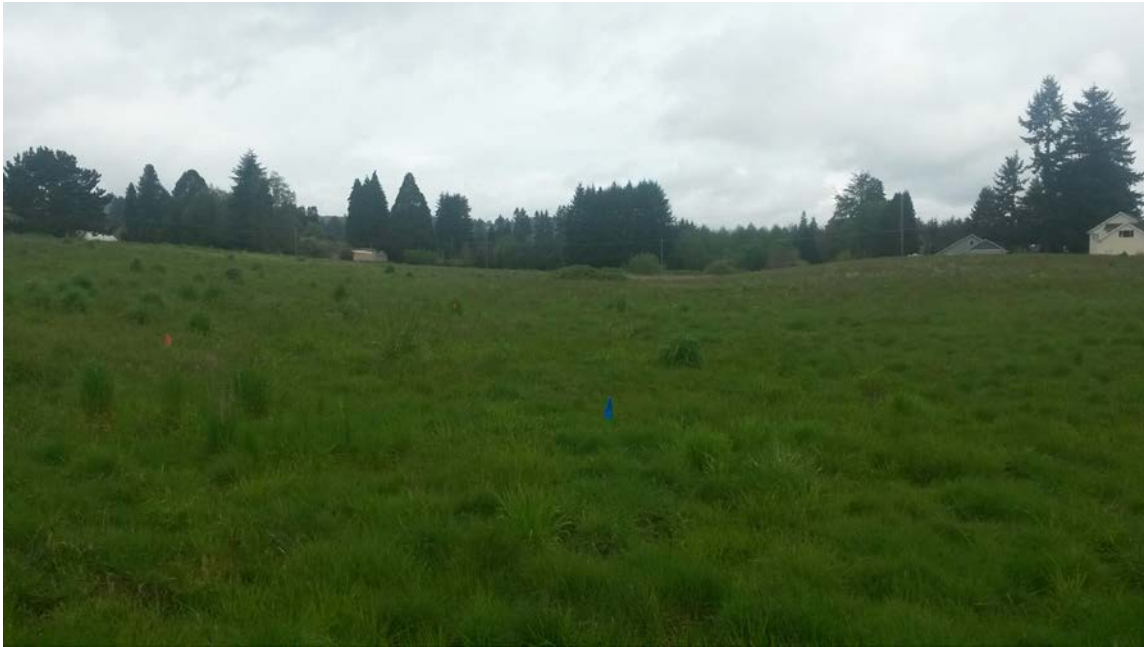
B. ADDITIONAL COMMENTS TO SUPPORT JD: The consultant’s report identified a 0.277 acre depressional portion of the investigation area that was identified to be uplands. The Corps concurs with this determination.

This 0.277 acre depressional area contains wetland hydrology and wetland vegetation, but does not contain hydric soils.

Figure 5. Upland depression. Camera within upland depression, facing north (looking at investigation area from the south perimeter. This picture best shows the topography of the entire site. The east and west sides of the property have a high elevation, and slopes downward towards the center of the property where rain run-off accumulates.

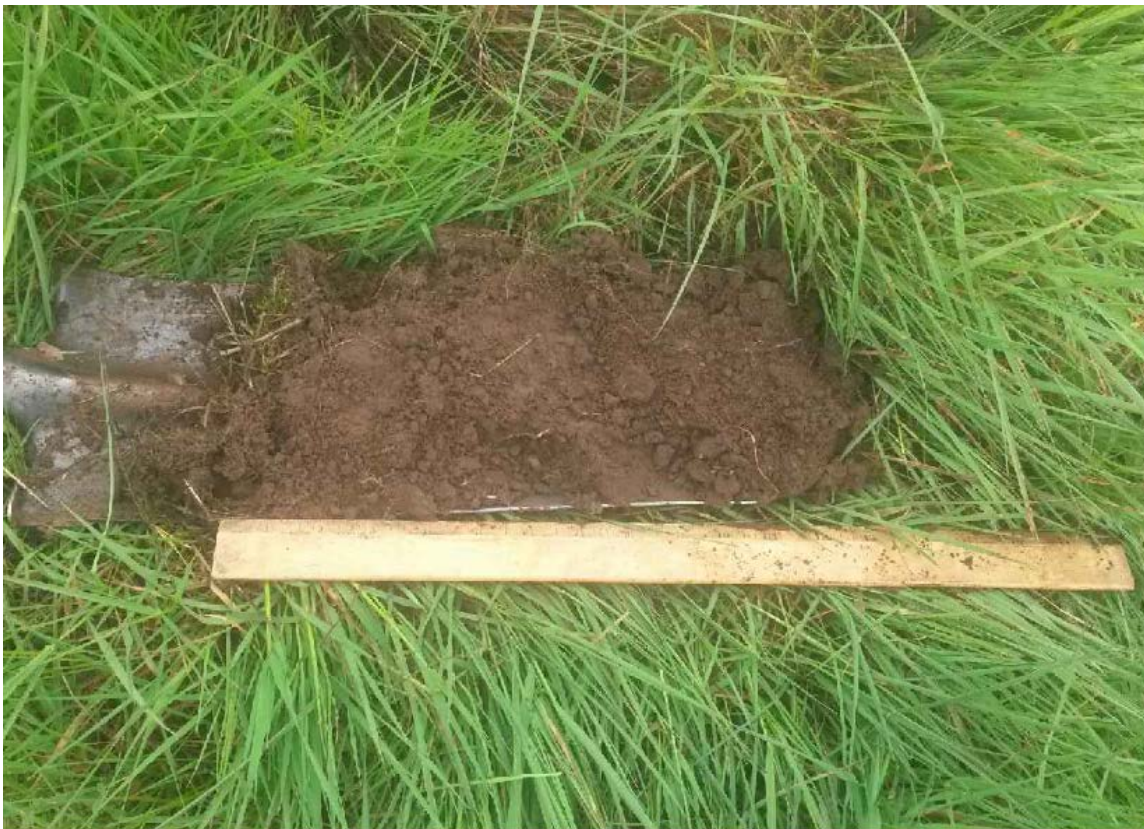
Figure 5. Soil sample taken within upland depression, 24 April 2015. 10YR 3/3 down to 12 inches. (16 inch ruler)

During the 24 April 2015 site visit, the soils taken within the depression were too high in chroma to meet hydric soil indicators. The USDA web soil surveys identified the soils as “Quafeno loam, 3 to 8 percent slopes”, a moderately well-drained soil with no near surface restrictive layer. Based on the soil surveys and data collected from the site visit, it was determined that this portion of the property does not meet the necessary requirements for hydric soils and is not a wetland.
