**DEPARTMENT OF THE ARMY**  
**U.S. ARMY CORPS OF ENGINEERS, PORTLAND DISTRICT**  
**P.O. BOX 2946**  
**PORTLAND, OR 97208-2946**

**MEMORANDUM FOR RECORD**

**SUBJECT:** U.S. Army Corps of Engineers (Corps) Approved Jurisdictional Determination in accordance with the "Revised Definition of 'Waters of the United States'"; 88 FR 3004 (18 January 2023) as amended by the "Revised Definition of 'Waters of the United States'; Conforming" 88 FR 61964 (8 September 2023),<sup>1</sup> NWP-2025-299.<sup>2</sup>

3. REVIEW AREA. The Review Area (RA) is approximately 15.04-acres in size located at the intersection of NW Garden Valley Road and Melrose Road, northwest of Roseburg, Douglas County, Oregon at latitude/longitude: 43.24121°, -123.39598°.

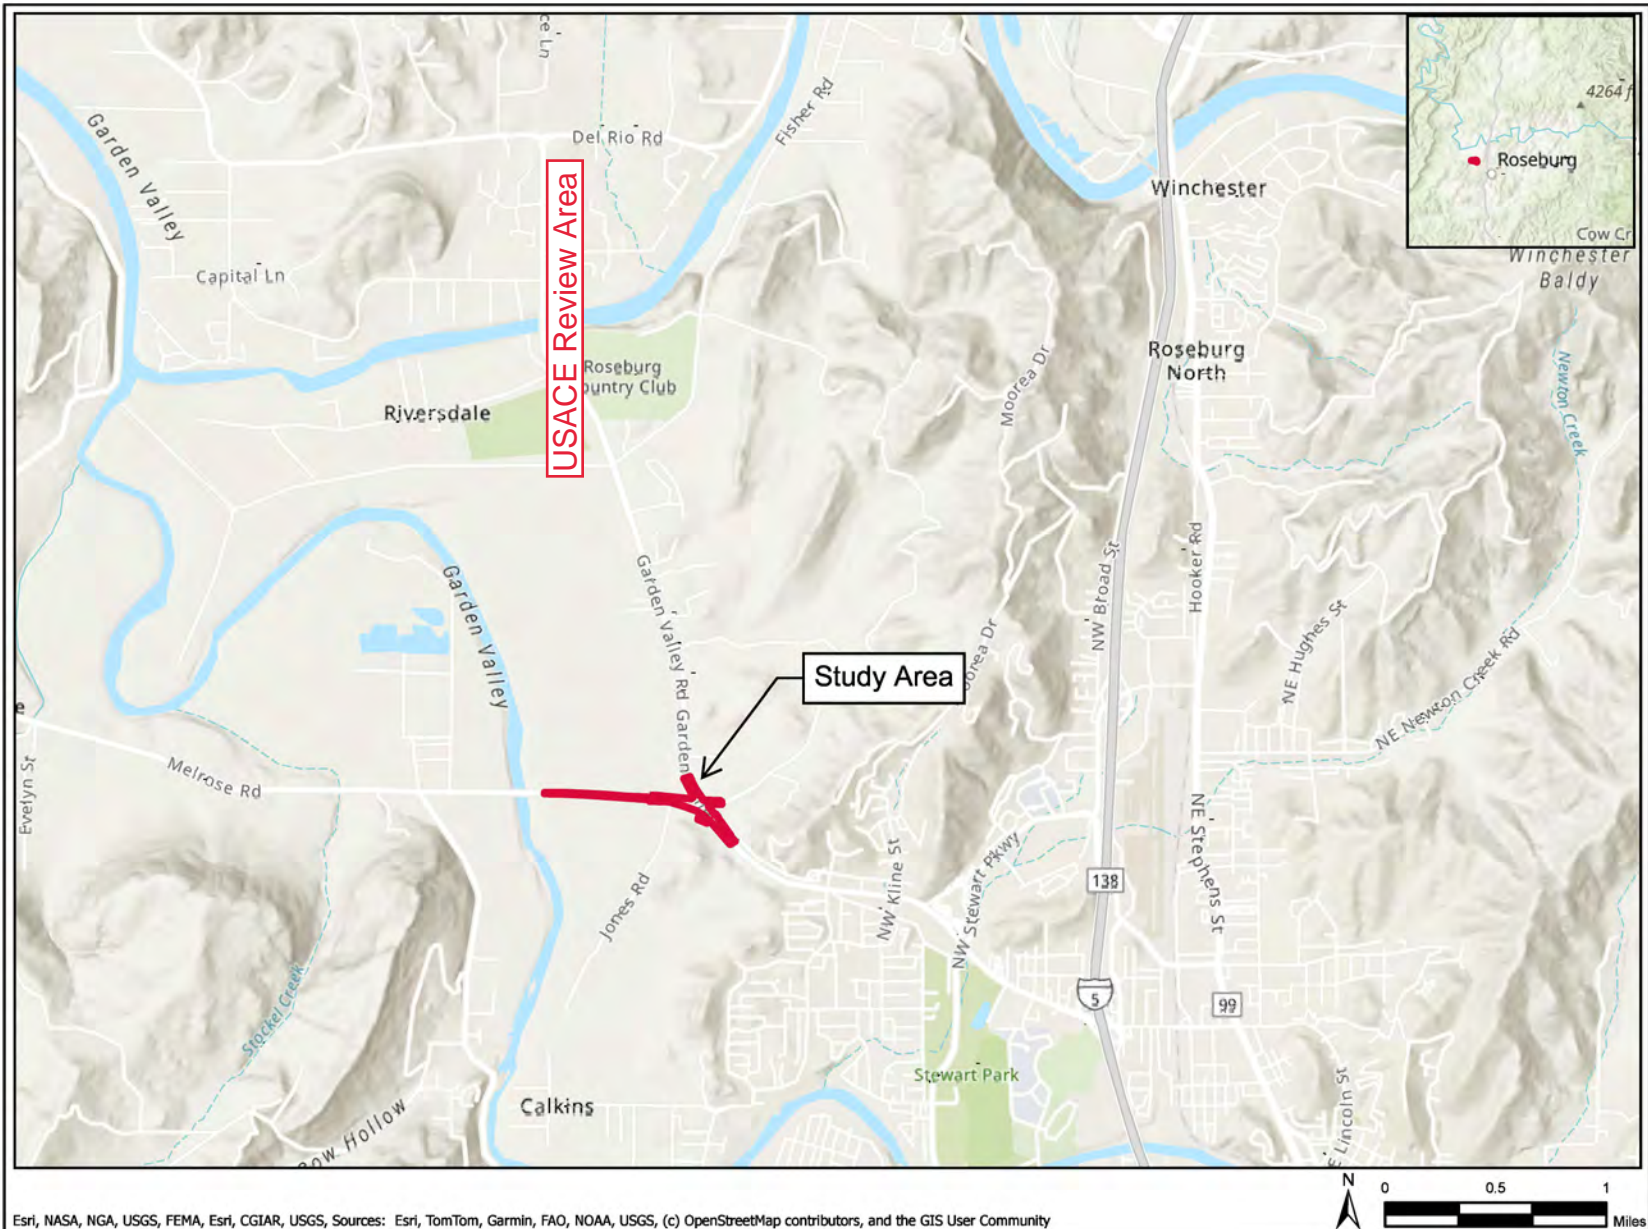
**Figure 1: Vicinity Map**

Garden Valley Road at Melrose Road Roundabout  
Roseburg, Oregon

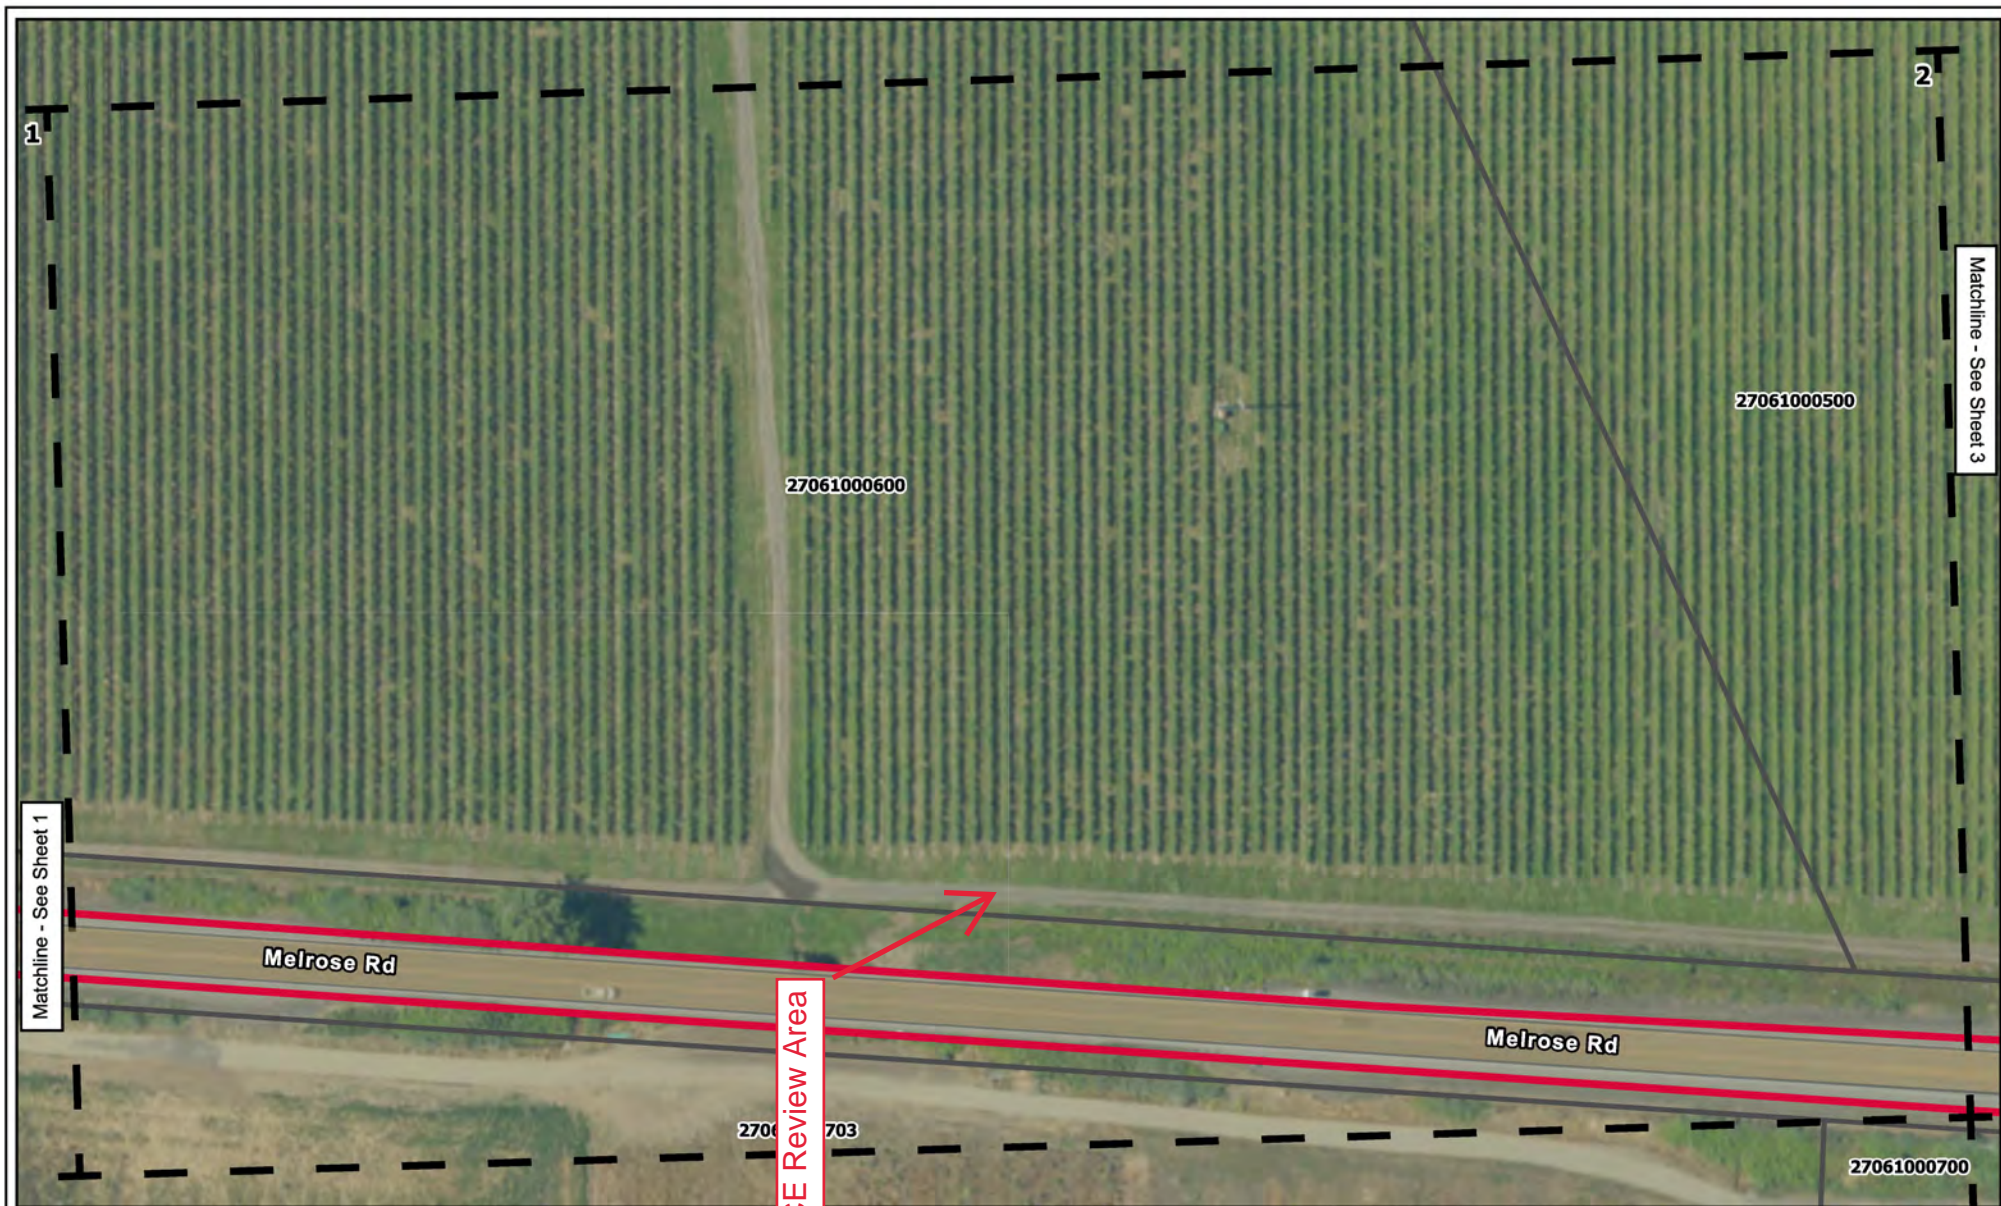
Figure 6: Wetland Delineation Exhibit  
Garden Valley Road at Melrose Road Roundabout  
Roseburg, Oregon

USACE Review Area

- Photo Points
- Auger
- Sample Plot
- OHWM Line
- Grid Index
- Wetlands

- Flow Direction
- API Boundaries
- Taxlots
- Ditch Centerline
- Culvert
- Fence

Stream 1: Stream 1 is a relatively permanent waterway (RPW) measuring 224 linear feet (LF) within the RA and is located in the southeast (SE) portion of the RA. Stream 1 flows east to west within the RA. Stream 1 is recognized on 2023 U.S. Geological Survey (USGS) quadrangle mapping as an intermittent waterway, and was delineated as an intermittent waterway. Stream 1 is a 2<sup>nd</sup> order stream pursuant to the Strahler stream order classification system. Flowing surface water was visible in Stream 1 during the wetland and waterway delineation. Stream 1 possesses an ordinary high water mark (OHWM) ranging from eight to ten feet and a streambed of silt and sand. Stream 1 follows the flowpath described in Section 5 above. The Corps has determined Stream 1 meets the definition of an (a)(3) tributary and is a waters of the U.S.

Tributary to Stream 1: Tributary to Stream 1 is an RPW measuring 343 LF within the RA and is located in the SE portion of the RA. Tributary to Stream 1 flows east to west within the RA. Tributary to Stream 1 is recognized on 2023 USGS quadrangle mapping as an intermittent waterway and was delineated as an intermittent waterway. Tributary to Stream 1 is a 1<sup>st</sup> order stream pursuant to the Strahler stream order classification system. Tributary to Stream 1 flows into Stream 1 within the RA where these streams combine to create a 2<sup>nd</sup> order stream (Stream 1). Flowing surface water was visible in Stream 1 during the wetland and waterway delineation. Tributary to Stream 1 possesses an OHWM ranging from three to five feet on the east side of NW Garden Valley Road and eight to ten feet west of NW Garden Valley Road. The streambed of Tributary to Stream 1 is comprised of silt. Tributary to Stream 1 follows the flowpath described in Section 5 above. The Corps has determined Tributary to Stream 1 meets the definition of an (a)(3) tributary and is a waters of the U.S.

Wetland A: Wetland A is a palustrine emergent (PEM) wetland measuring 1.36-acres located in the SE portion of the RA. Wetland A abuts Stream 1 within the RA. The Corps has determined Wetland A possesses a requisite continuous surface connection (CSC) to an (a)(3) water and is a waters of the U.S.
