Cottonwood Island, W-70.1

Howard Island, W-68.7

International Paper Rehandle, W-67.5

Rainier Beach, O-67.0

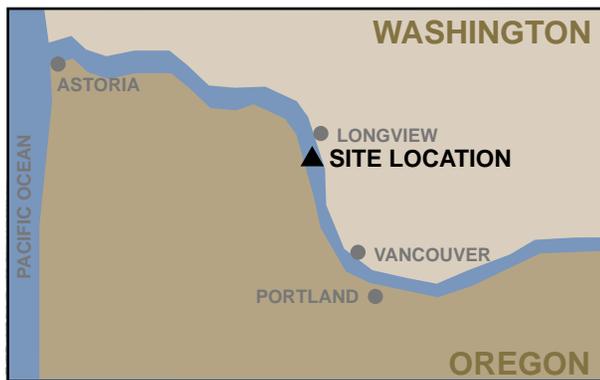
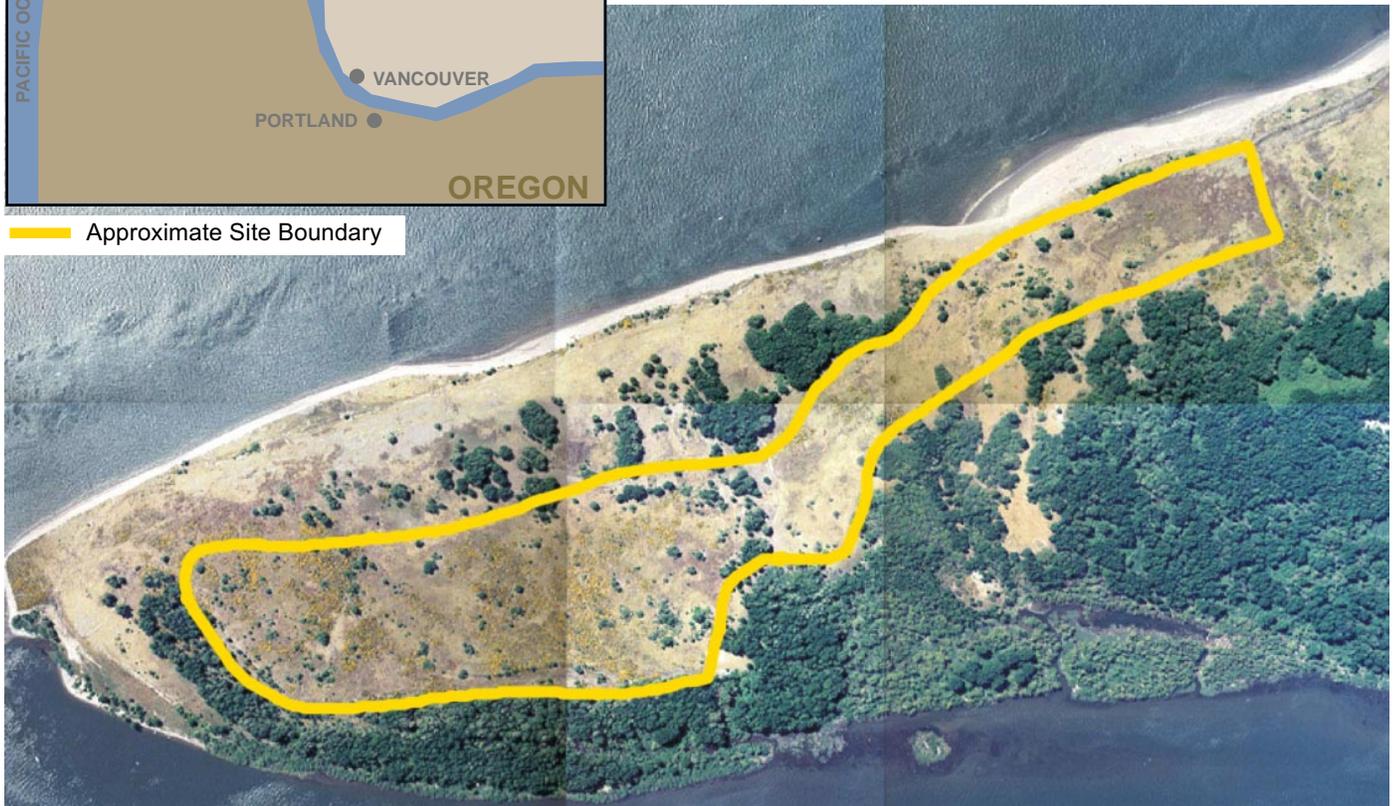
Description: Cottonwood and Howard Islands were once separate, but are now contiguous. Nearly all of the subject property has been covered in the past with dredge material. The majority of the island is relatively level and situated approximately 20 feet above the Columbia River with steep banks dropping off to both the Columbia River and Carrolls Channel along portions of the shoreline. A pond and wetlands area are located 1/2 mile northwest of the site. The disposal site is set back 300 feet from the Columbia River and side channel shorelines to avoid ESA Critical Habitat.

The property is nearly devoid of development except for the presence of navigational aids (beacons), groins (wooden piles placed perpendicular to longshore current), and a few campsites. The property is roughly kidney shaped and is located at a northwest trending bend in the Columbia River. There is no water service to the property.

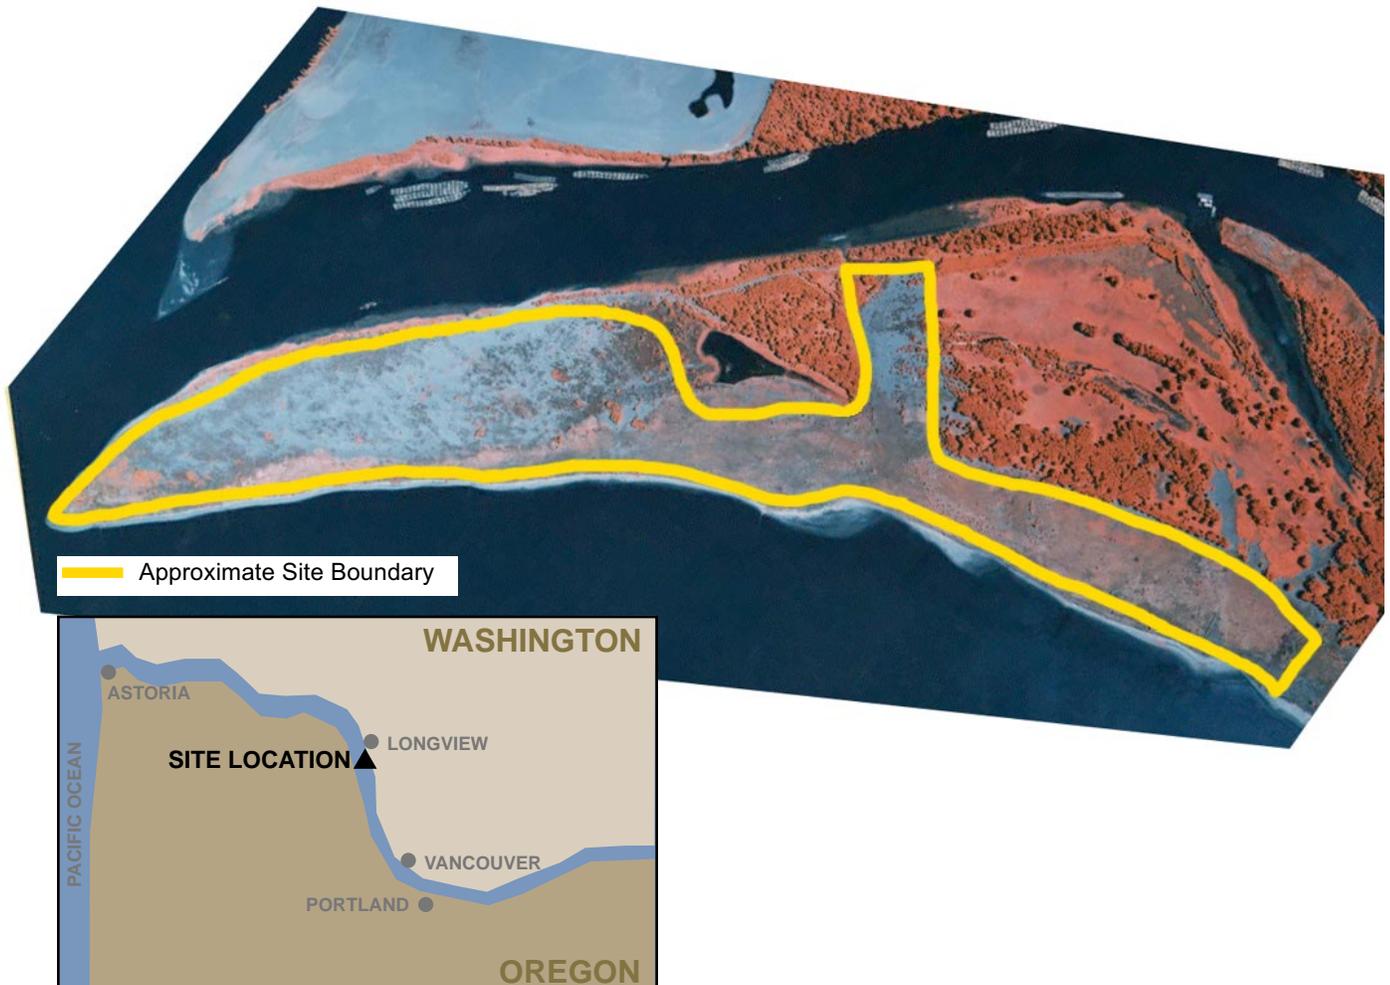
Description: Nearly all of the property has been covered in the past 40 years with material dredged from the Columbia River. The site is roughly crescent shaped and relatively level. Steep 20-foot banks drop off to both the Columbia River and Carrolls Channel along portions of the shoreline. A lowland area with a pond and wetlands area is located adjacent to the north-northeast boundary of the property near Carrolls Channel. A small drainage channel runs north from the pond into Carrolls Channel. The wetland will be avoided during disposal. The northwest and northeast portions of the site are forest. Except for the presence of navigational aids and groins, the property is devoid of development. There is no water service or access to the island property.

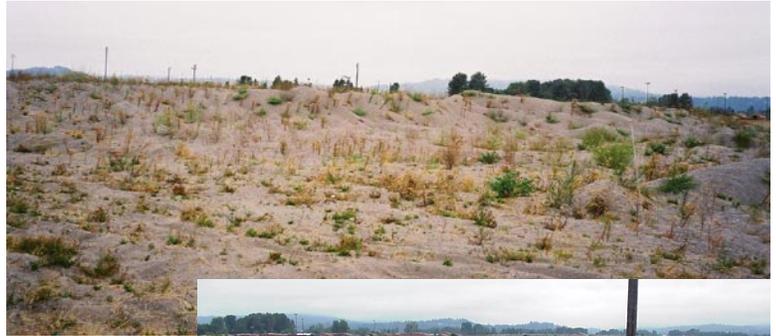
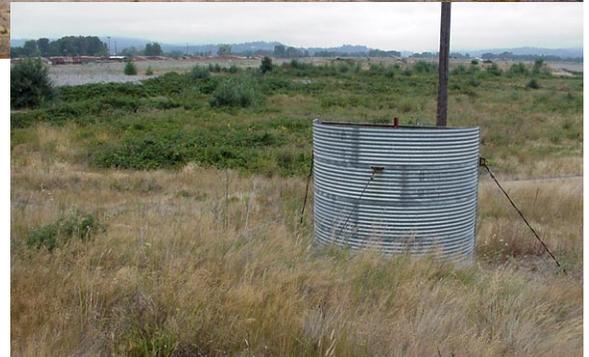
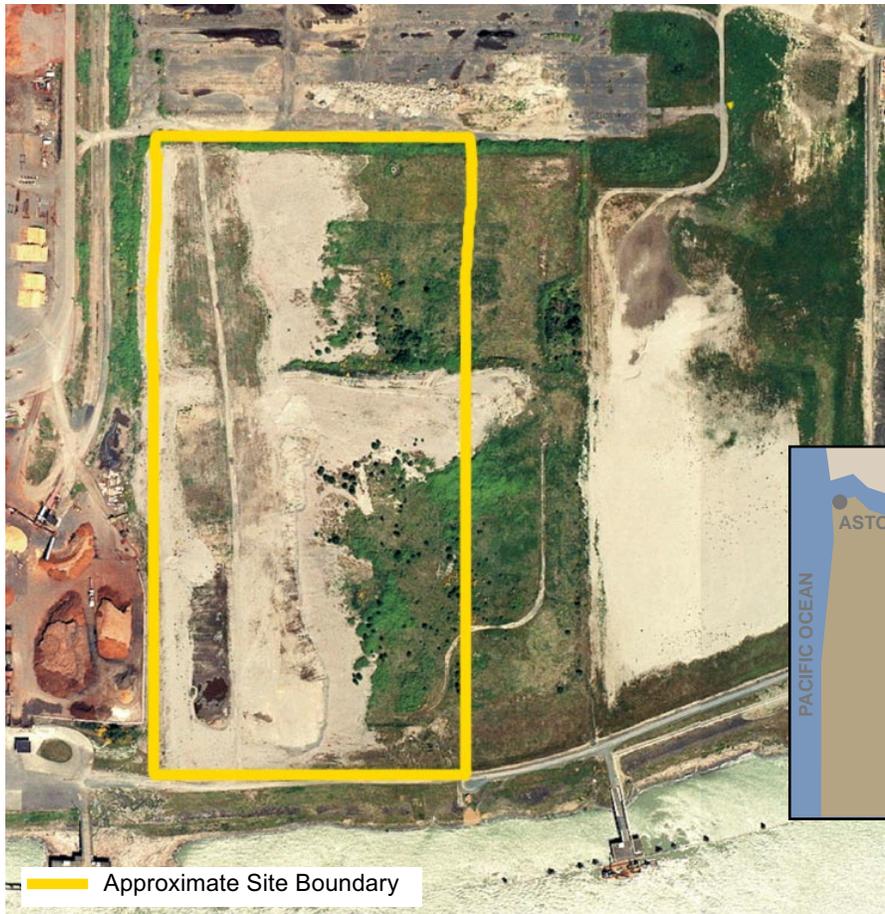
Description: The site is bounded on the north and east by vacant lots, the south by the Columbia River, and the west by a Pacific Fibre wood products facility. The topography of the property was altered by the placement of dredged material, resulting in a relatively flat to gently undulating topography. Steep 10-to-15-foot banks slope off to the north, east, and west from the dredge pile to the adjoining piles. The southern end of the property drops gradually to the Columbia River.

The property is zoned for heavy manufacturing. It is currently being used as a receiving site for dredged material. Improvements on the property include a drainage structure used for dewatering the dredge material.

To the south, an offsite levee separates the site from the Columbia River, located approximately 200 feet south of the property. Pacific Fibre owns and operates a debarking facility on the adjoining property to the west. No water service exists on the property.

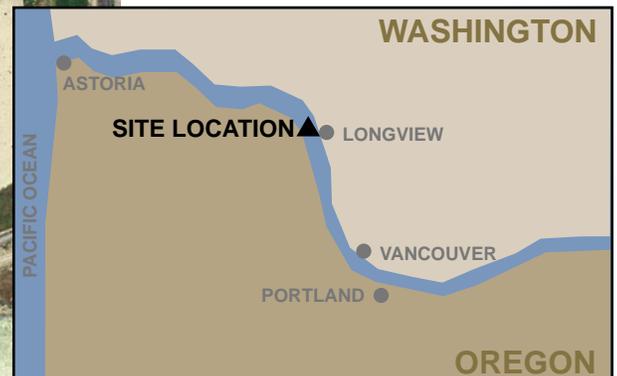
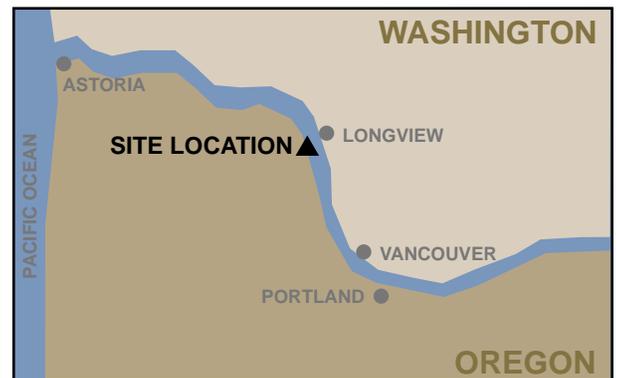
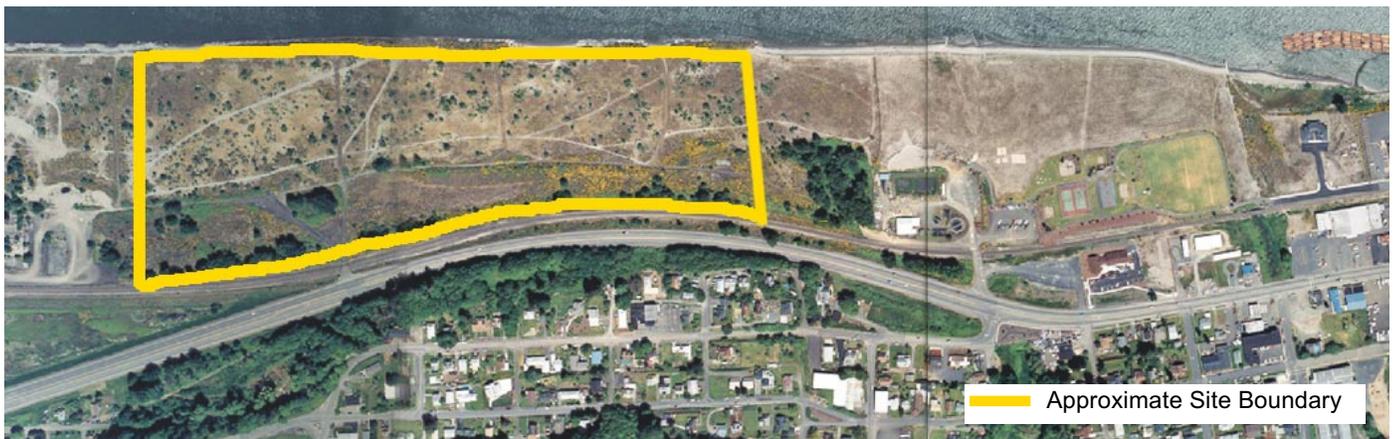
Description: Rainier Beach is currently privately owned. The site was cleared and was initially used for dredged materials following the eruption of Mt. St. Helens in 1980. The site is currently covered by dredged material deposited there from maintenance dredging. It is bordered on the north by an active log decking yard and on the east by a railroad line that parallels the entire site.

There are no improvements on the site and no vegetation cover. There is rip-rap along the Columbia River that borders the site to the east.

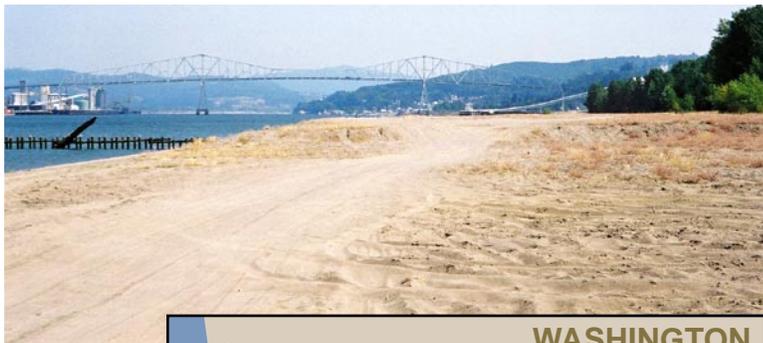
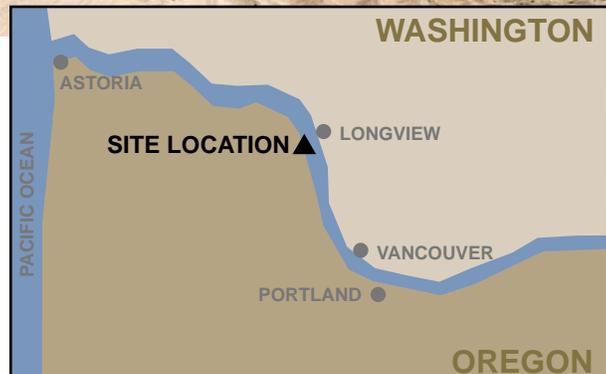
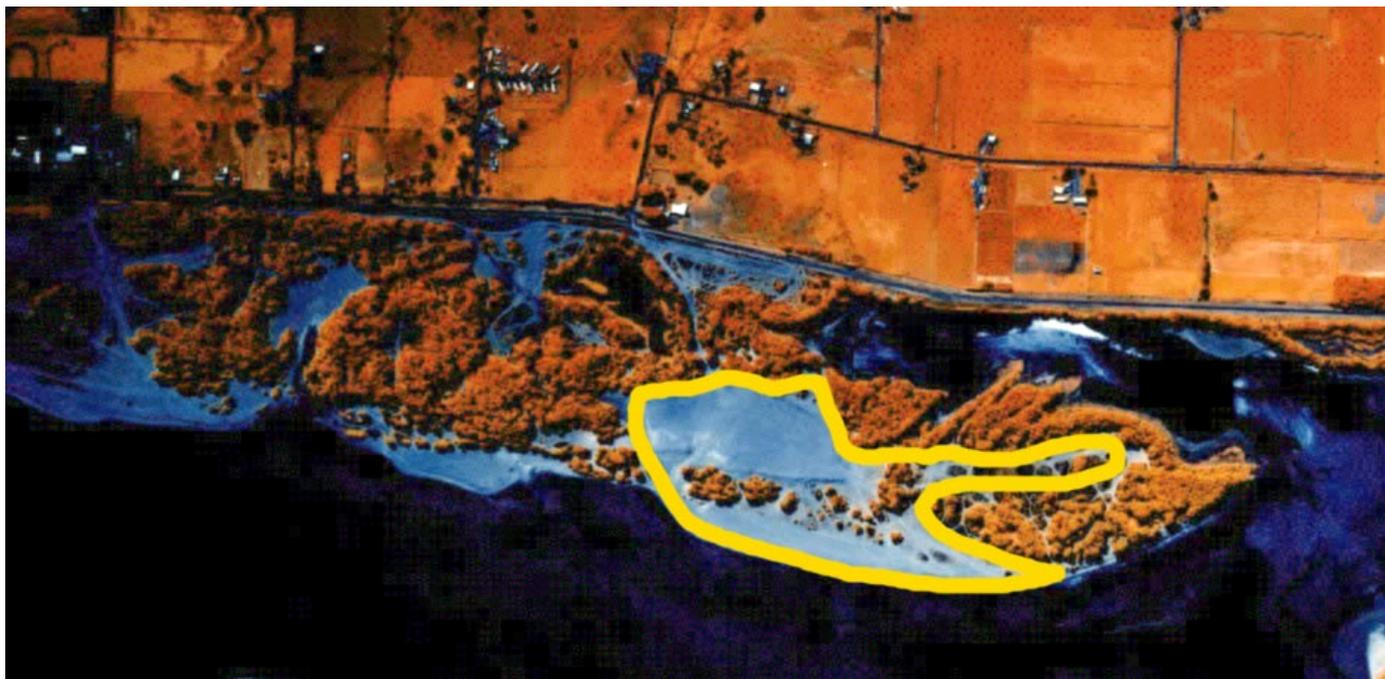
Rainier Industrial, O-64.8

Description: The entire Dibbley Point peninsula on which the site is located has received dredge spoils from past dredging operations. Ground surface generally slopes away from the center of the peninsula, toward the Columbia River to the north and toward a backwater slough off the Columbia River to the south. The southeast corner of the property contains an active sand and gravel mining operation. Dredge spoils in this area rise about 10 to 20 feet above the surrounding area.

Approximately 1/4 mile east of the property is the United States Gypsum (USG) sheet-rock plant. The southeast portion of the property is currently being mined for sand and gravel.

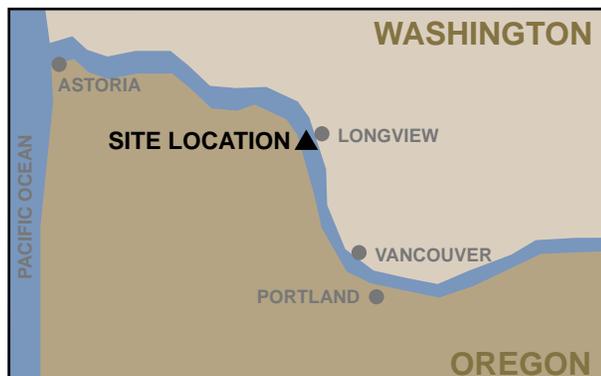
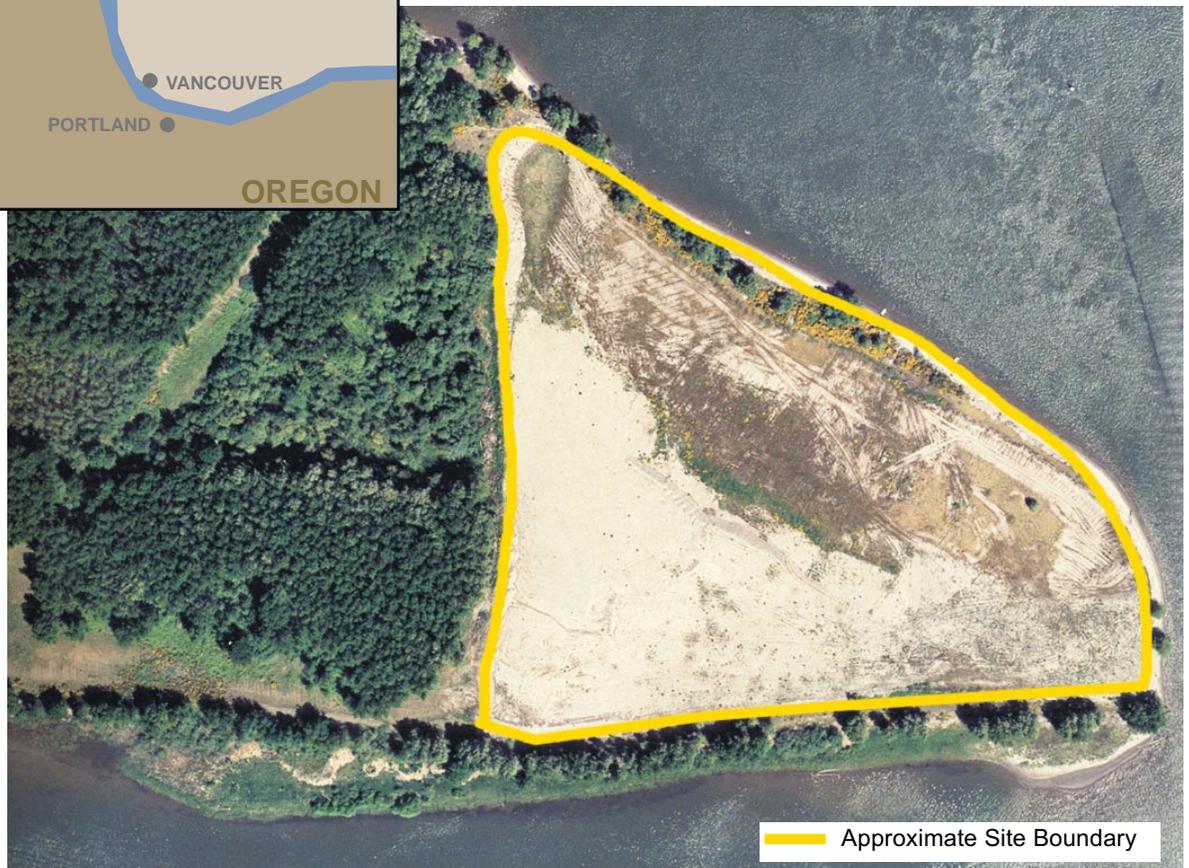
Lord Island, O-63.5

Description: Most of the subject property has been covered in the past with material dredged from the Columbia River. The adjacent (downstream) portion of Lord Island, to the west and northwest of the property, is mostly covered with riparian forest and lowland marsh. Steep 20- to 25-foot banks drop off along the edges of the dredge pile to the Columbia River and the offsite portion of Lord Island. The island was historically formed from dredged material. The central portion of the disposal site is relatively level.

The disposal site is diked. There are no other improvements. Offsite (downstream) portions of Lord Island contain slack water, lowland areas, and marsh. Wooded areas extend along the southern and western boundaries of the site. These will be avoided.

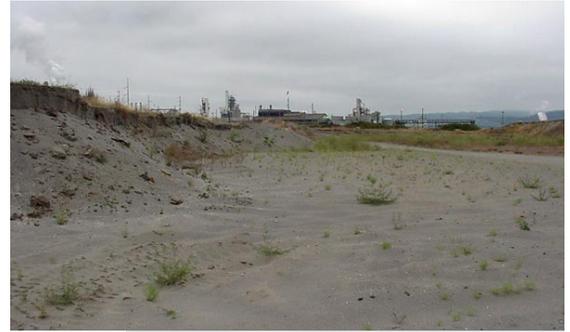
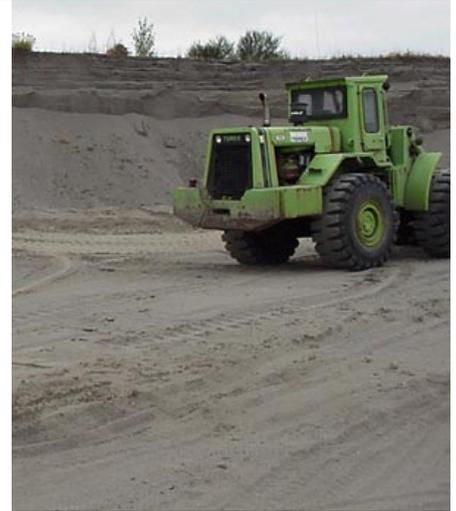
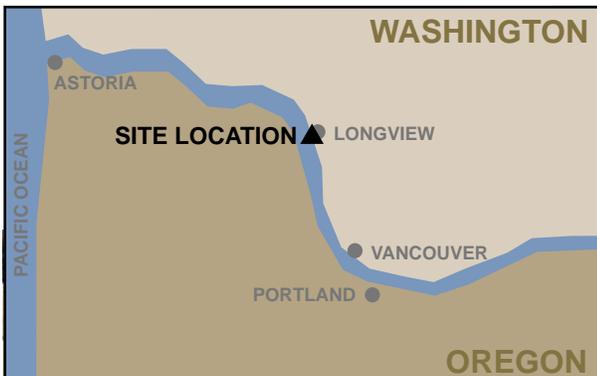
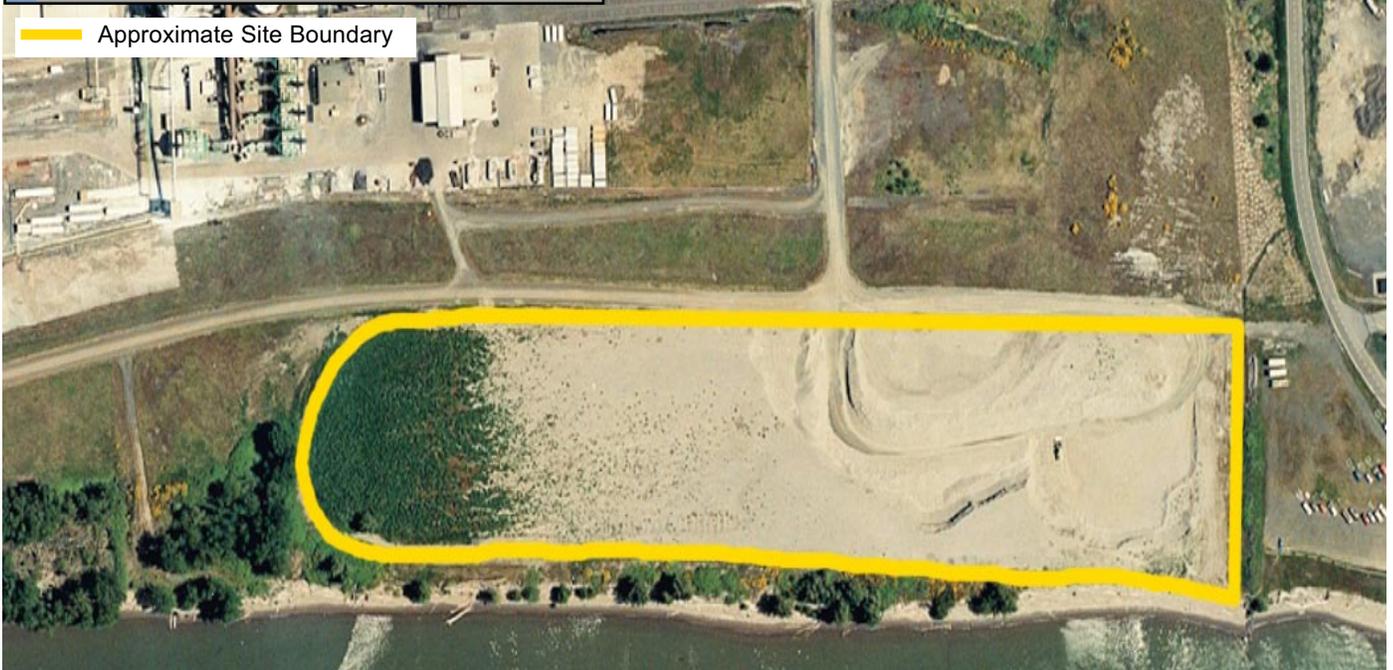
Reynolds Aluminum, W-63.5

Description: The property is bordered on the northwest, northeast, and southeast by the former Reynolds Aluminum plant, which is now closed. The entire site is diked and used for disposal. Reynolds Aluminum has used this site in the past as a disposal site for the dredging of the access channel from the main Columbia River Channel to their docking facility. The capacity at this site is limited. The property has been covered in dredge material that is being sold under contract. The only improvement on the site is a drainage system for the material dredged from the Columbia River.

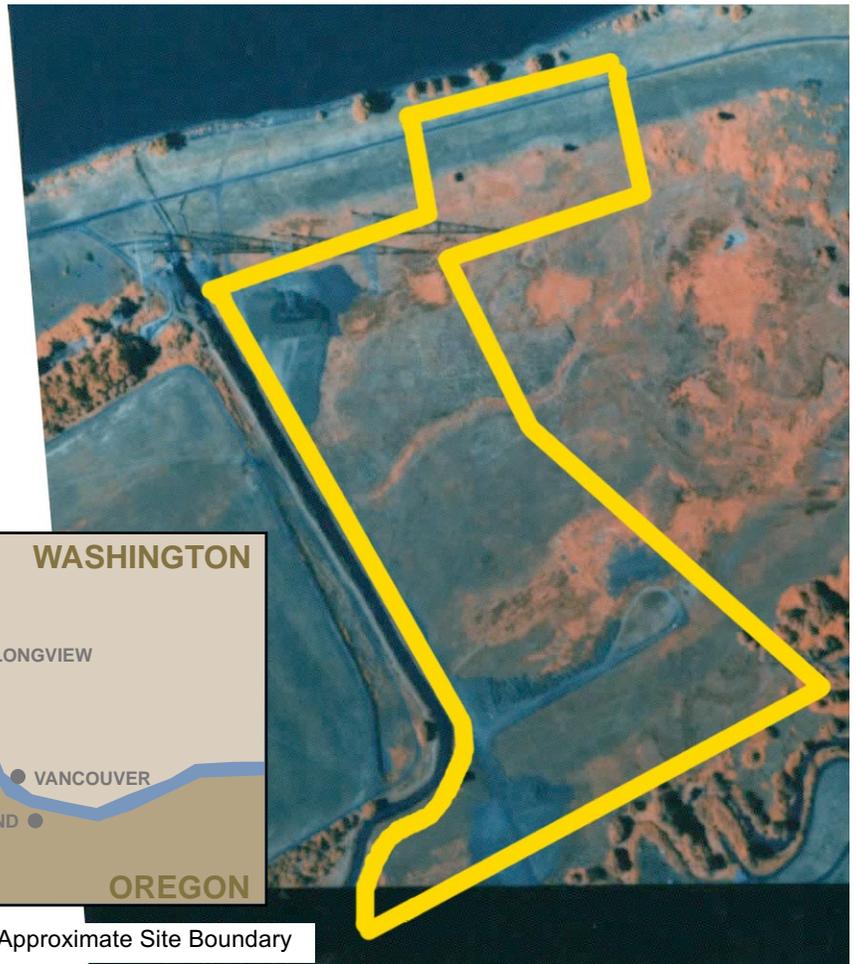
Mount Solo, W-62.0

The topography is nearly level across the entire site. The dike has gentle north and south slopes, and separates the majority of the site from the Columbia River. The center of the site has a slight depression, which was partially filled with water during the site reconnaissance. The northern half of the site slopes slightly to the north-northwest into the meandering surface water drainage ditch. To the west, the topography is relatively flat and similar to that of the subject property

Standing water was observed in the center of the property as well as in two drainage ditches. There are no wastewater services at the property.

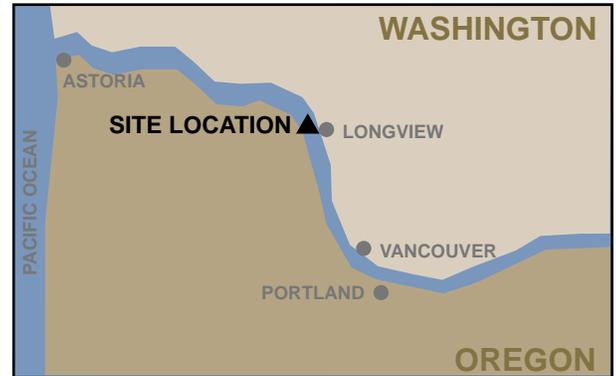
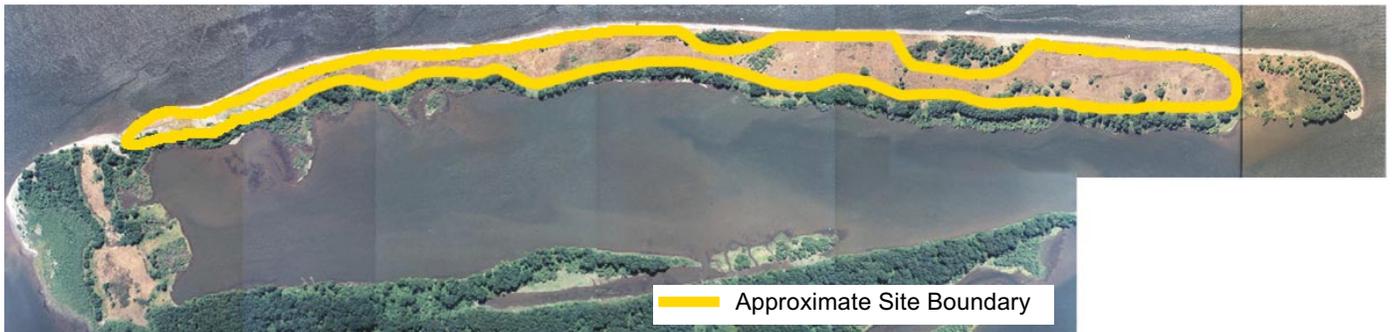
Hump Island, W-59.7

Description: Hump Island is a long thin island located between Walker Island and the Columbia River. It is approximately 9,500 feet in length with an average width of 600 feet. There are clusters of cottonwoods on the north and south ends of the island. The site is currently covered by disposal material deposited during maintenance dredging.

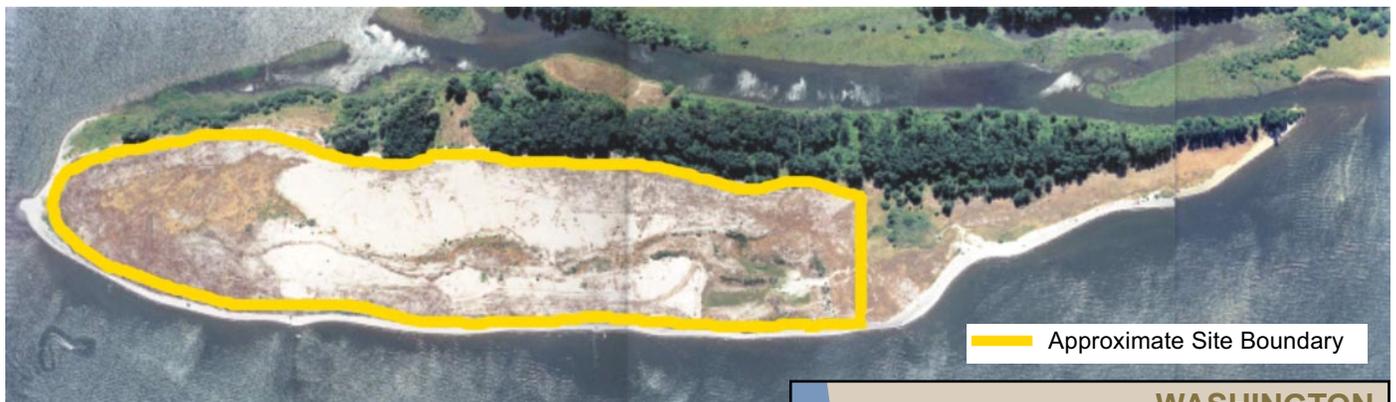
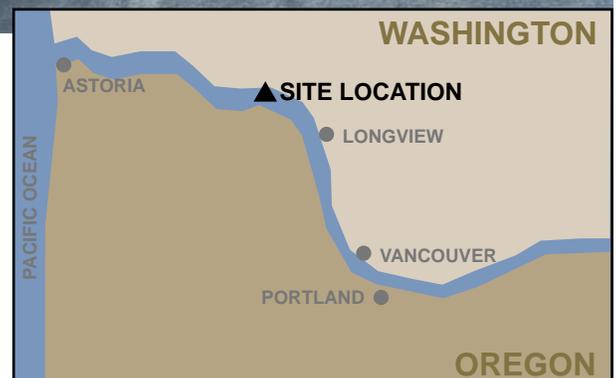
Crims Island, O-57.0

Description: Most of the subject property has been covered in the past with material dredged from the Columbia River. Steep 5- to 25-foot banks drop off the edges of the sand pile to the Columbia River and adjacent offsite portions of Crims Island. The oblong-shaped property is approximately 3,300 feet long by 500 feet wide and is diked. It is situated along the upstream end of the island.

A narrow slough is located on the south-southwest side of the site, and nearly separates the site from the main body of Crims Island. Wooded areas extend along the southern and western boundaries of the property. These wooded areas will be avoided during disposal.
