Tenasillahe Island, O-38.3

Welch Island, O-34.0

Skamokawa, W-33.4

Pillar Rock, O-27.2

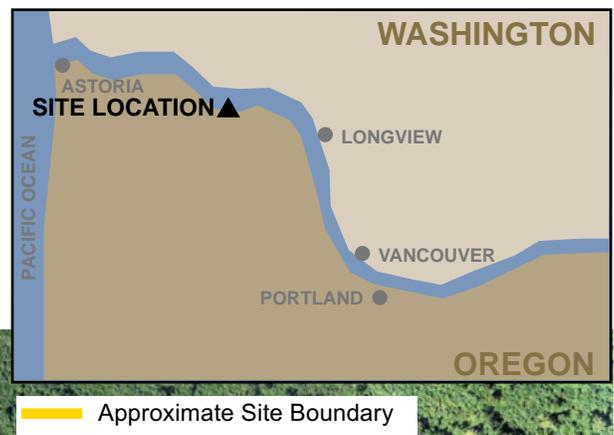
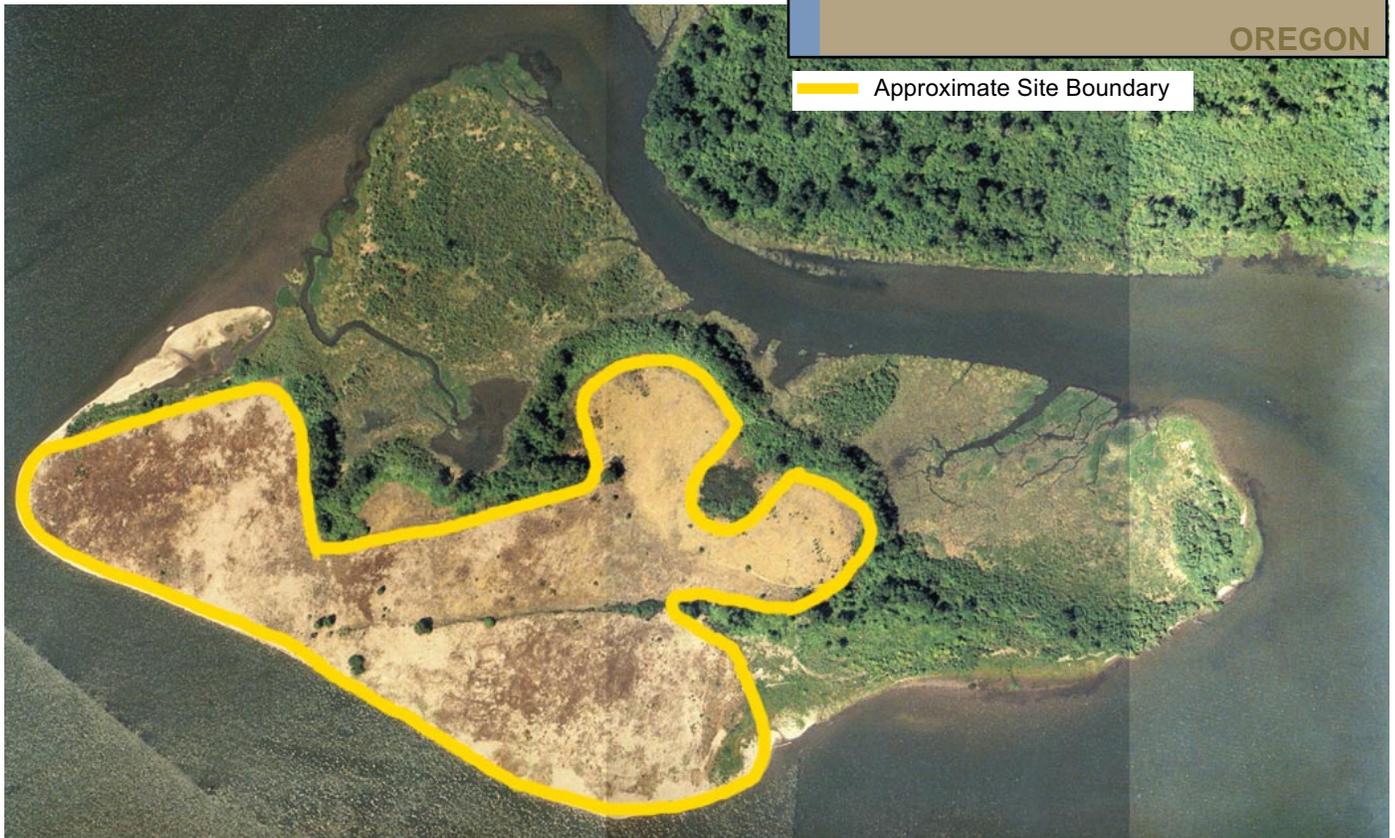
Description: The property has been covered in the past with material dredged from the Columbia River. The majority of the island is relatively level and elevated above the Columbia River. Steep 10-foot banks drop off to both the Columbia River and Clifton Channel along portions of the shoreline. A lowland marsh is located adjacent to the northeast edge of the property. The site is nearly devoid of improvements except for temporary campsites and an outhouse. No wetlands will be impacted by disposal.

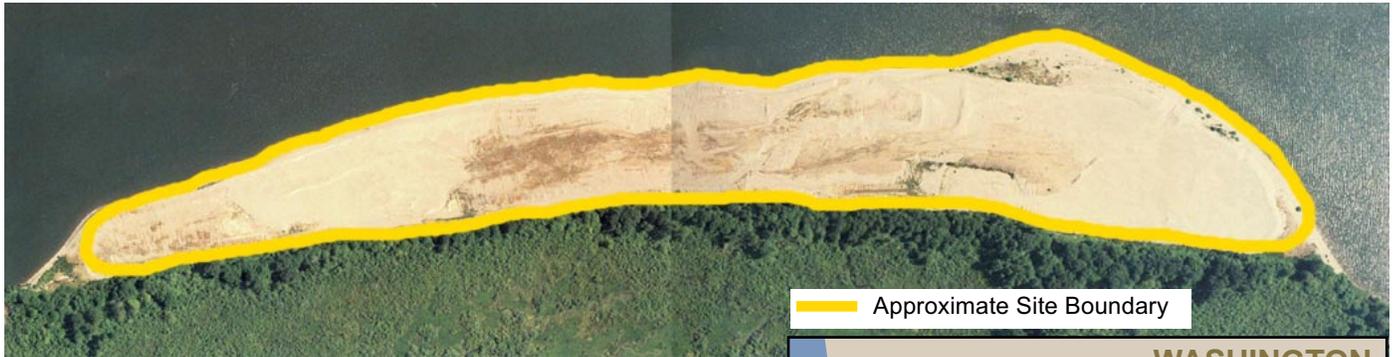
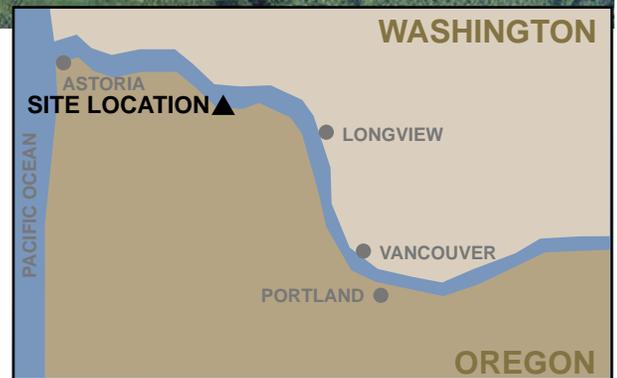
Description: Most of the property has been covered in the past with material dredged from the Columbia River. A slightly uneven topography was observed on the interior of the site, indicating uneven dredge spoil placement.

The interior of the property is bermed, and steep 10-foot banks drop off from the site to the Columbia River and along the southwestern side of the property. A lowland marsh and riparian forest is located adjacent to the southwest of the property. There is no water service to the property.

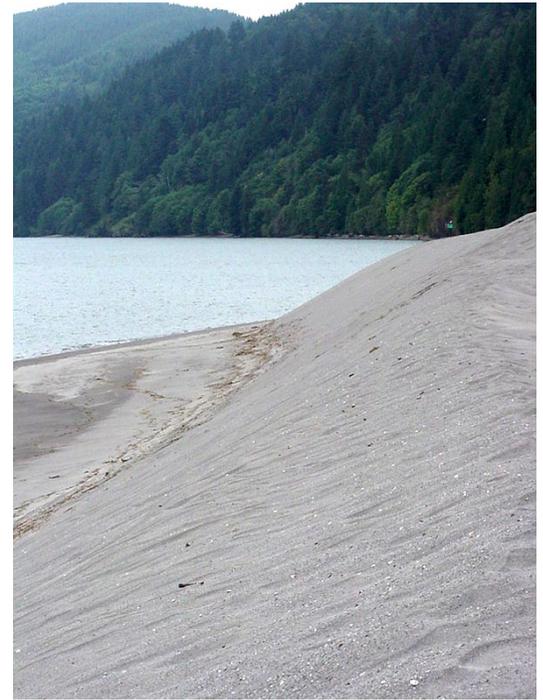
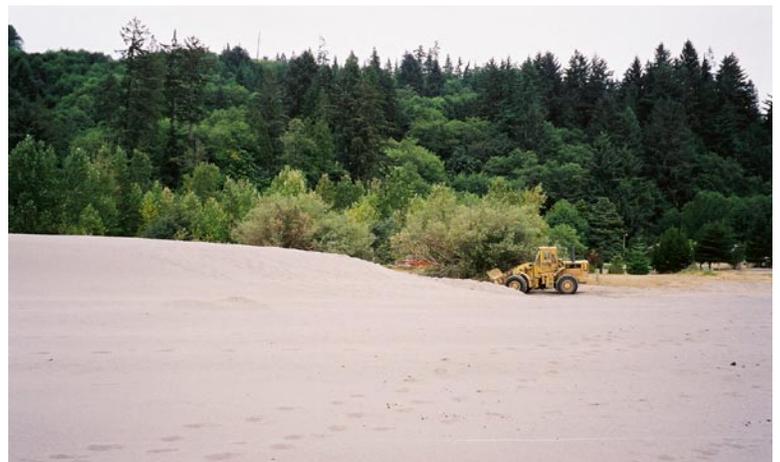
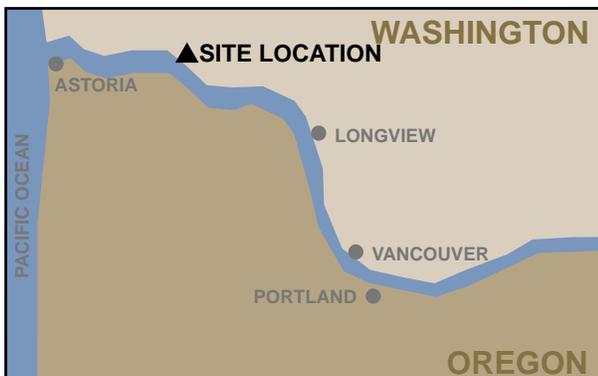
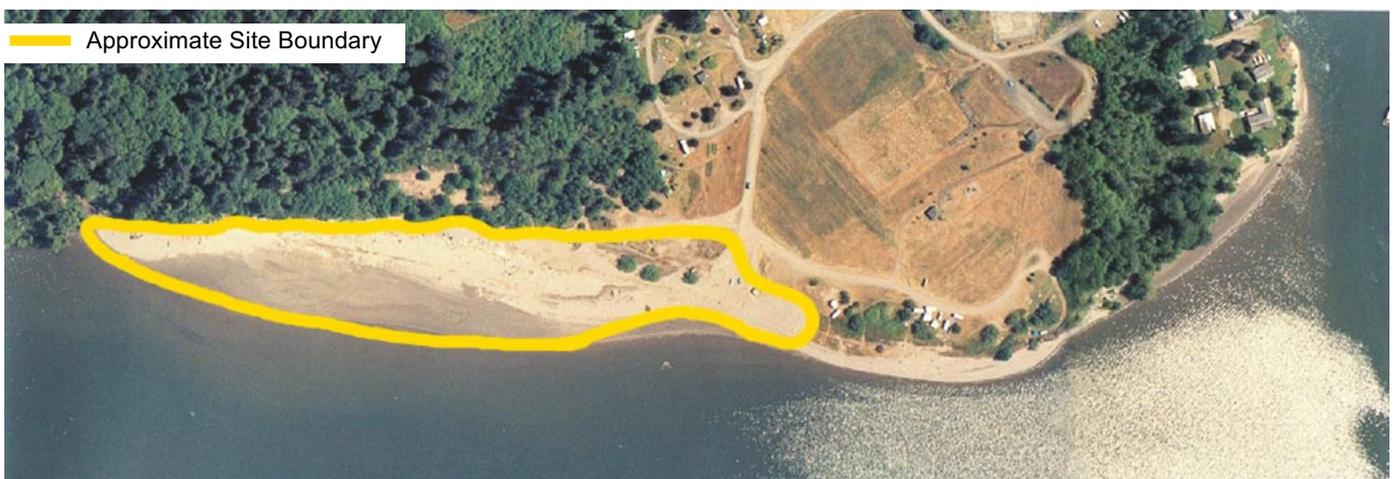
Description: The site is currently used for material disposal from the Columbia River. A day-use park borders the property to the southeast and northeast. The southeast corner of the property contains an active sand and gravel mining operation. There are no other improvements on the site. Only about 50% of the park is covered with sand, which is sold to offset operating costs.

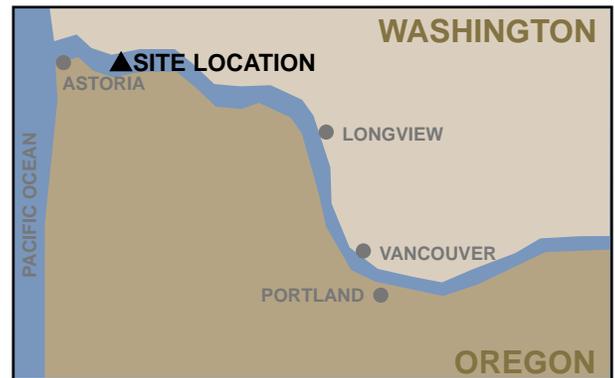
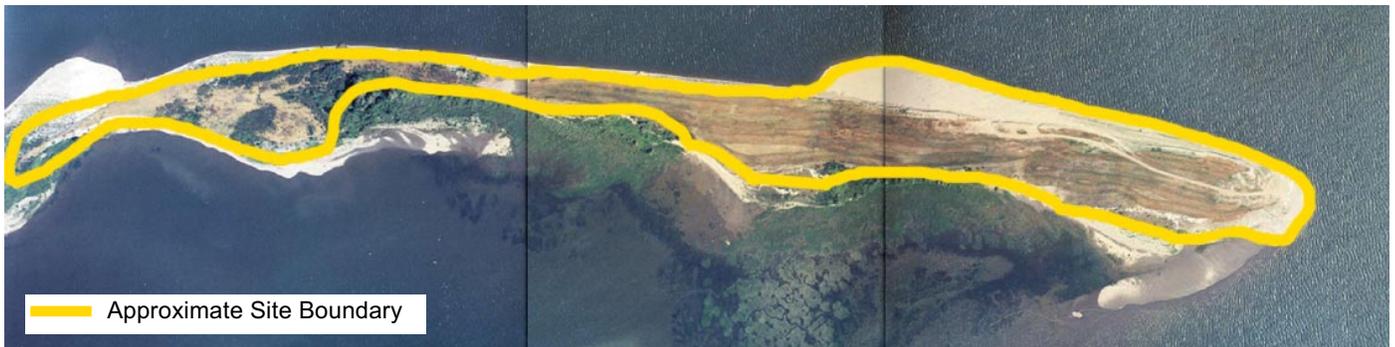
Description: The property occupies the majority of a roughly east-west trending bar island and is within the Lewis and Clark National Wildlife Refuge. Most of the site has been covered in the past with sandy material dredged from the Columbia River. The topography of the island interior is relatively level, as the dredged material has been evenly distributed across it. Steep 10- to 25-foot banks exist along portions of the dredge pile.

A tidal flat/marsh area is located (offsite) along the southern side of the island. Improvements to the site include two pile dikes that extend out from the northwest side of the site into the Columbia River channel. Wetlands will be avoided during disposal.

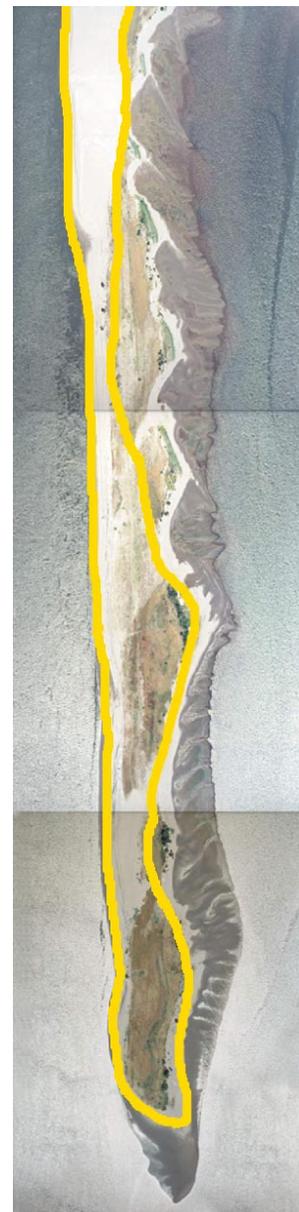
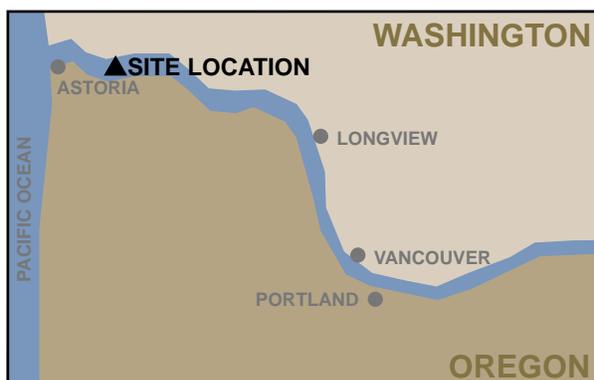
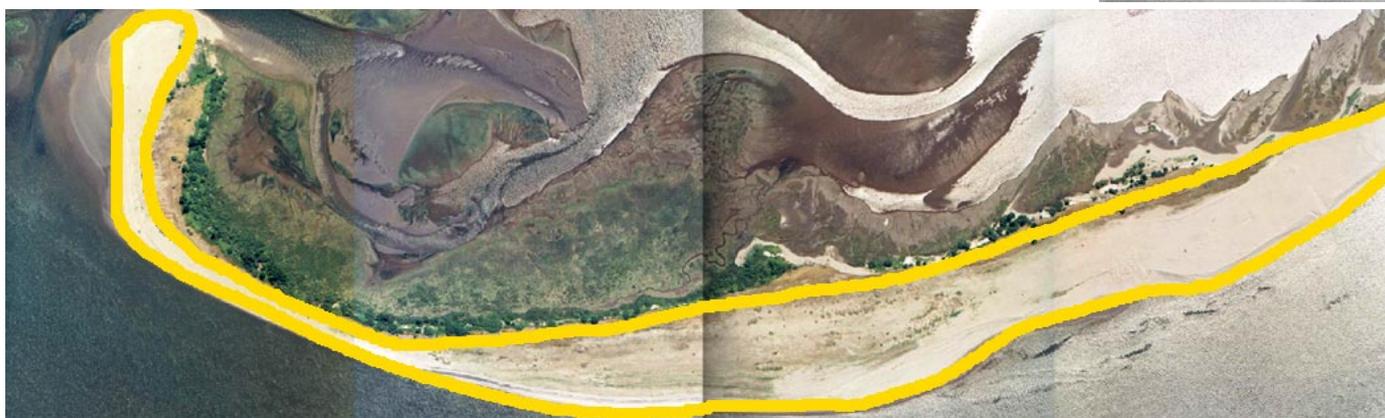
Miller Sands, O-23.5

Description: The site is within the Lewis and Clark National Wildlife Refuge. Much of the subject property has been covered with material dredged from the Columbia River. The site has an undulating topography. Steep 10-foot banks drop off from portions of the interior to the north and south sides of the island.

An offsite tidal flat/marsh area and narrow channel are located to the south of the site. The southeastern (upstream) end of the site is vegetated with small shrubs and trees. There is no water service to the property.

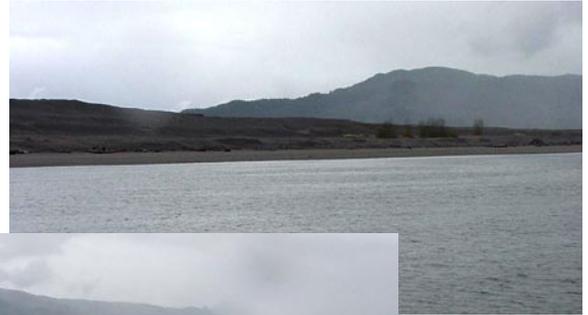
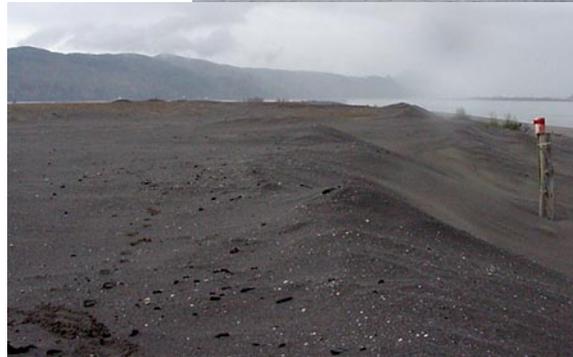
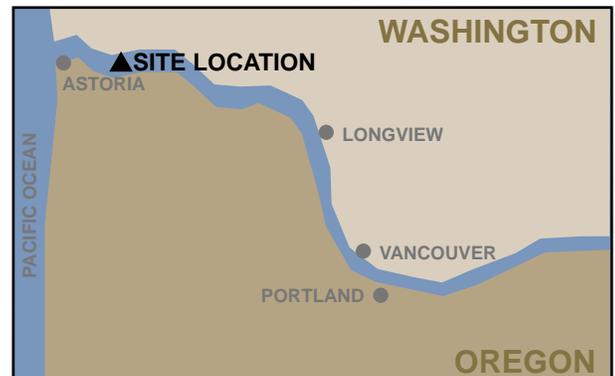
Rice Island, W-21.0 and O-21.0

Description: The property occupies the majority of a roughly northeast-southwest trending bar island. The island was created in the past with material dredged from the Columbia River. The topography of the island interior is relatively level, as the dredged material has been evenly distributed across it. Steep 20- to 35-foot banks drop off from the dredge pile.

A small amount of standing water, which was located within the retention pond used for dredge spoil dewatering, was observed on the property. Improvements observed onsite include a retention pond and metal drainage structure for the dredge material dewatering. The downstream end of the island is used by terns and access to the island is limited. Rice Island will be a future maintenance dredging disposal site after Channel Improvement.
