Public Meeting & Information Exchange
for
Repair/Rehab Columbia River N. & S. Jetties

Columbia River Jetty System

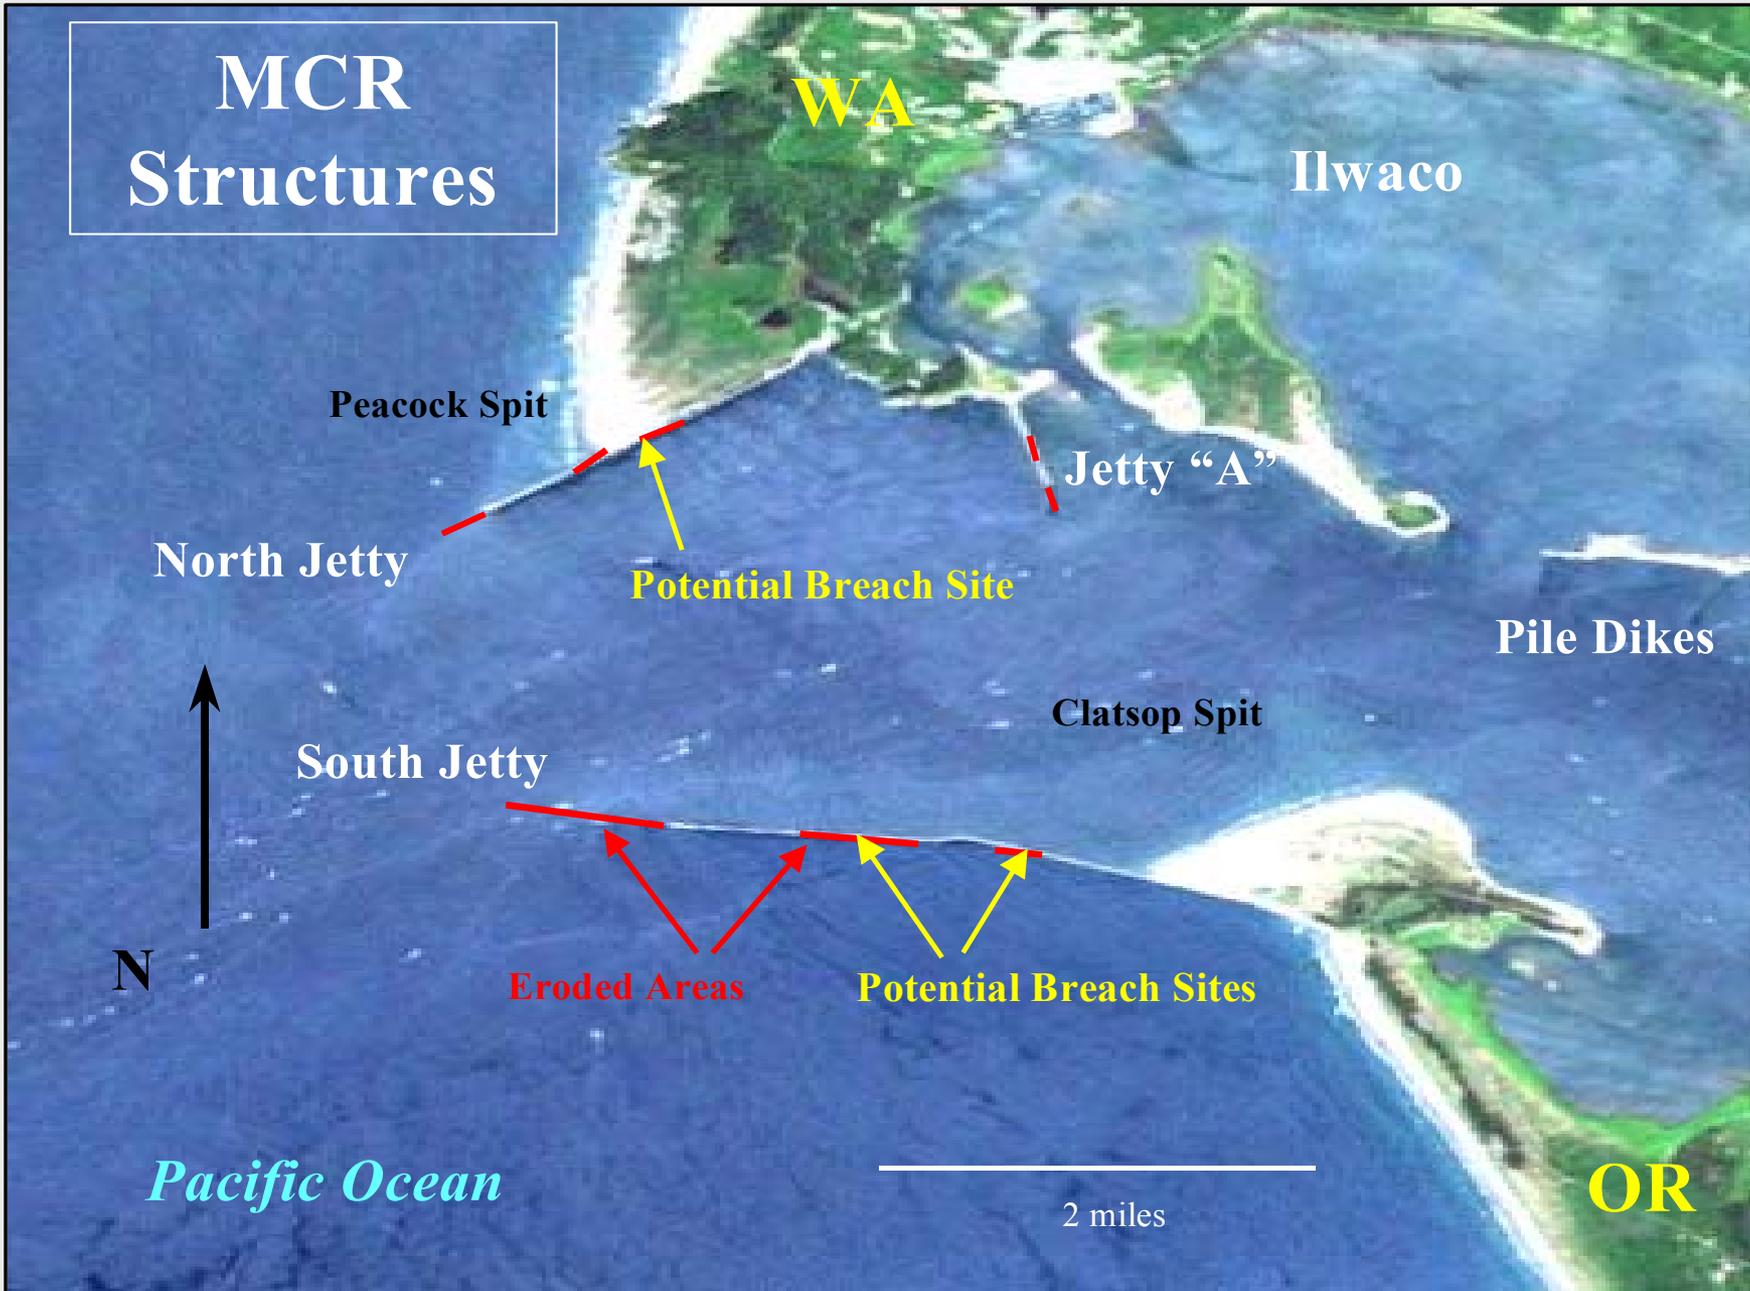
MCR Structures

North Jetty

Potential Breach Site

Pile Dikes

South Jetty

Eroded Areas

Potential Breach Sites

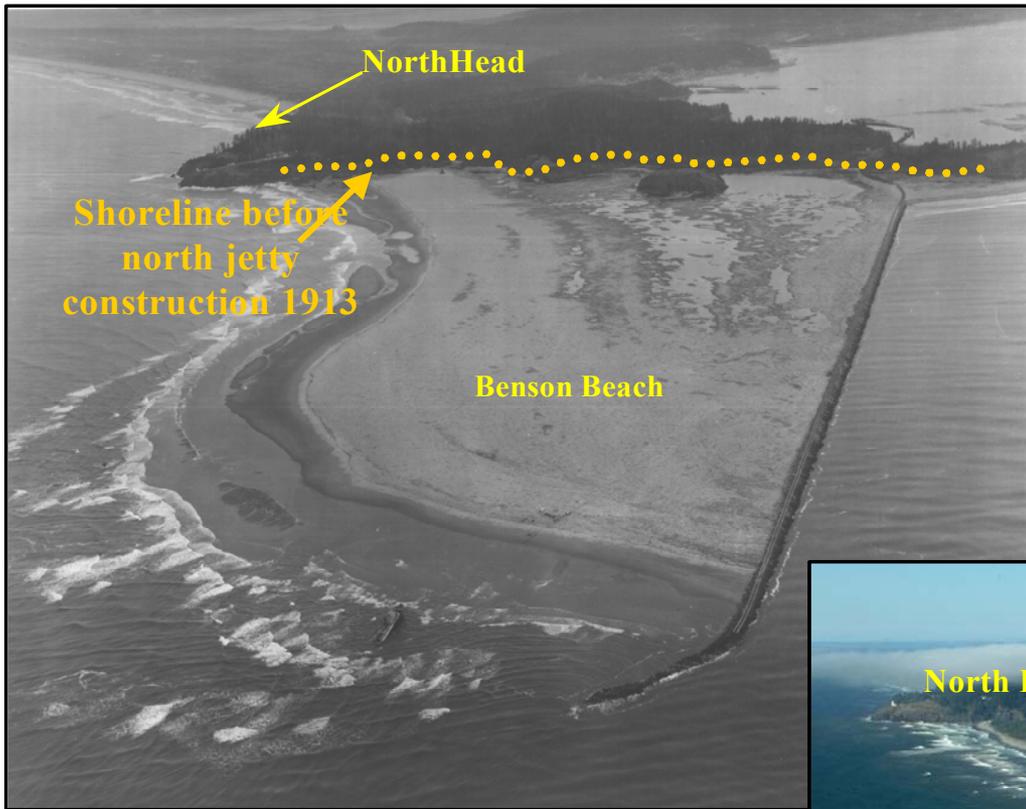
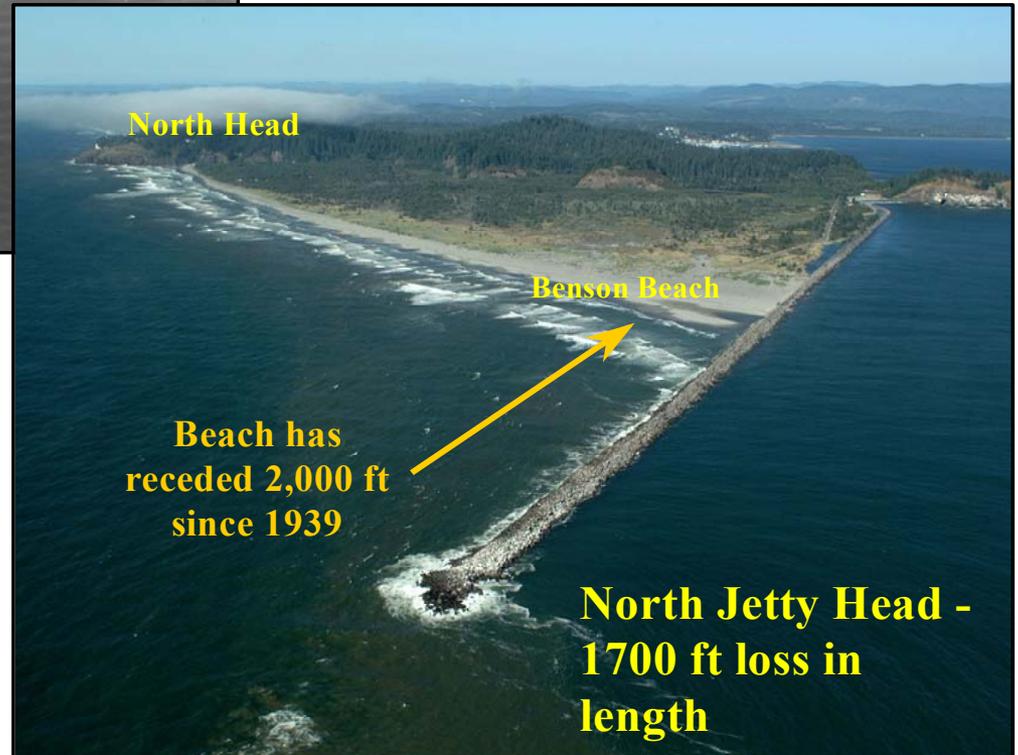
1939

What was a “spending beach” for wave action along the ocean side of the north jetty no longer exists. Now waves and currents act directly on much of the north jetty. The north jetty is now compromised along much of its length.

2002

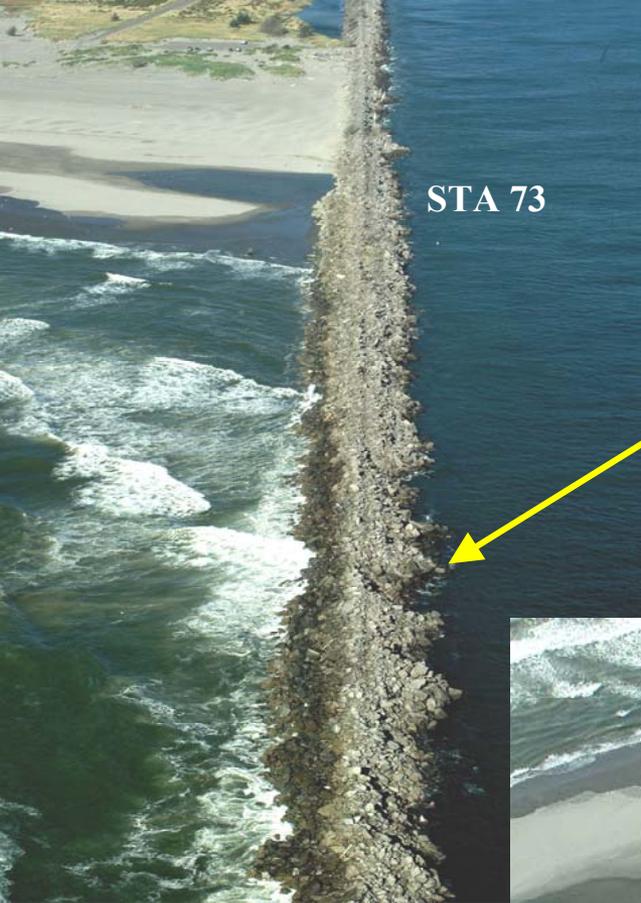
STA 73

**Damaged Areas
along Trunk**

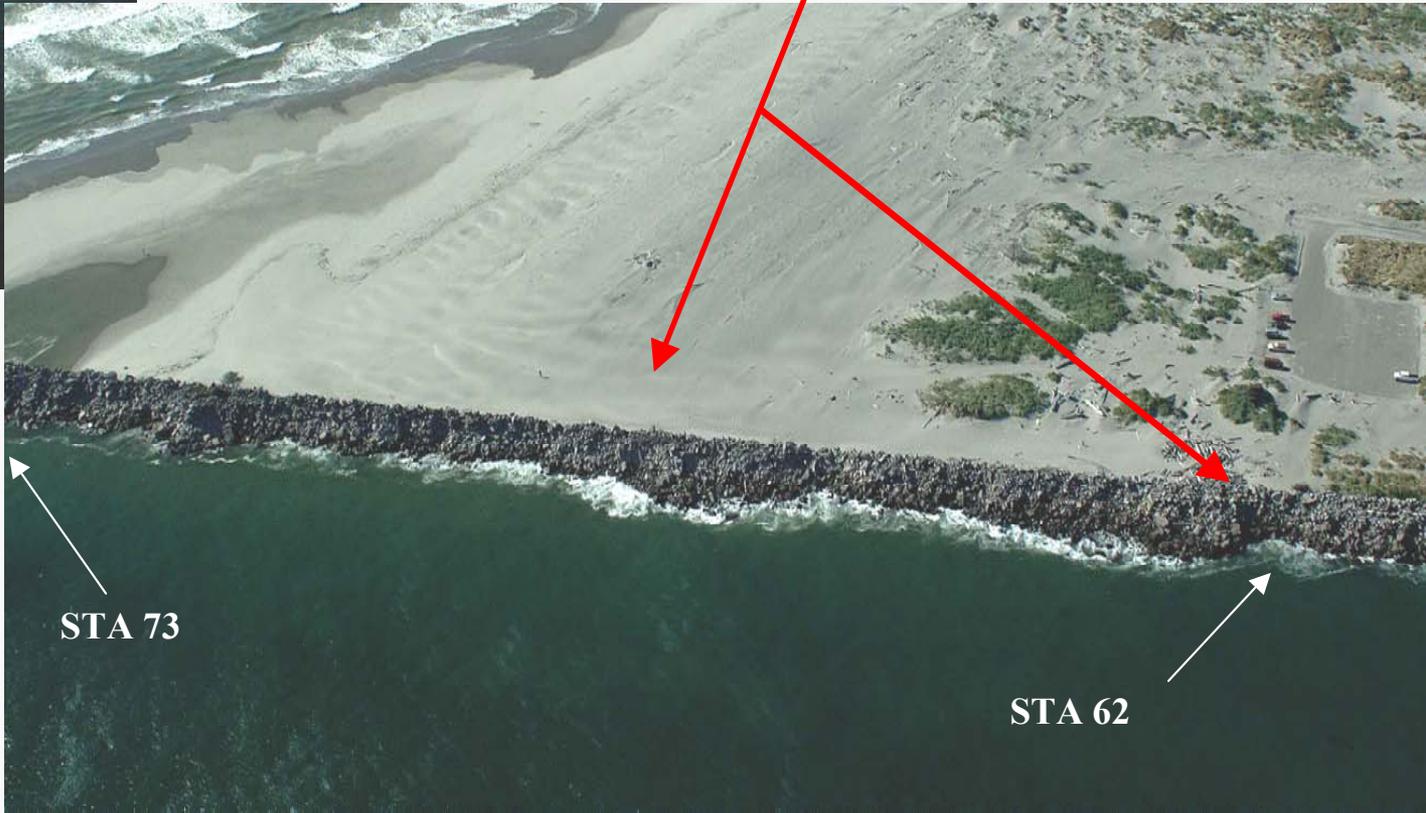
**Damaged Areas
along Root**

**Transition to Unrepaired
Landward Half of North Jetty**

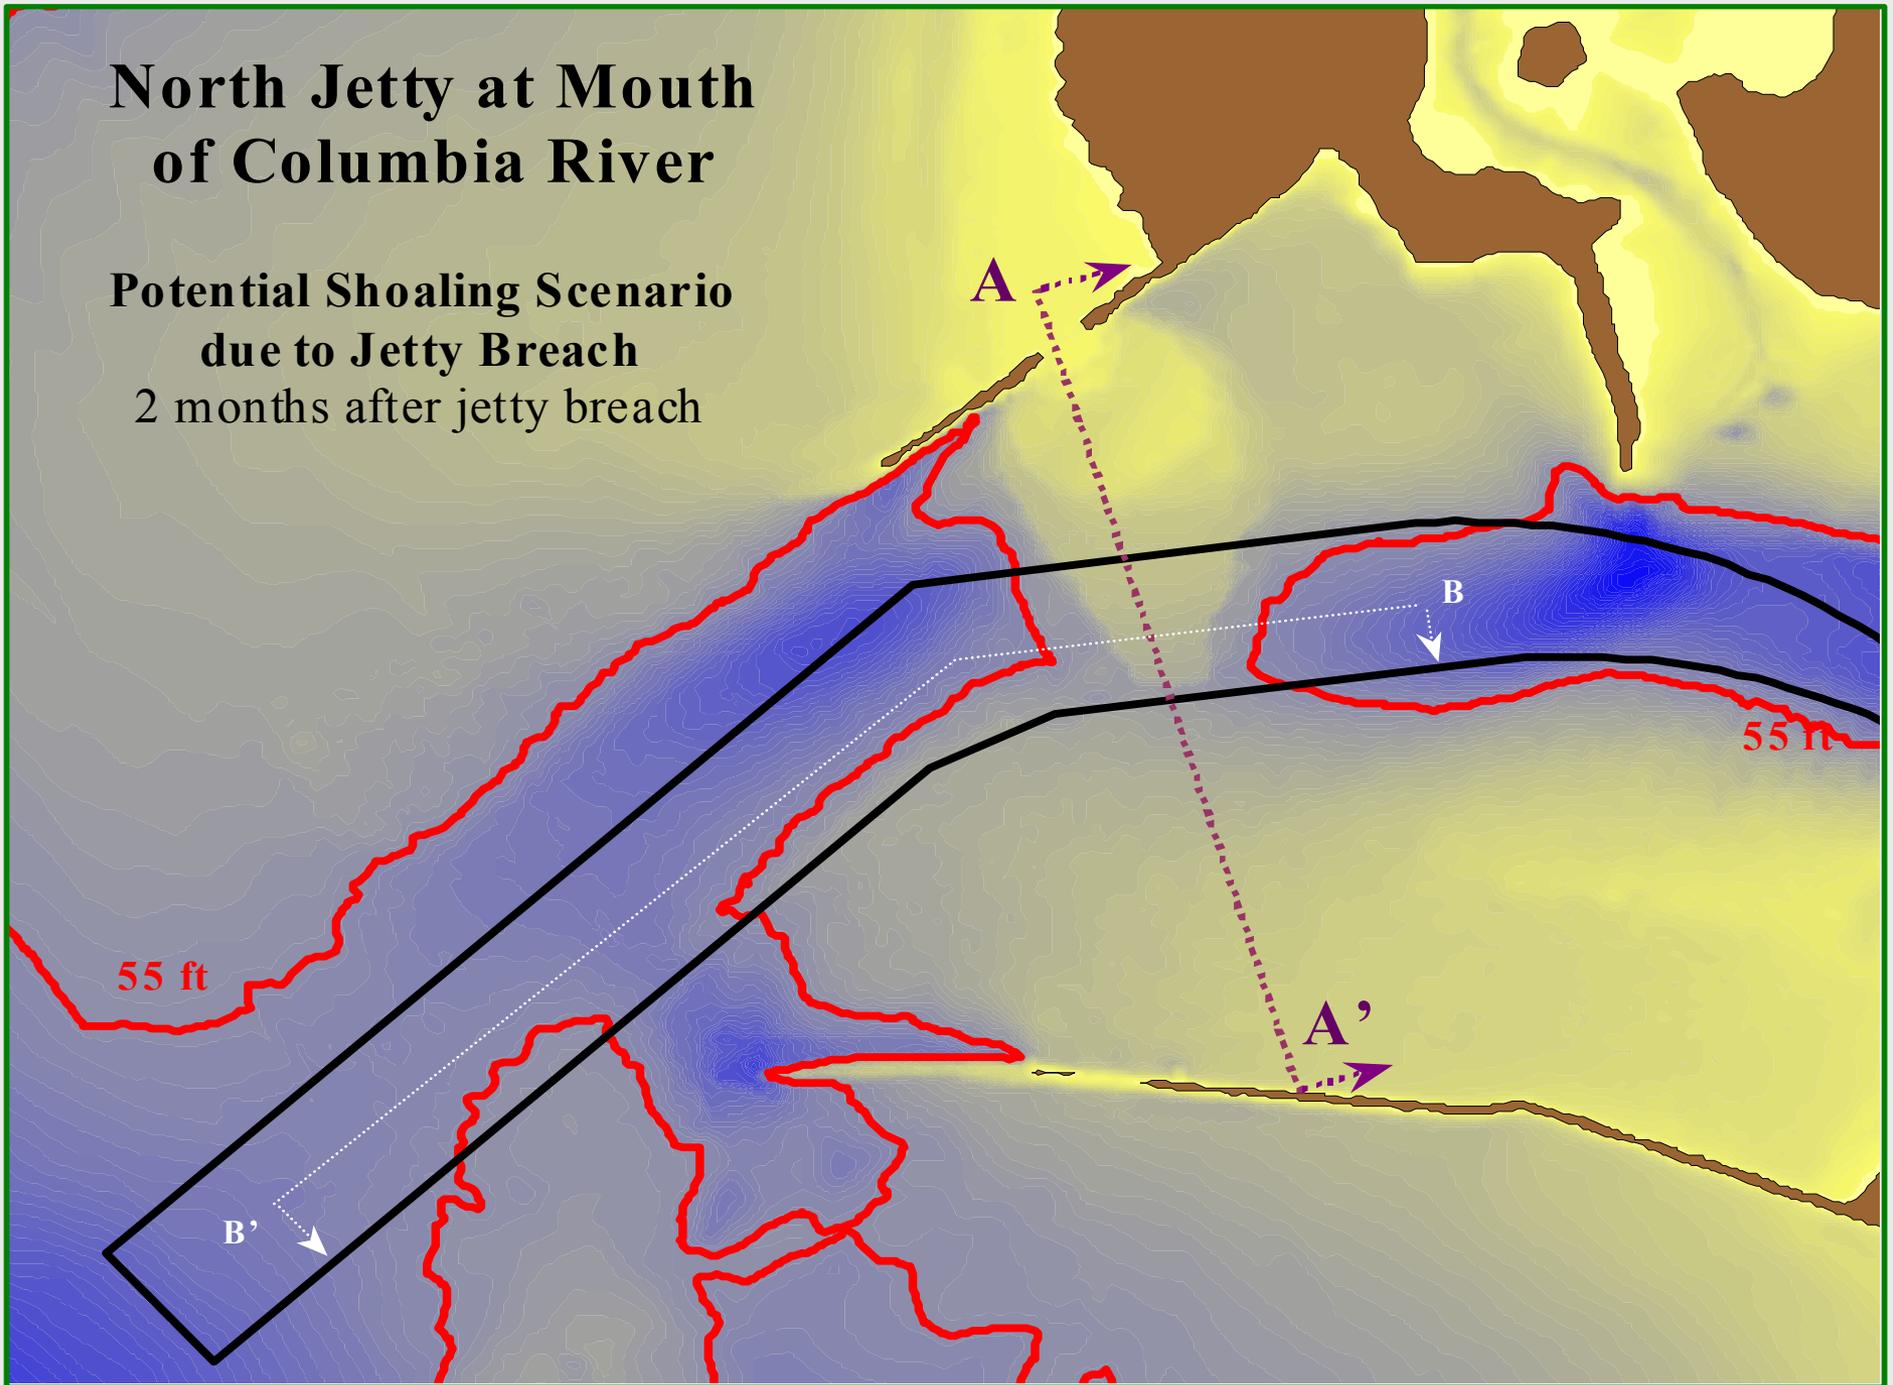
North Jetty at Mouth of Columbia River

Potential Shoaling Scenario
due to Jetty Breach
2 months after jetty breach

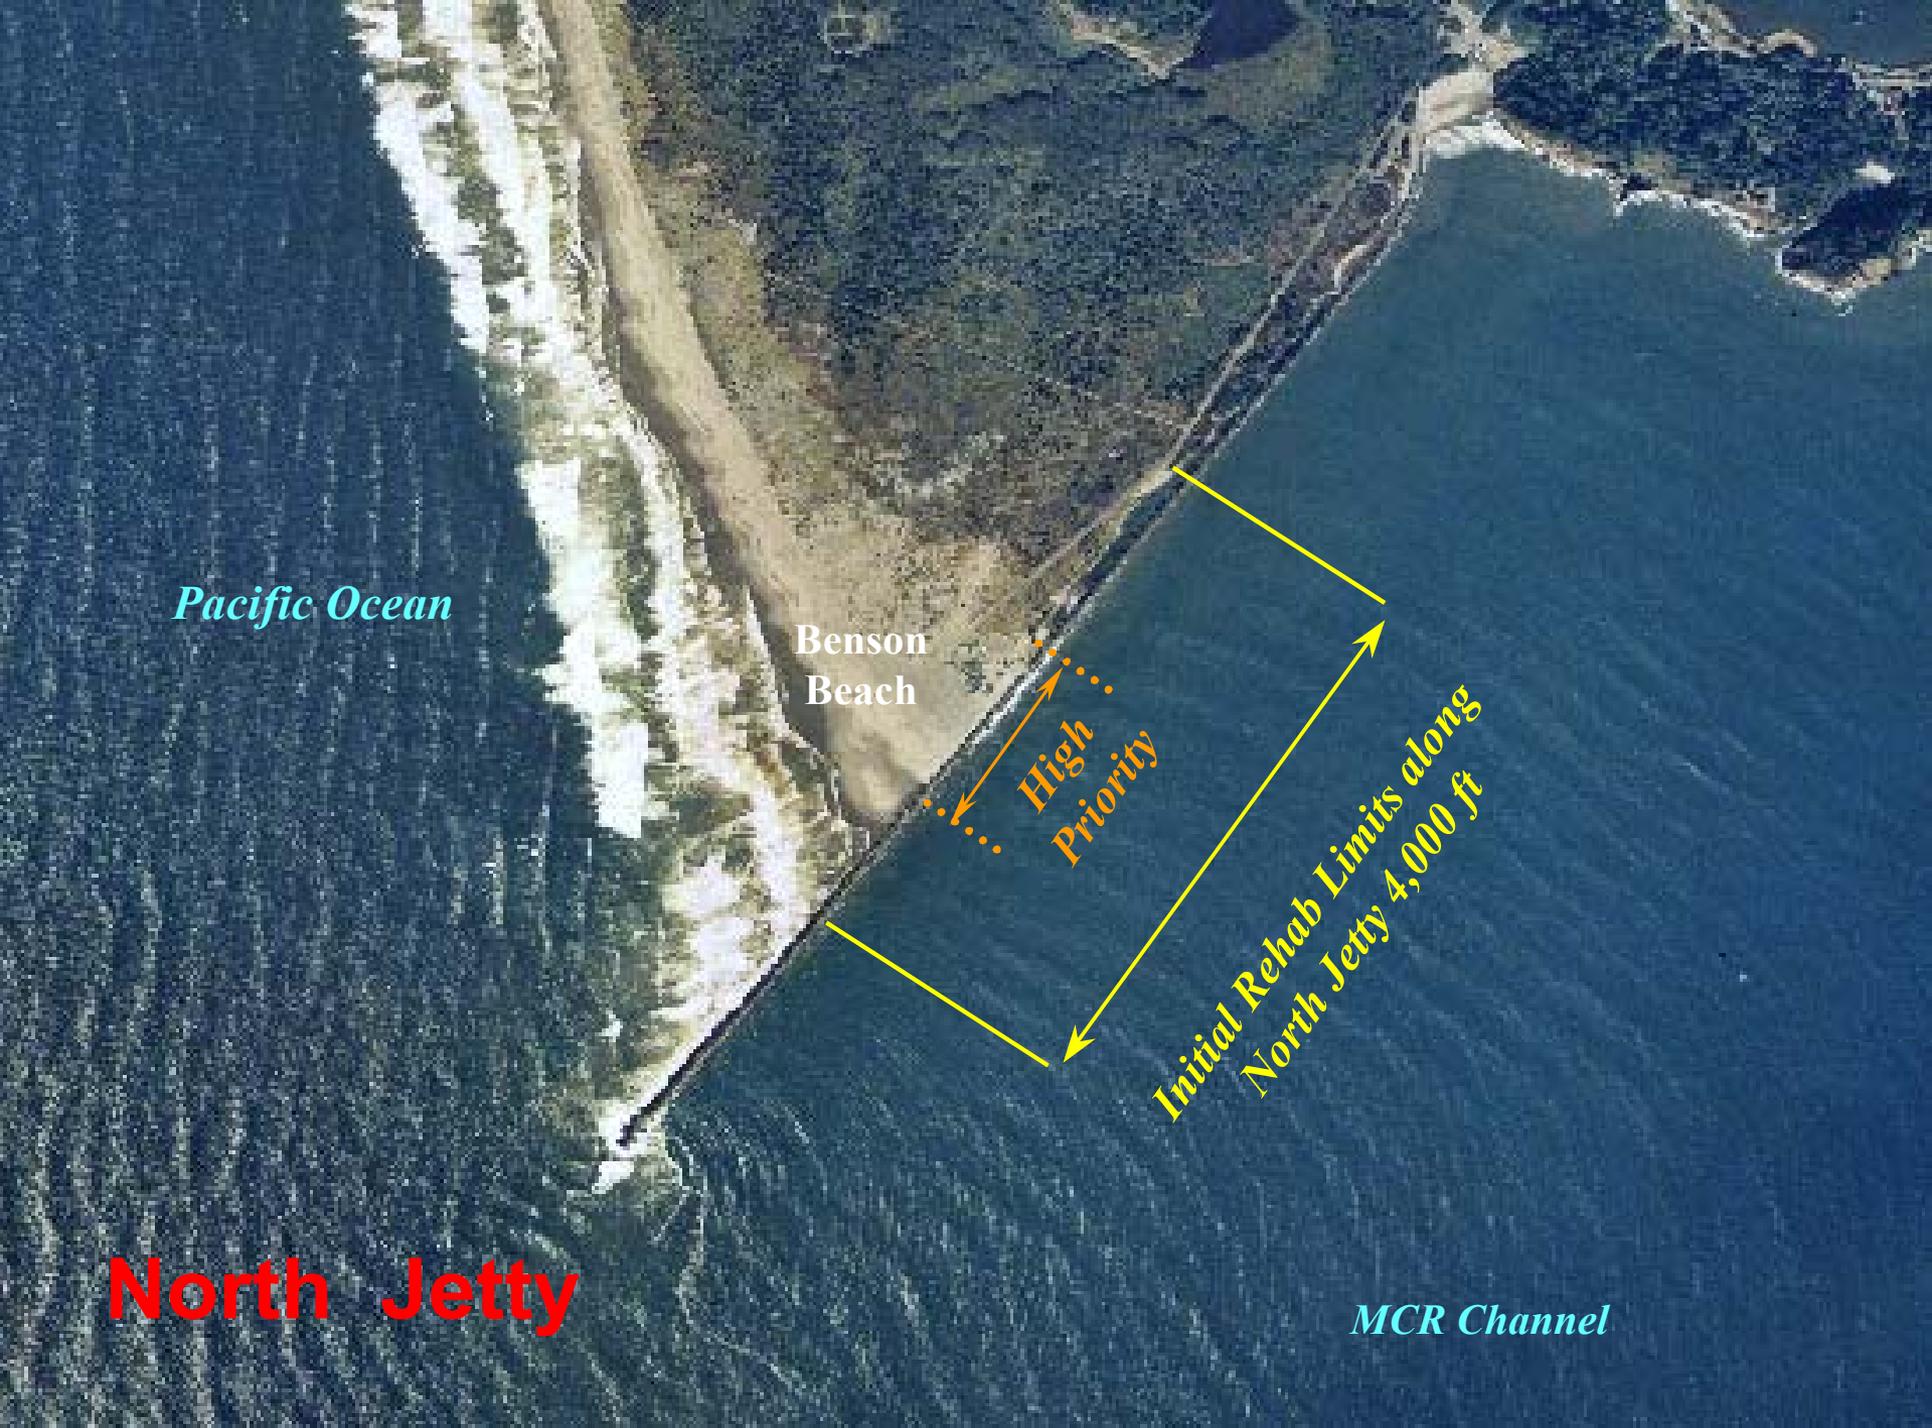
High Priority

Initial Rehab Limits along North Jetty 4,000 ft

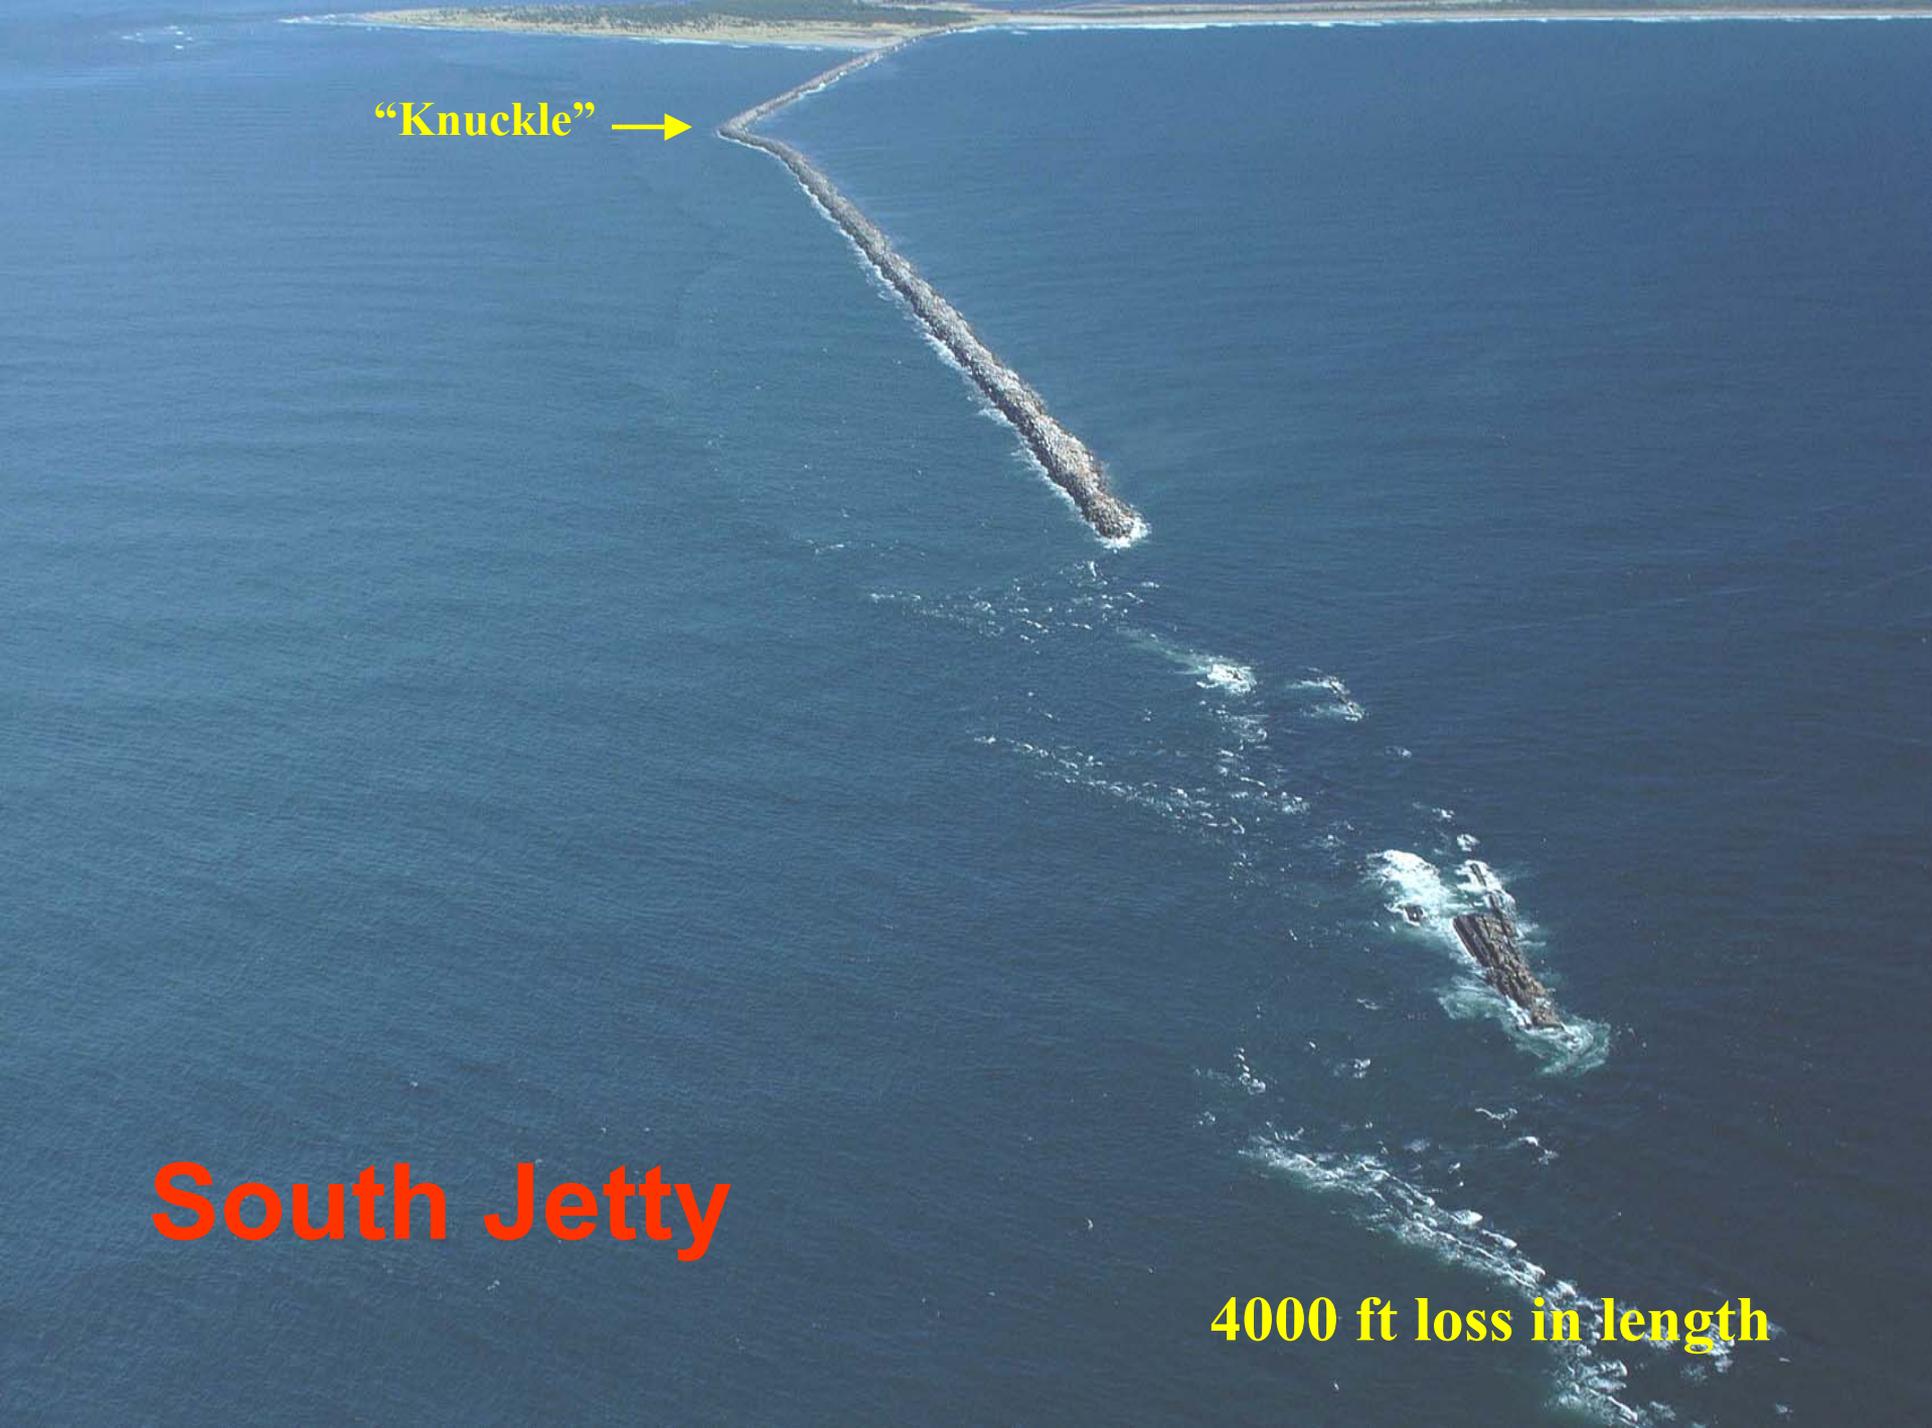
SOUTH JETTY

Beach line before south jetty construction

Trestle used to construct 6-mile long jetty

Original Construction
1886-96, 4 miles offshore
from Ft Stevens: 946,000
tons of stone

Repair and extension 1903-
14, 2 more miles offshore:
4.8 million tons of stone

8 Subsequent Repairs
1931-82: 2.9 million tons of
stone

Total stone placed 1886-
1982: 8.7 million tons

4000 ft loss in length

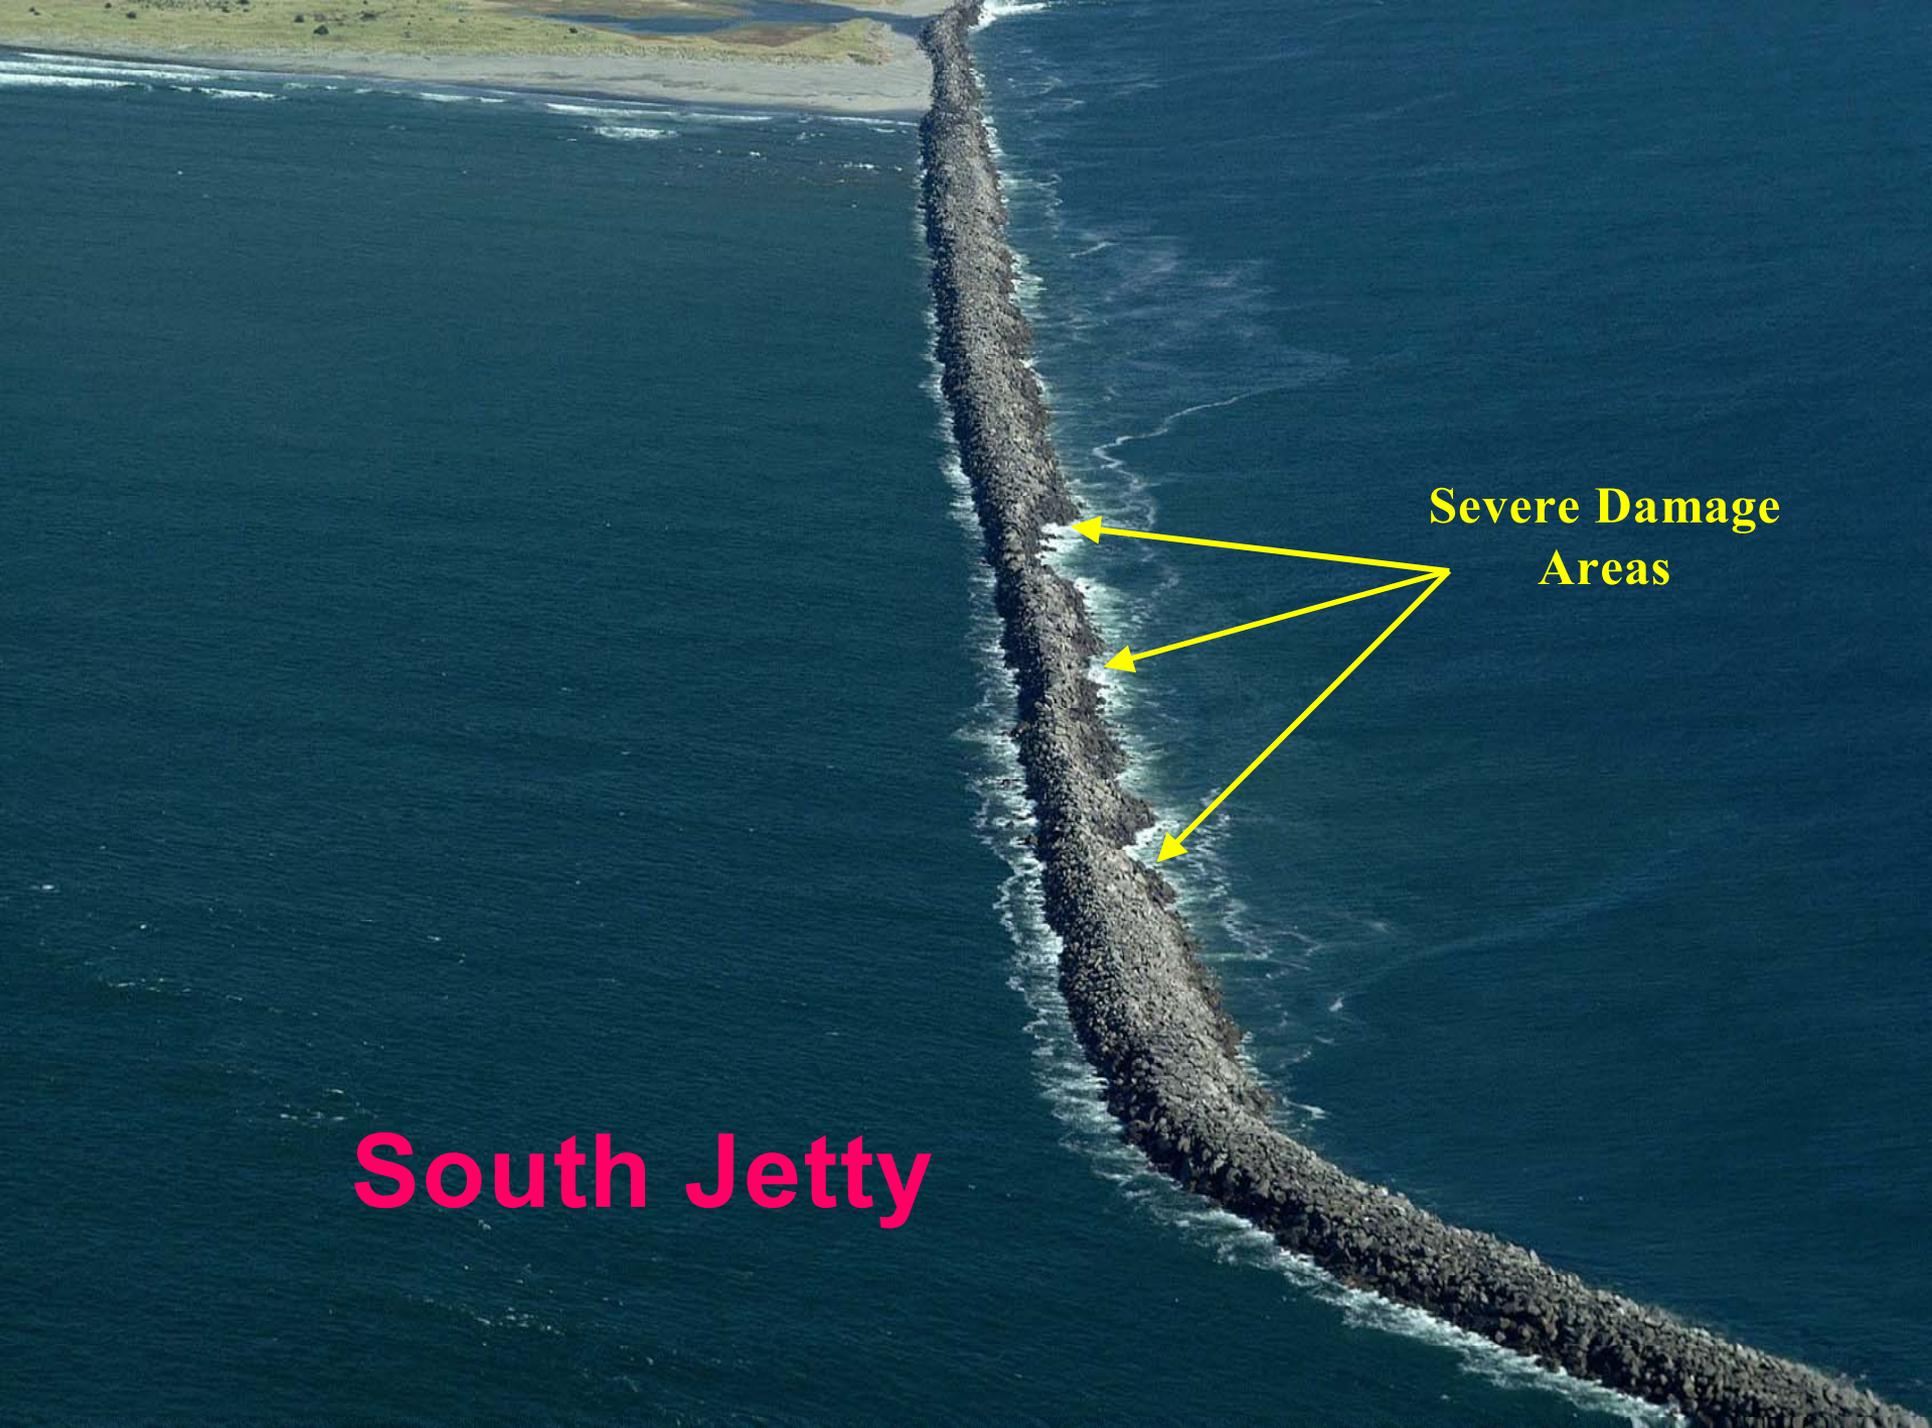
**Severe Damage
Areas**

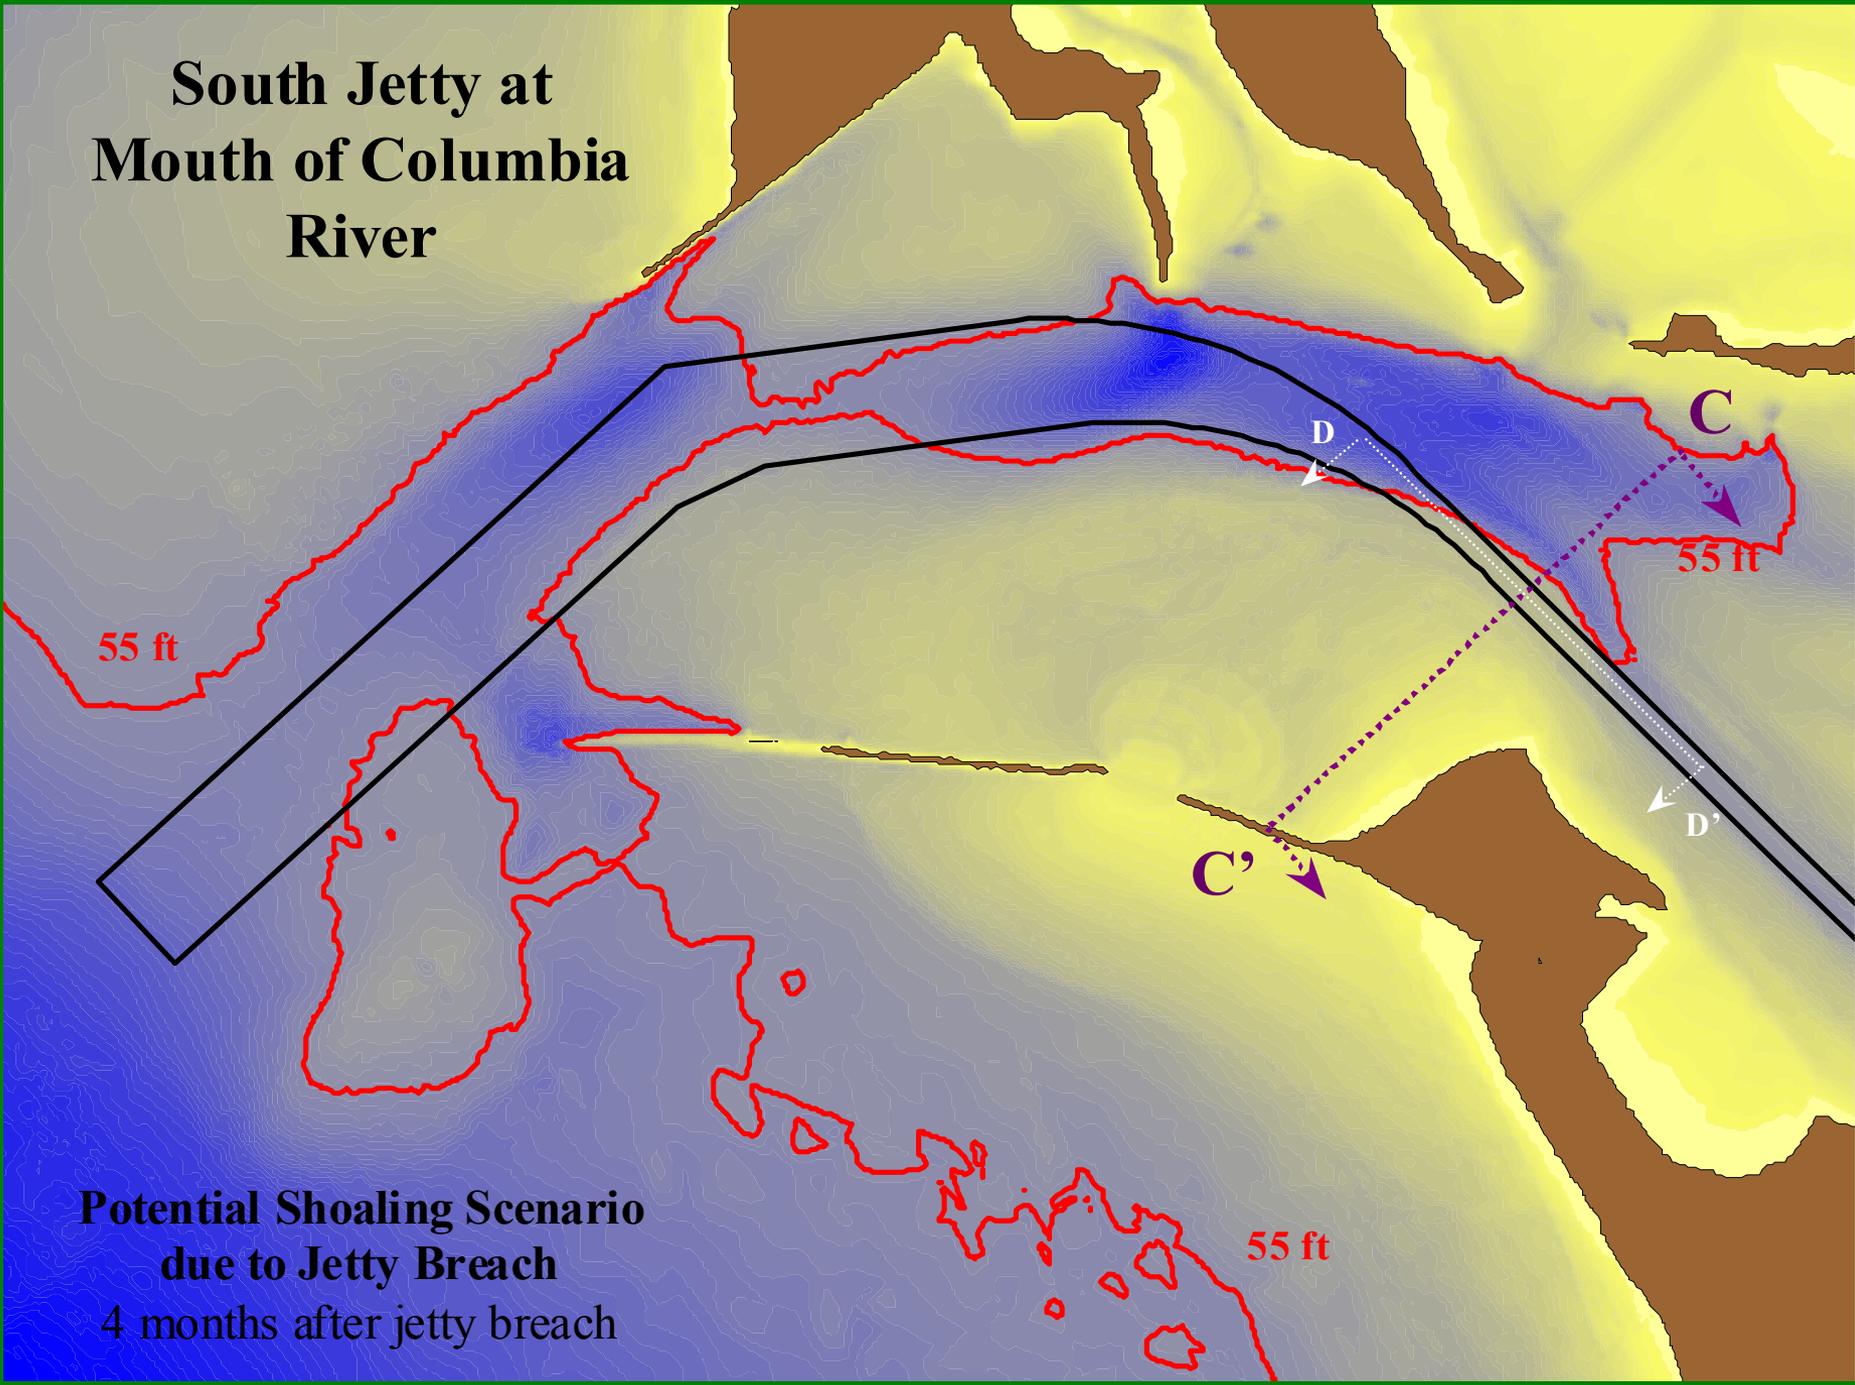
South Jetty at Mouth of Columbia River

**Potential Shoaling Scenario
due to Jetty Breach
4 months after jetty breach**

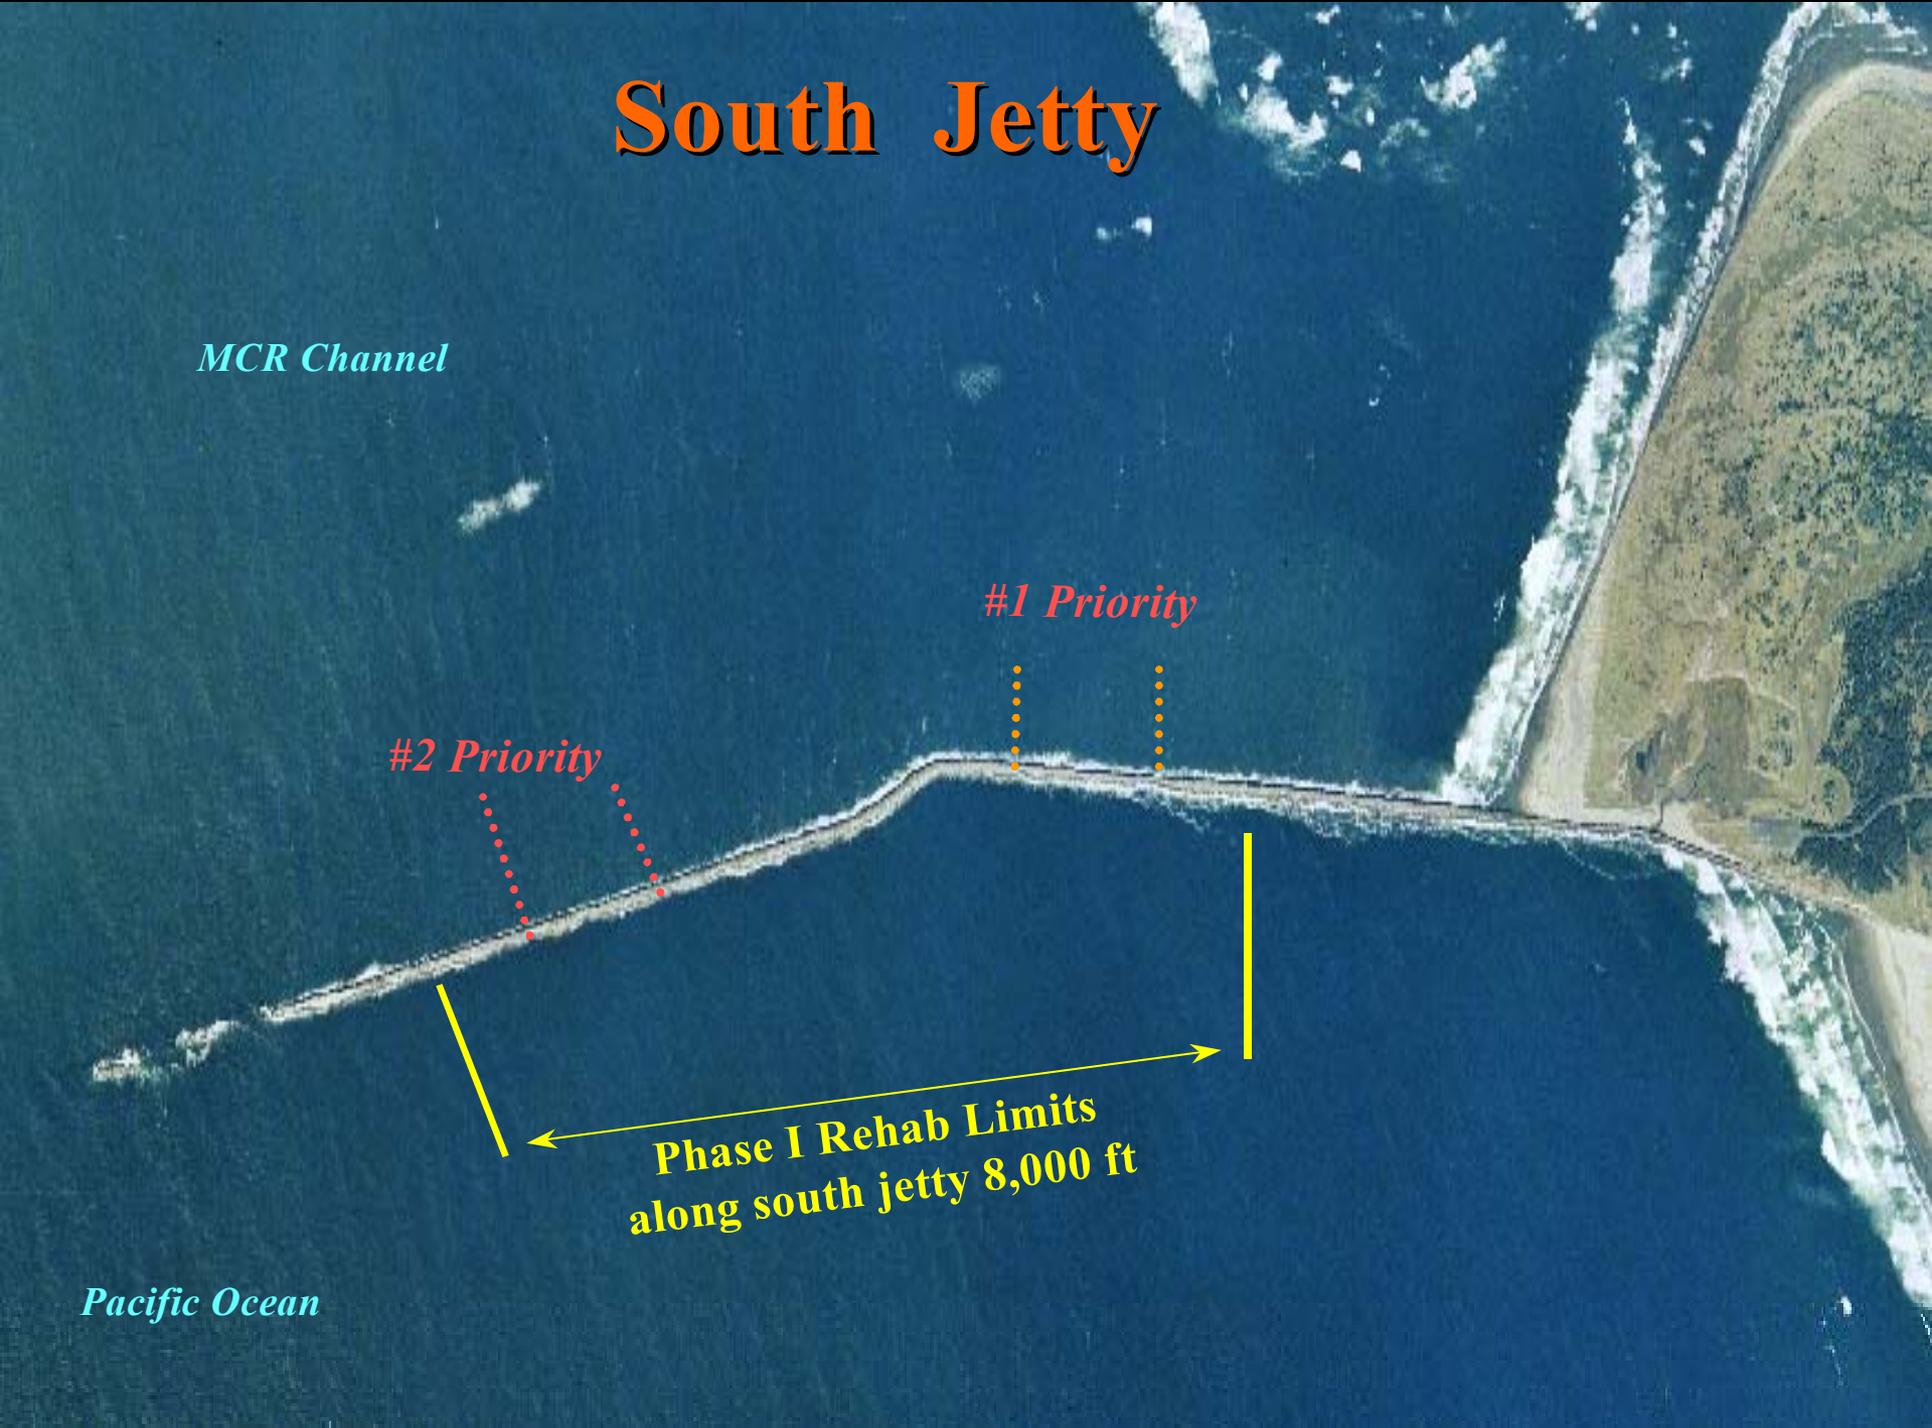
#1 Priority

#2 Priority

**Phase I Rehab Limits
along south jetty 8,000 ft**
