Public Meeting & Information Exchange
for
Repair/Rehab Columbia River N. & S. Jetties

Columbia River Jetty System

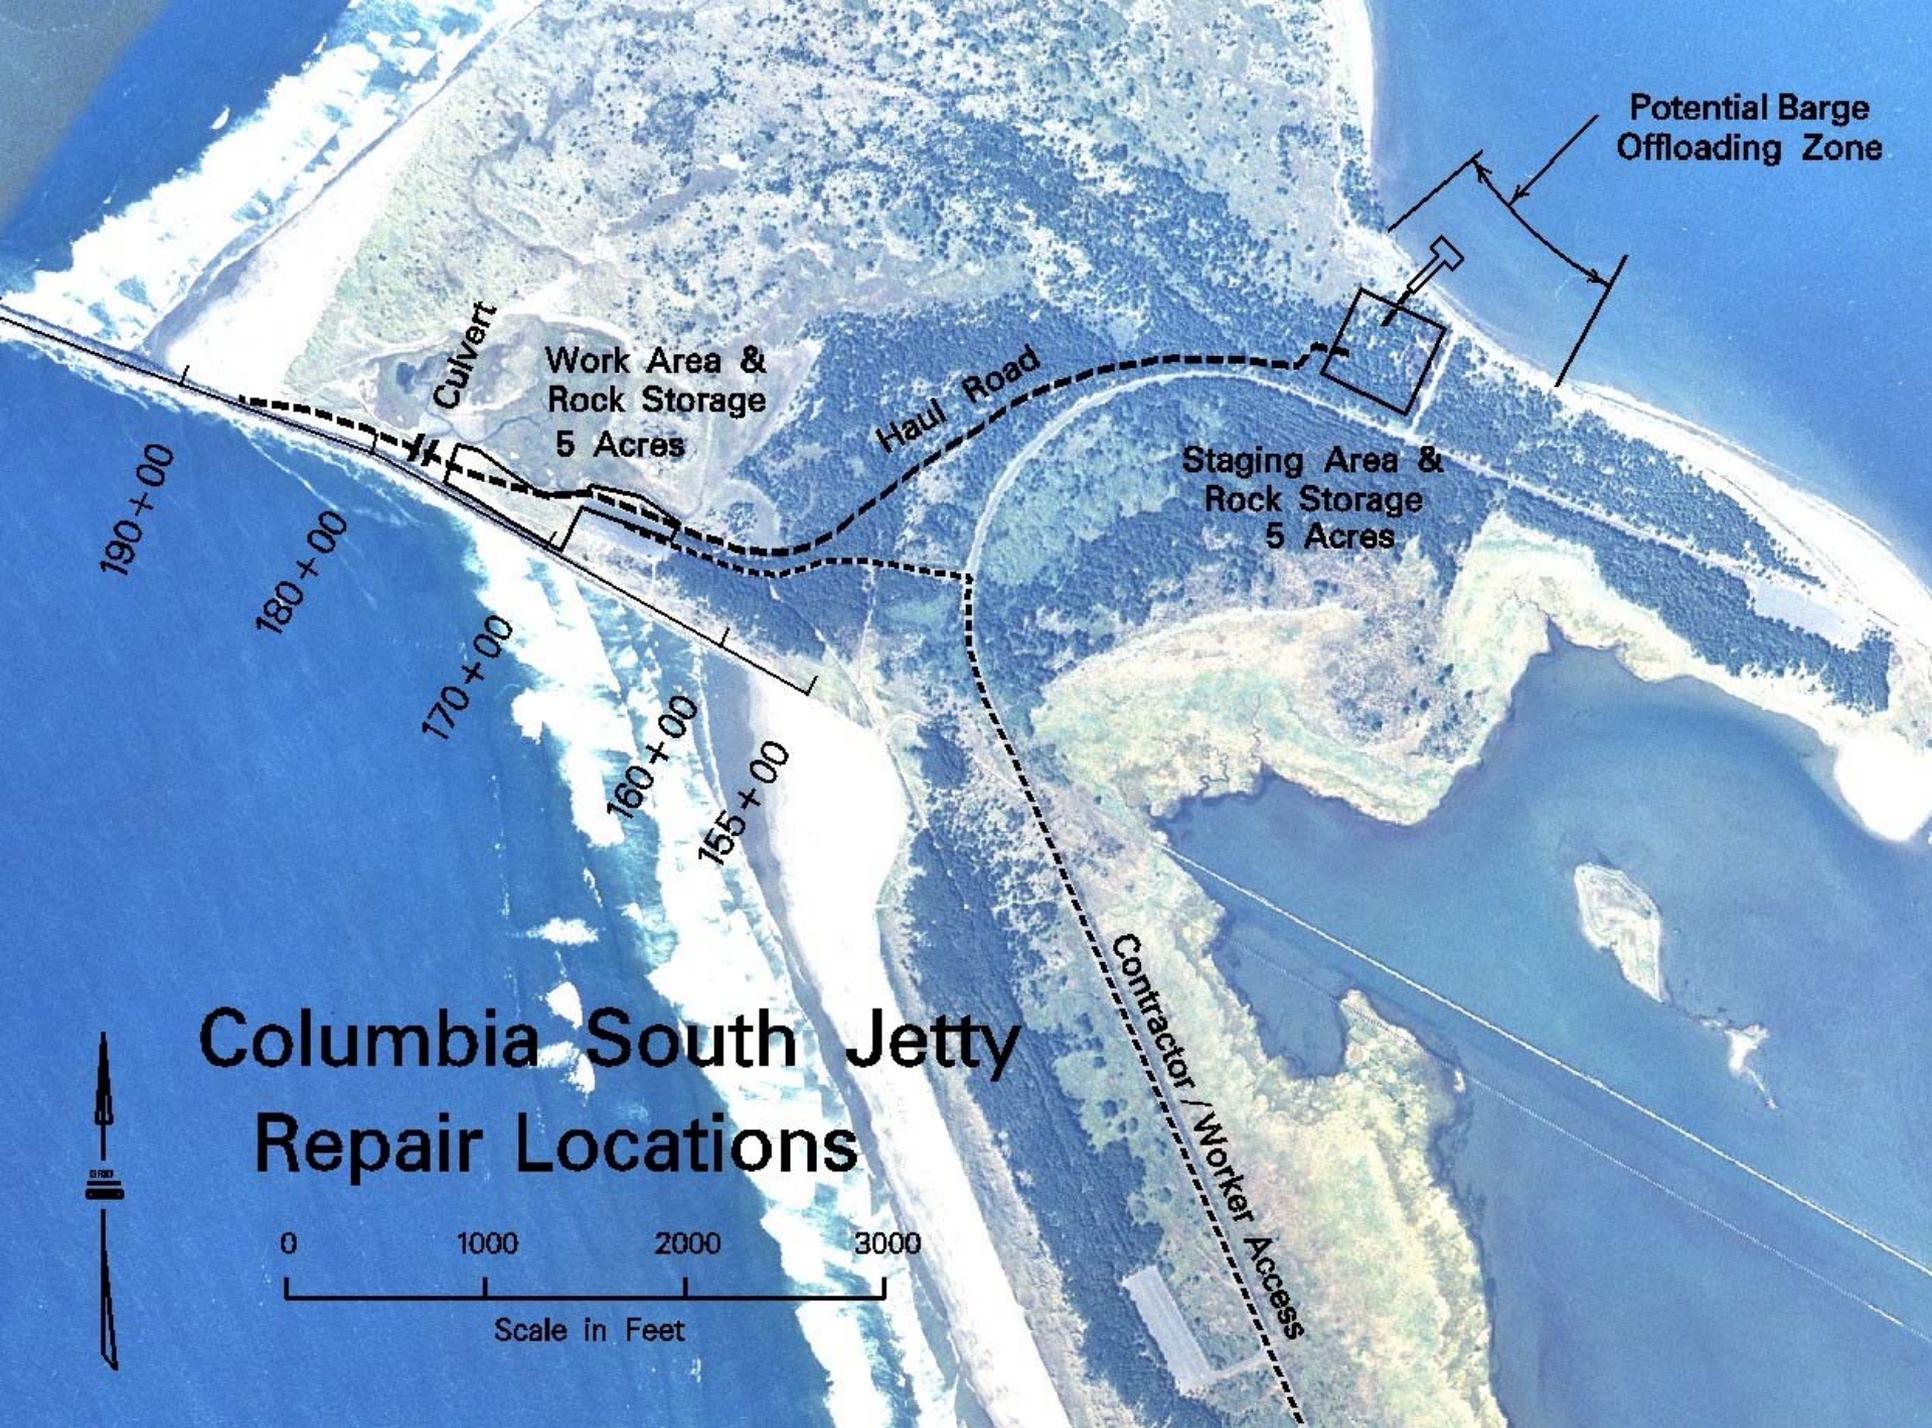
Columbia South Jetty Repair Locations

Potential Barge Offloading Zone

Work Area & Rock Storage
5 Acres

Haul Road

Staging Area & Rock Storage
5 Acres

Contractor / Worker Access
