Figure 1. Coastal region of the mouth of the Columbia River showing the location of the Shallow Water ocean dredged material disposal site (ODMDS).

Figure 2 . Mouth of the Columbia River (MCR) project features and present nearshore bathymetry. Note the location of the SW ODMDS with respect to Peacock Spit.

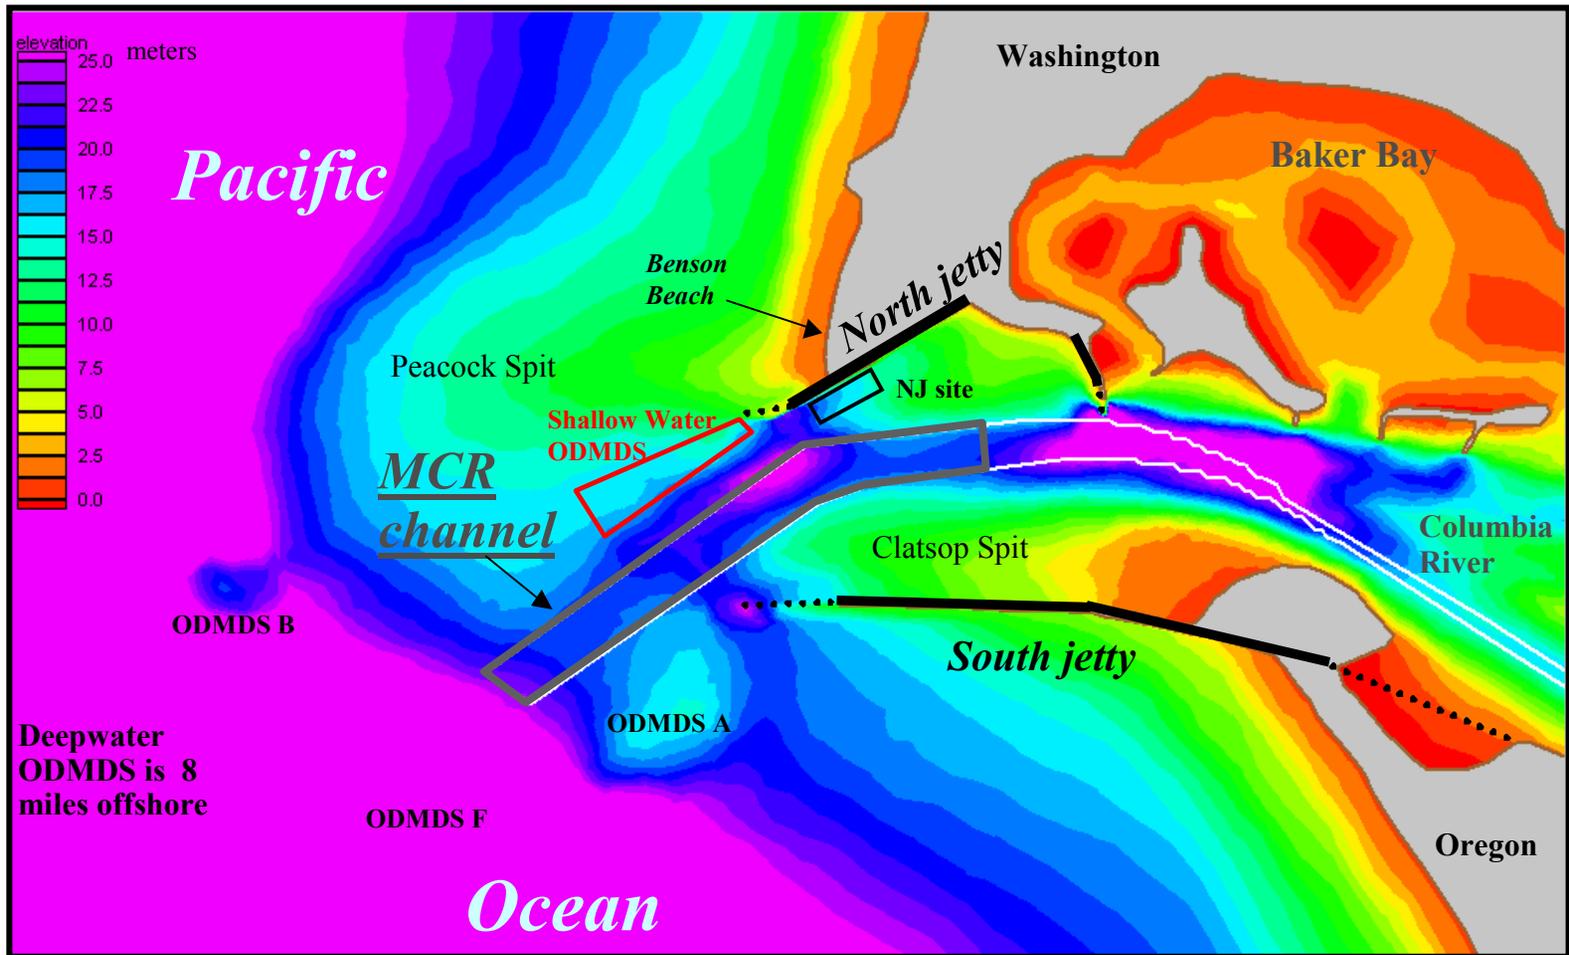
ODMDS = ocean dredged material disposal site

3-5 mcy/yr of sand dredged at MCR dredged sand is placed in ODMDS

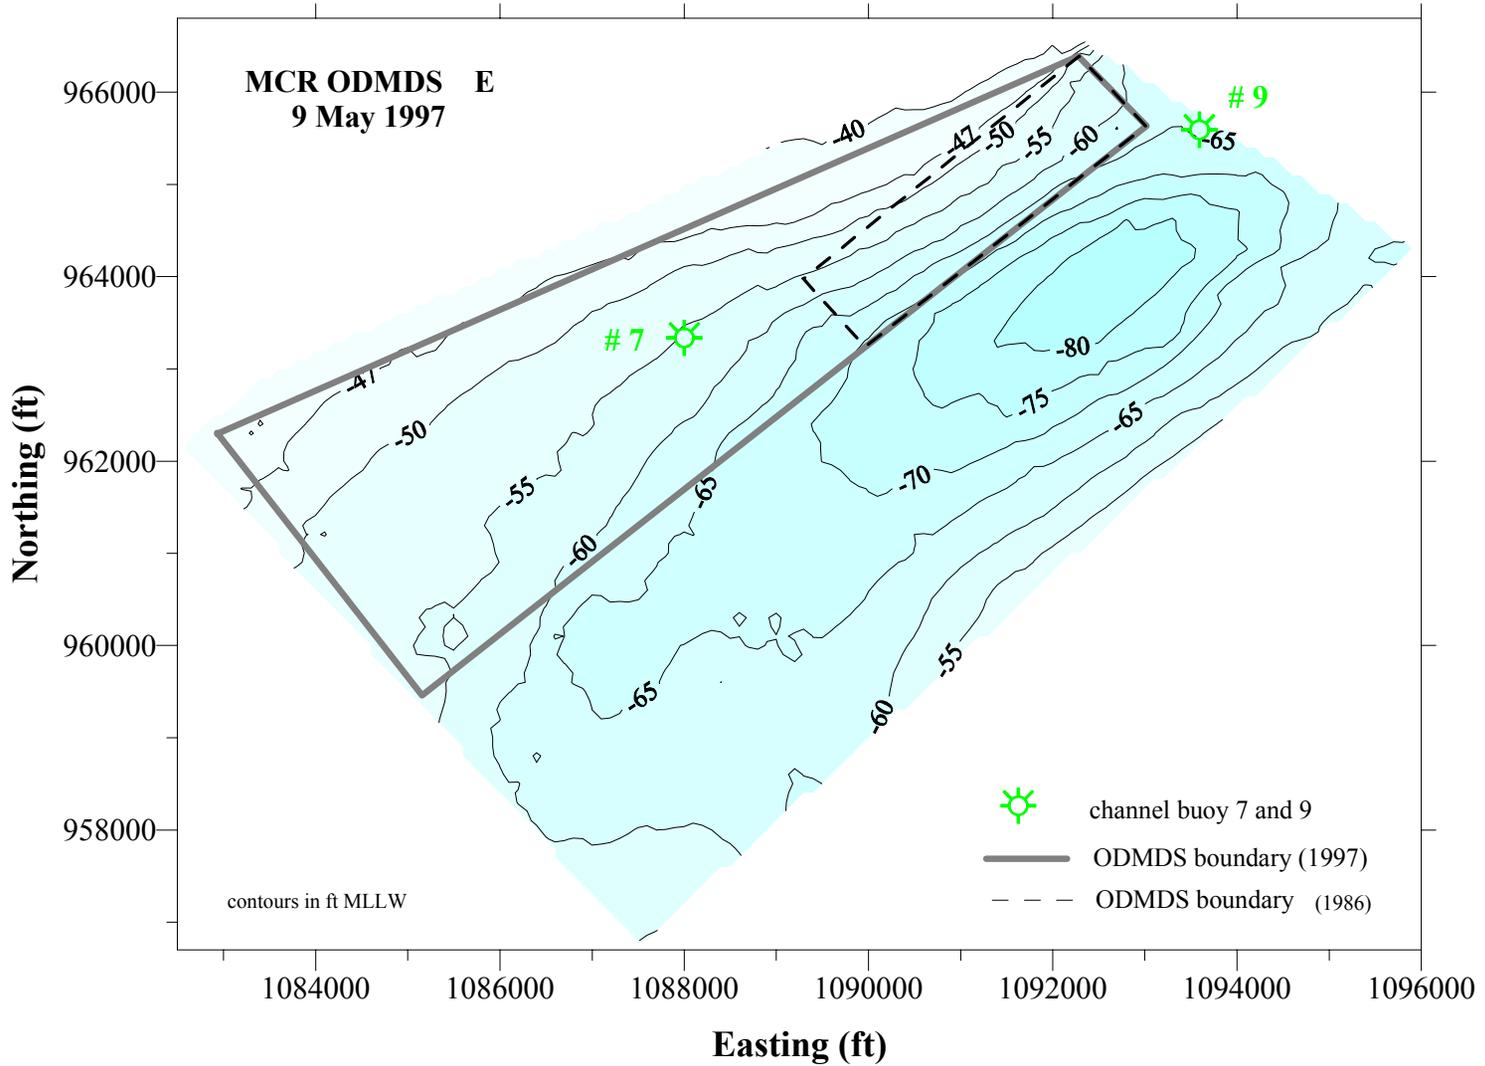
Project Baseline Bathymetry for ODMDS E

Figure 3. Baseline bathymetry condition of the Shallow Water ODMDS (ODMDS E). Assessment of potential impacts arising from the use of the SW ODMDS is performed with respect to the 1997 baseline condition.

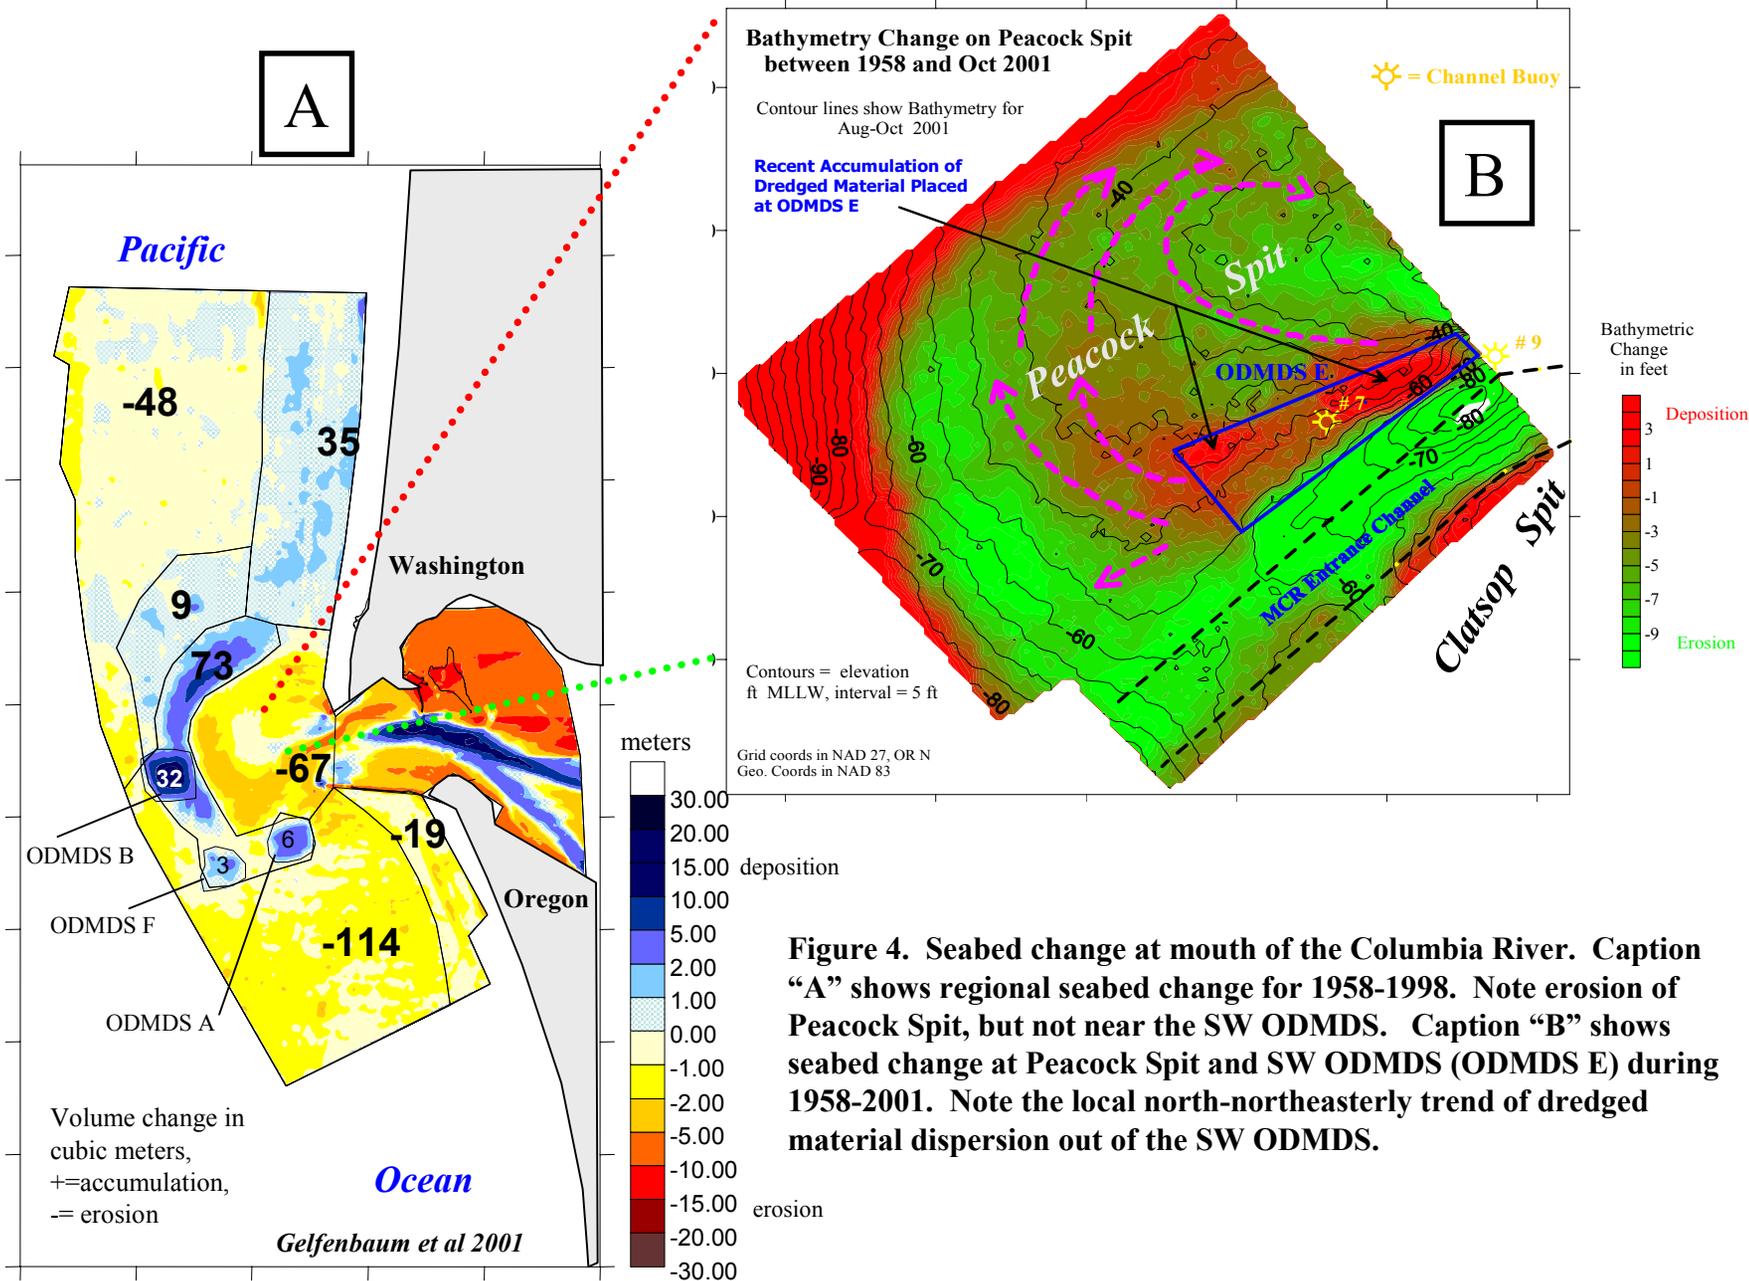
Figure 4. Seabed change at mouth of the Columbia River. Caption "A" shows regional seabed change for 1958-1998. Note erosion of Peacock Spit, but not near the SW ODMDS. Caption "B" shows seabed change at Peacock Spit and SW ODMDS (ODMDS E) during 1958-2001. Note the local north-northeasterly trend of dredged material dispersion out of the SW ODMDS.

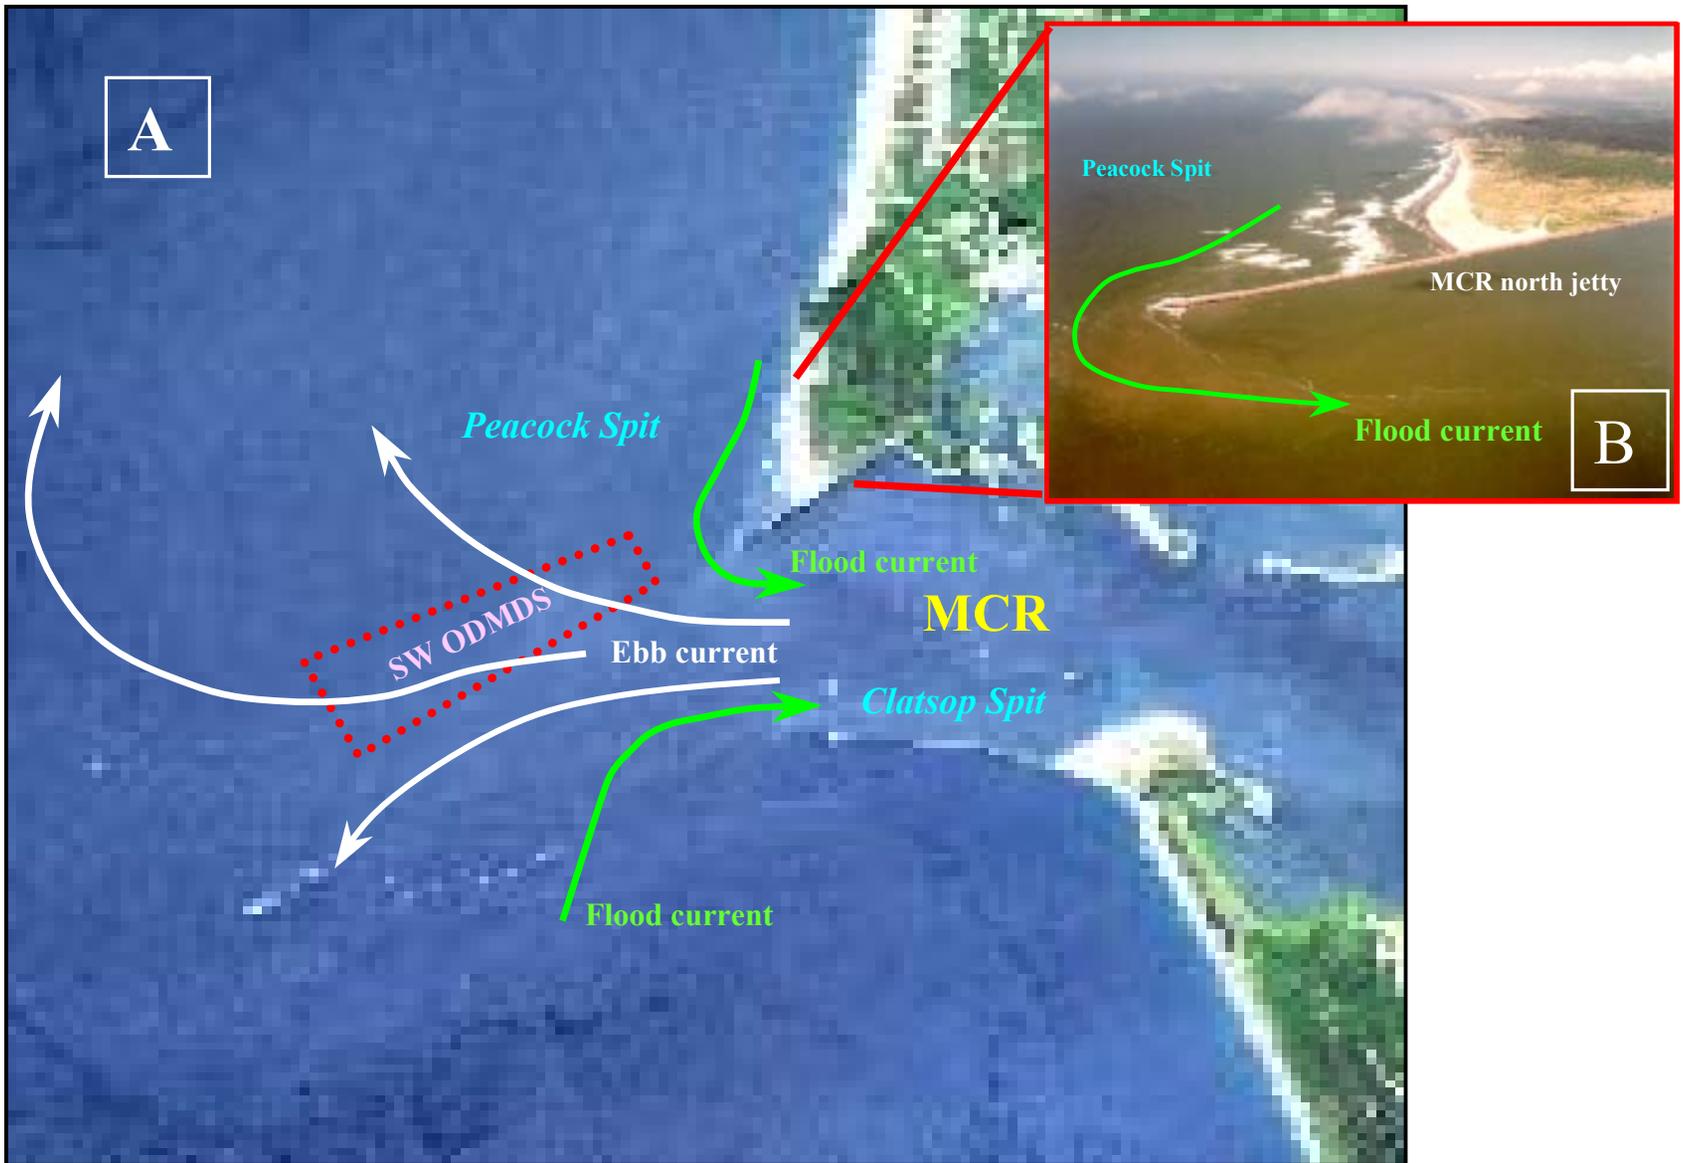
Figure 5. Dominant tidal current patterns for the mouth of the Columbia River. Caption “A” shows typical ebb and flood current patterns. Flood currents (green) concentrate around the ends of jetties. Ebb currents (white) concentrate near the center of the entrance. Caption “B” shows detail of flood current carrying sand into the entrance, between the north jetty and the SW ODMDS.

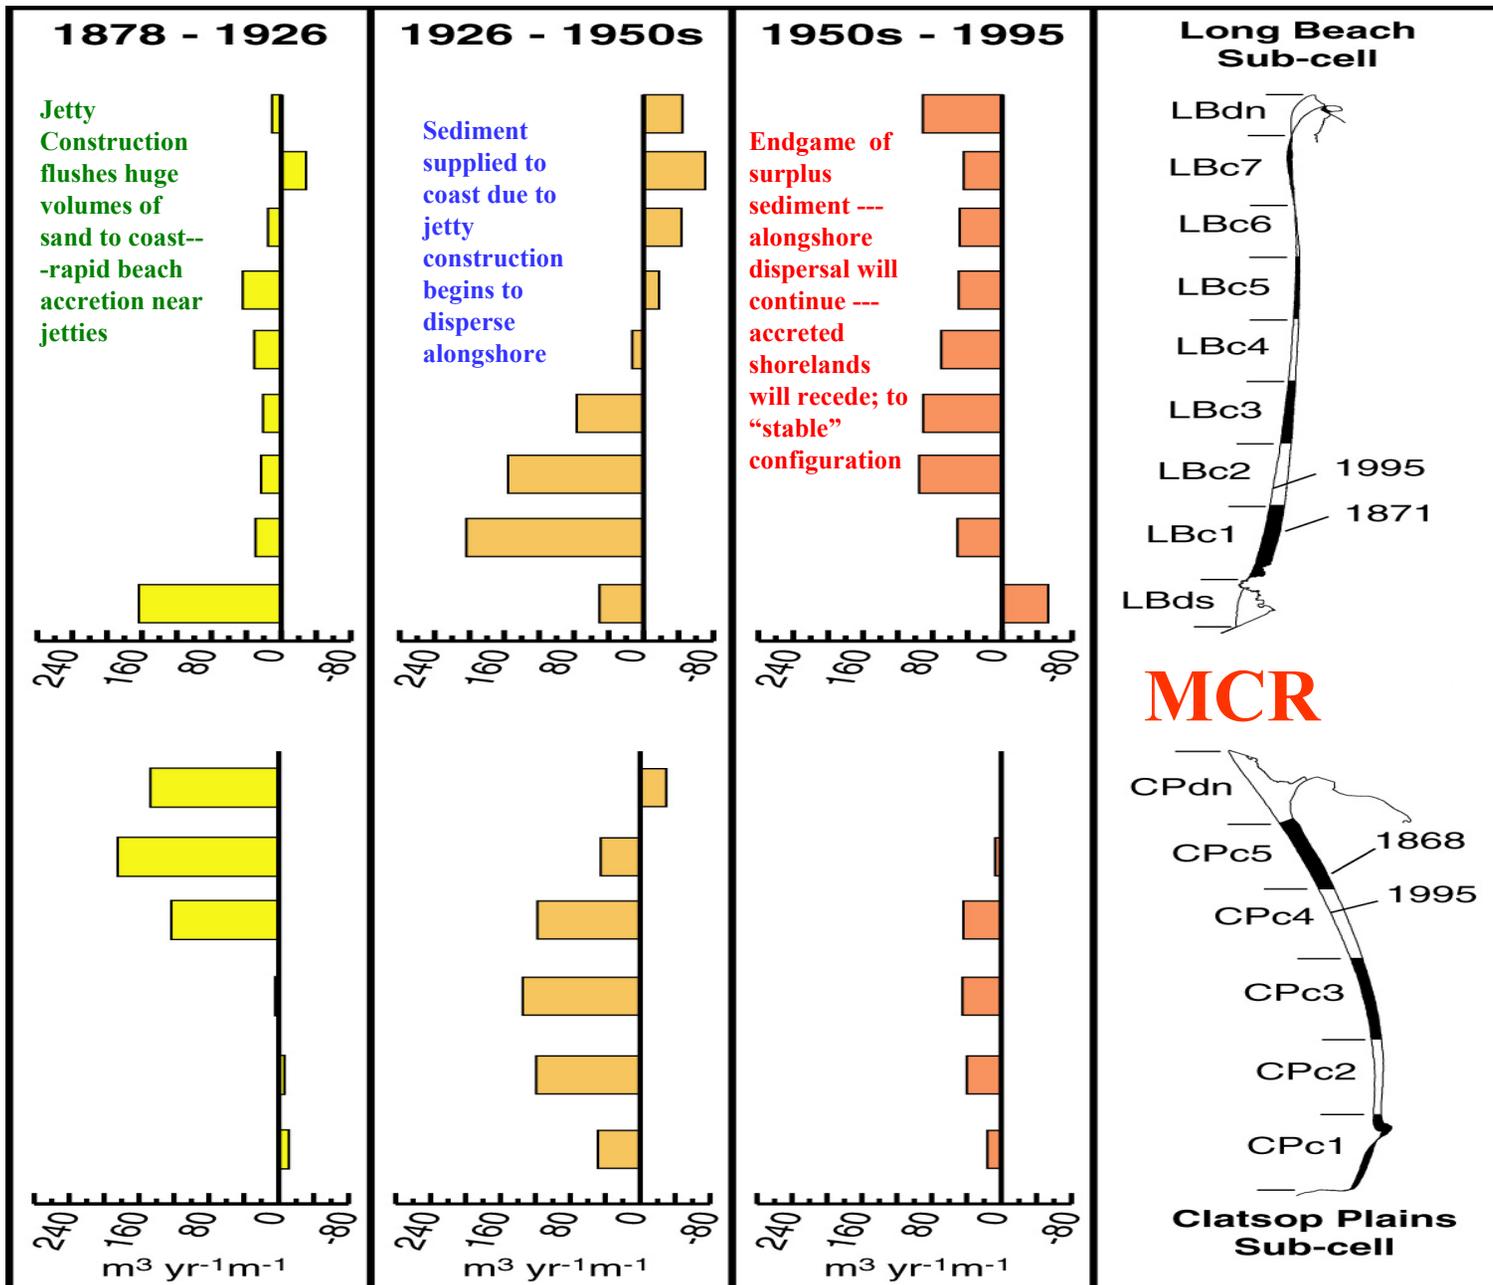
Figure 6

Graphs show unit volumetric rate of sediment deposition (+) or erosion (-) within the active beach profile; for 3 time periods at MCR

Shoreline position north and south of MCR is shown for 1868 and 1995

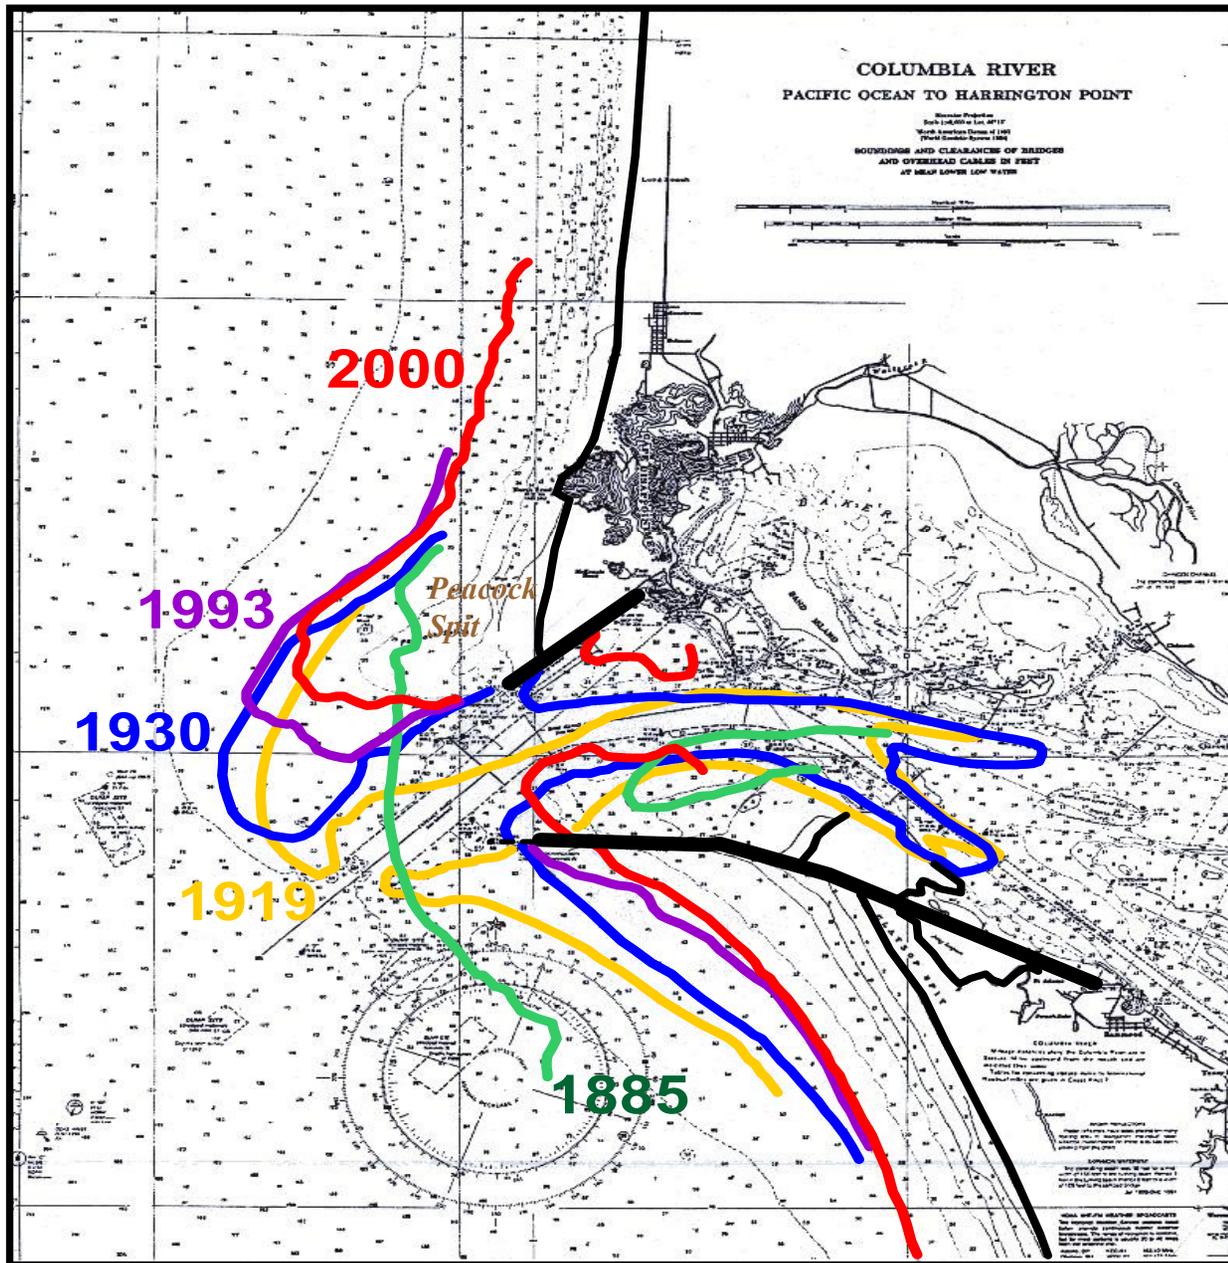
Figure 7. Map of -40 ft depth contour at MCR for 5 time periods

During 1993 to 2000, the 40 ft contour on Peacock Spit receded landward at a rate 7x faster than during 1930 to 1993. As the offshore shoals recede, the wave climate at will change. MCR jetties were built on tidal shoals 1885-1917 that are now eroding. Stability of jetties is compromised due to scour-based failure.
