Vibracores at the Mouth of the Columbia River FY2003 Initial Report

November 2003
Ecology Publication #03-06-031

Prepared in support of US Army Corps of Engineers
and Washington Department of Ecology
Cooperative Agreement

George M. Kaminsky¹ and Marie A. Ferland²

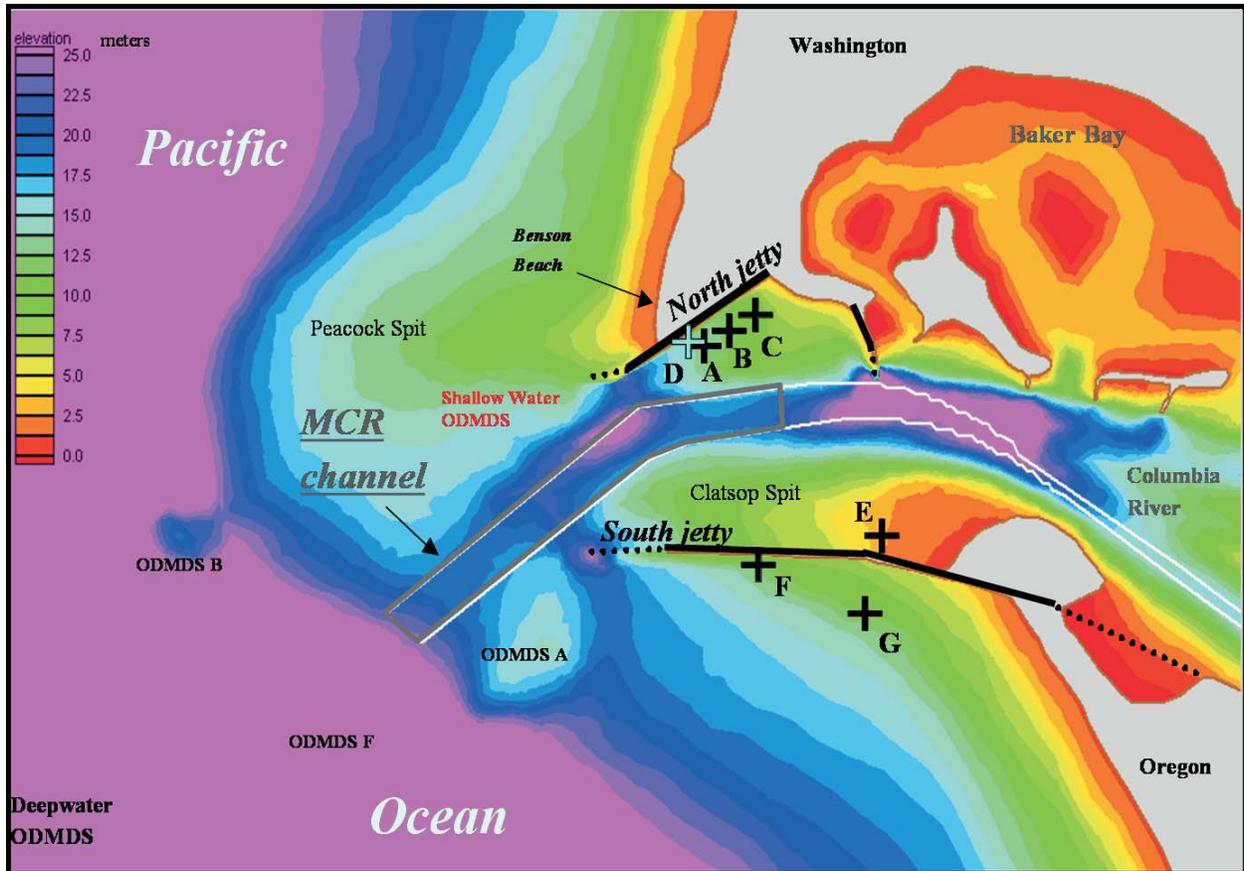
Fig. 1. Planned locations of vibracore sites of this project (figure by R. Moritz).

Through discussions with the Corps of Engineers, 7 locations were selected to collect vibracores to 20 ft length as shown on Fig. 1, sites A-G. The plan included collecting two cores at sites A, C, F, and G; 1 core for minimum disturbance of sample, not to be driven to absolute refusal, and 1 core driven to refusal or to the entire extent of sampling tube to determine gross changes in sediment profile. The total number of cores intended for collection was 11 cores for the 7 sites.

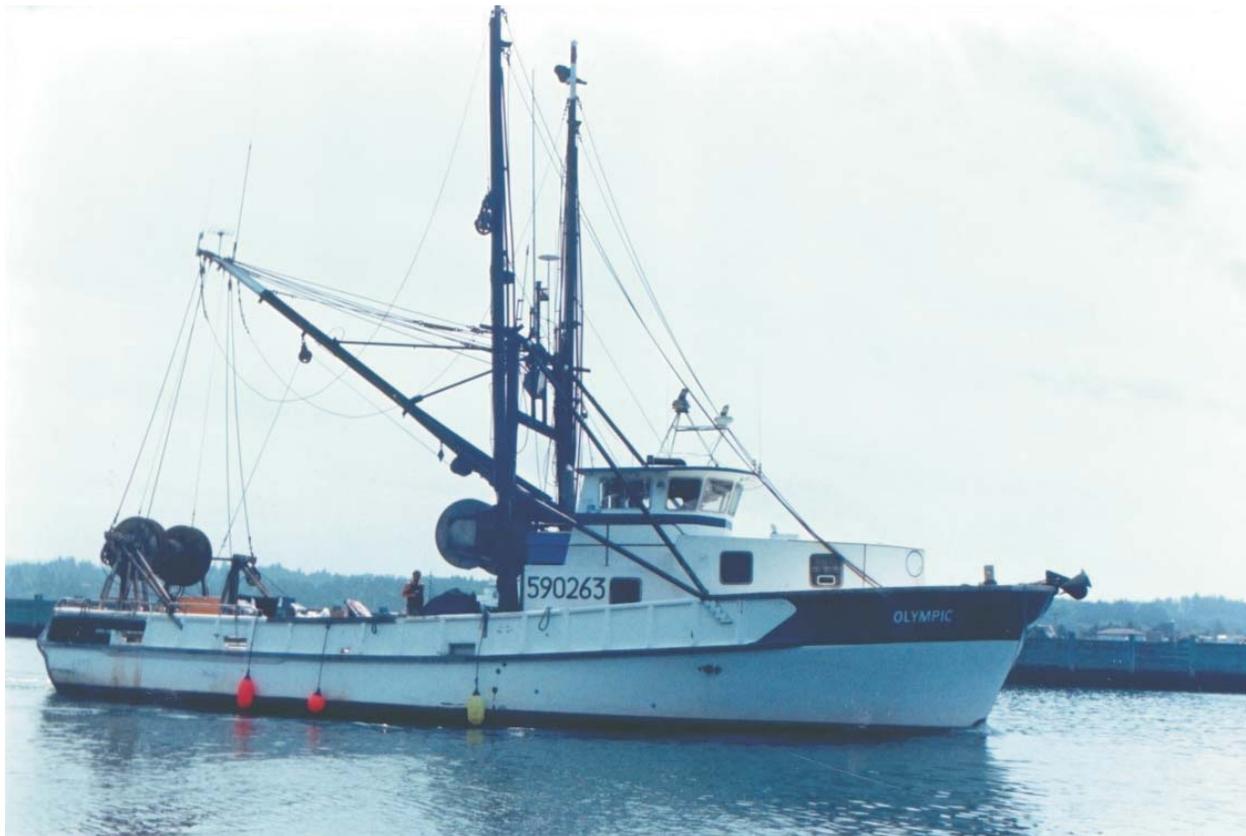
Fig. 2. Photo of the 75-ft vessel "Olympic" used to collect the vibracores.

Vibracores were collected using the vessel "Olympic" (Fig. 2) which has an elaborate rigging system, large aft working deck and capacity for cold storage to maintain core quality for the period of field work. The starboard outrigger and three-point lift system enabled the vibracorer to be deployed over the starboard side. A stabilizer, suspended from the port outrigger, reduced roll and thereby improved the stability of the boat as a coring platform. The use of this vessel enabled the collection of cores in water depths as shallow as 7 m. The captain and crew had an excellent working knowledge of the Columbia River entrance channel and jetty areas which was essential for successful completion of the project.

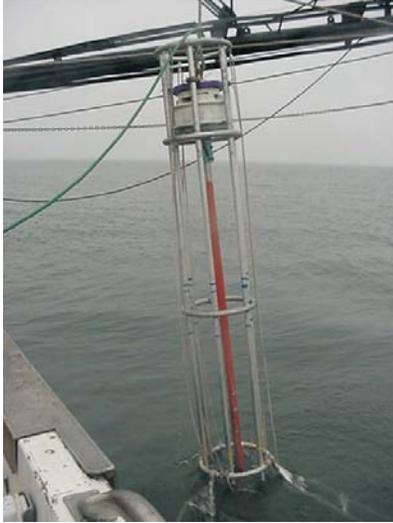
Fig. 3. Photo of the 7-m high vibracorer (Quaternary Resources, Ltd.) suspended from the starboard outrigger of the "Olympic". The upper 4 m of the tower are shown.

The Australian-designed vibracorer (Fig. 3) has a lightweight, 7-m high aluminum frame fitted with 3 retractable legs and 6.1 m aluminum barrels. The relatively light vibrating

head delivers maximum vibration energy to the barrel, with little energy expended on vibrating the head. A special feature of this system is that the barrel and head are contained within, but not attached to, the frame. Their ability to freely rotate within frame improved the capability of the corer to penetrate quickly through difficult substrates. Typical vibrating times for this corer have ranged from 90-125 seconds depending on seabed conditions, substrate and response of the corer.

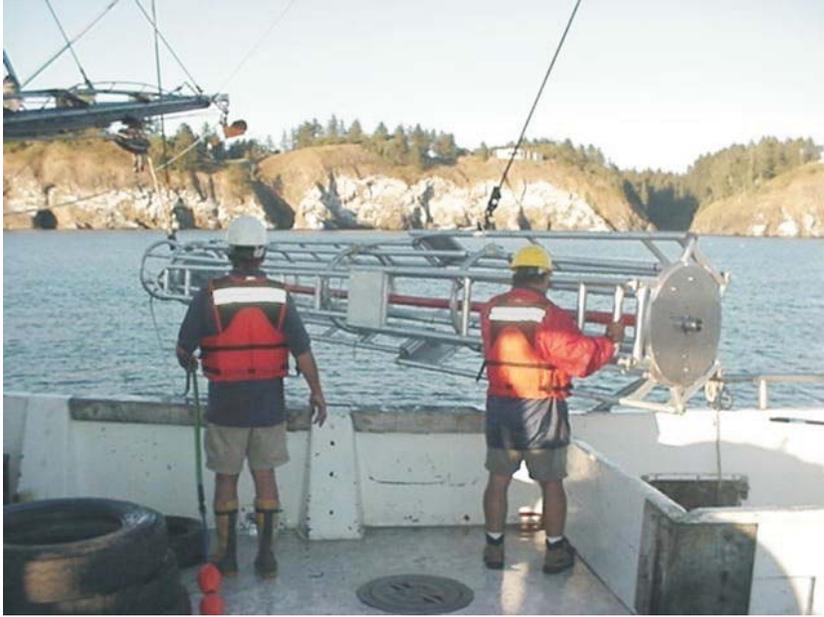
Fig 4. Photo of the vibracorer suspended above the deck of the "Olympic" for deployment over the starboard side of the vessel.

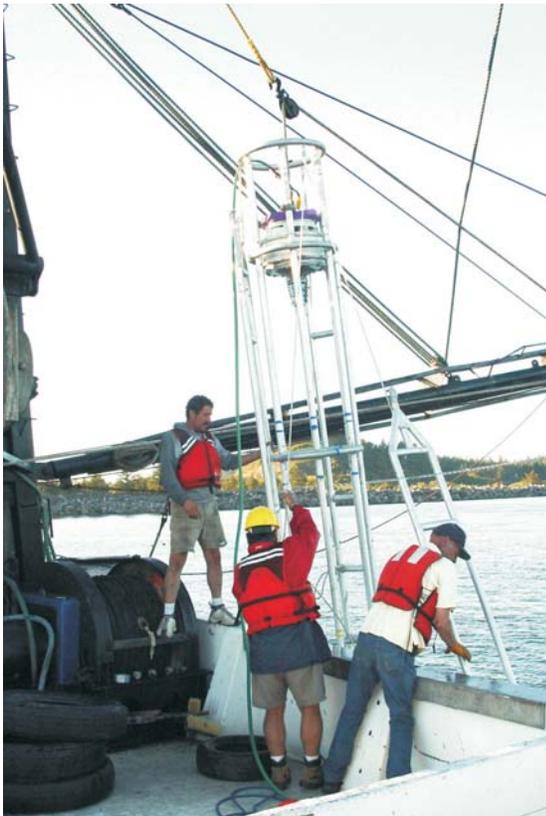
Fig. 5. Photo of crew adjusting the retractable legs of the vibracorer.

The core barrel, with the core-catcher installed, was painted with red paint prior to being attached to the vibrating head (rationale discussed below). After the barrel was attached to the head, within the coring frame, the entire rig was raised from the deck and deployed over the starboard side (Fig. 4). The corer was brought alongside the vessel where the three legs were lowered and secured (Figs. 5 and 6).

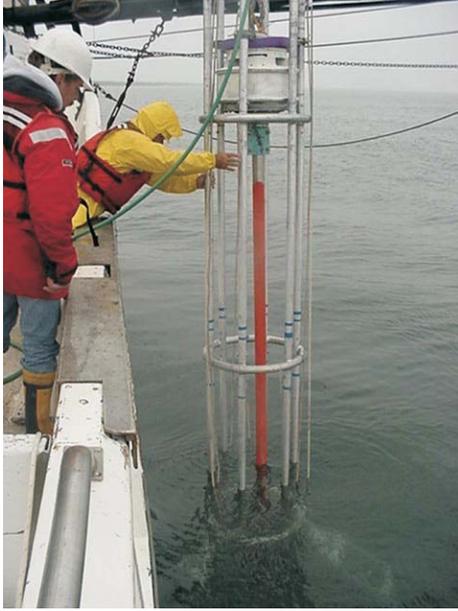
Fig. 6. Photo of vibracorer suspended at starboard side of the "Olympic".

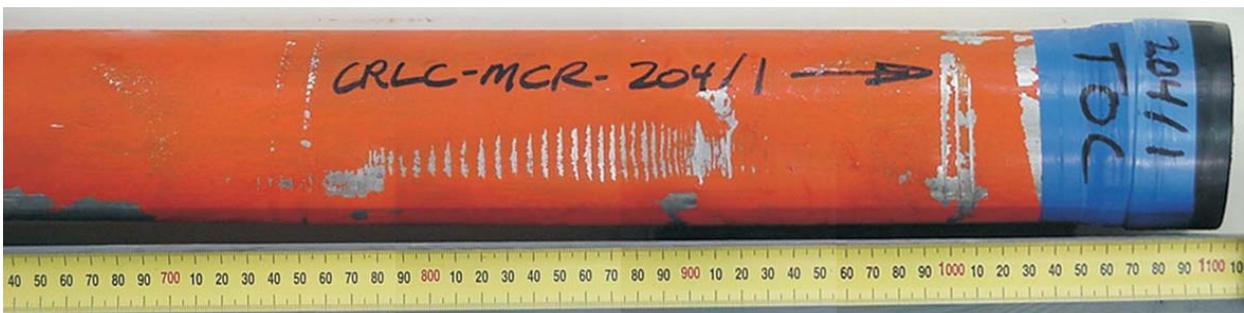
Fig. 7. Photo of scrape marks along a core barrel indicating progressive penetration into the seabed, with the abrasion mark closest to the top of the barrel denoting maximum penetration.

Once the vibracorer was on deck and secured, the red paint on the barrel was examined closely to determine the depth of core penetration into the seabed (Fig. 7). (Note: A spring-action "gate" at the base of the coring tower scraped the barrel as it passed, just before it entered the sediment, which removed the paint and scored the barrel.) The penetration depth (i.e. length along the barrel from the core catcher) was measured and recorded, for later comparison with the length of recovered sediment in the core barrel. Cores were labeled, placed in the vertical position to settle and drain, and secured to the aft A-frame net spool of the vessel (Fig. 8). Later, the cores were cut into 1.5-m sections, the sediment at the cuts between sections was briefly described and recorded, and the ends of each core section were sealed with an end cap and electrical tape (blue at the top of each section, green at the bottom). The core sections were then stored in the refrigerated hold of the vessel until removal for transit to OSU.

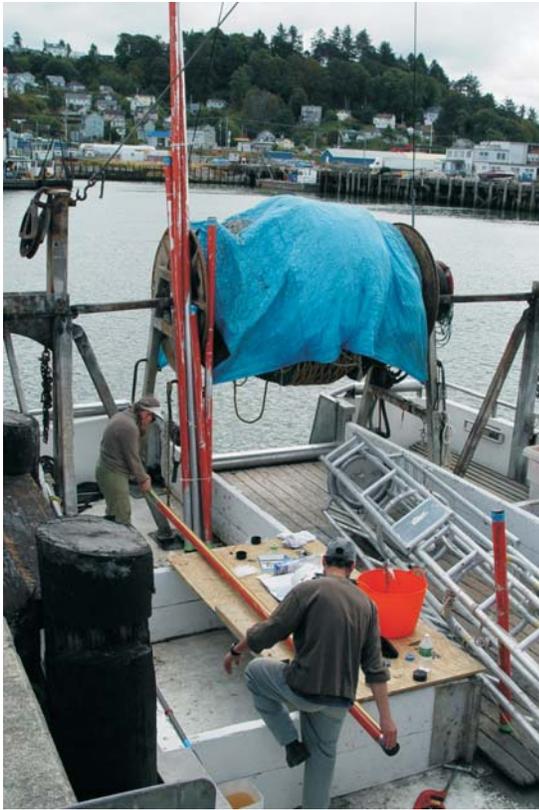
Fig 8. Photo of core processing aboard the "Olympic" while docked at the Port of Astoria. Immediately after collection, cores were secured in an upright position to settle and drain, and within several hours, final measurements of recovery and penetration were made, and each core was then cut into 1.5-m sections for storage in the refrigerated hold of the vessel (photo by R. Gammisch).

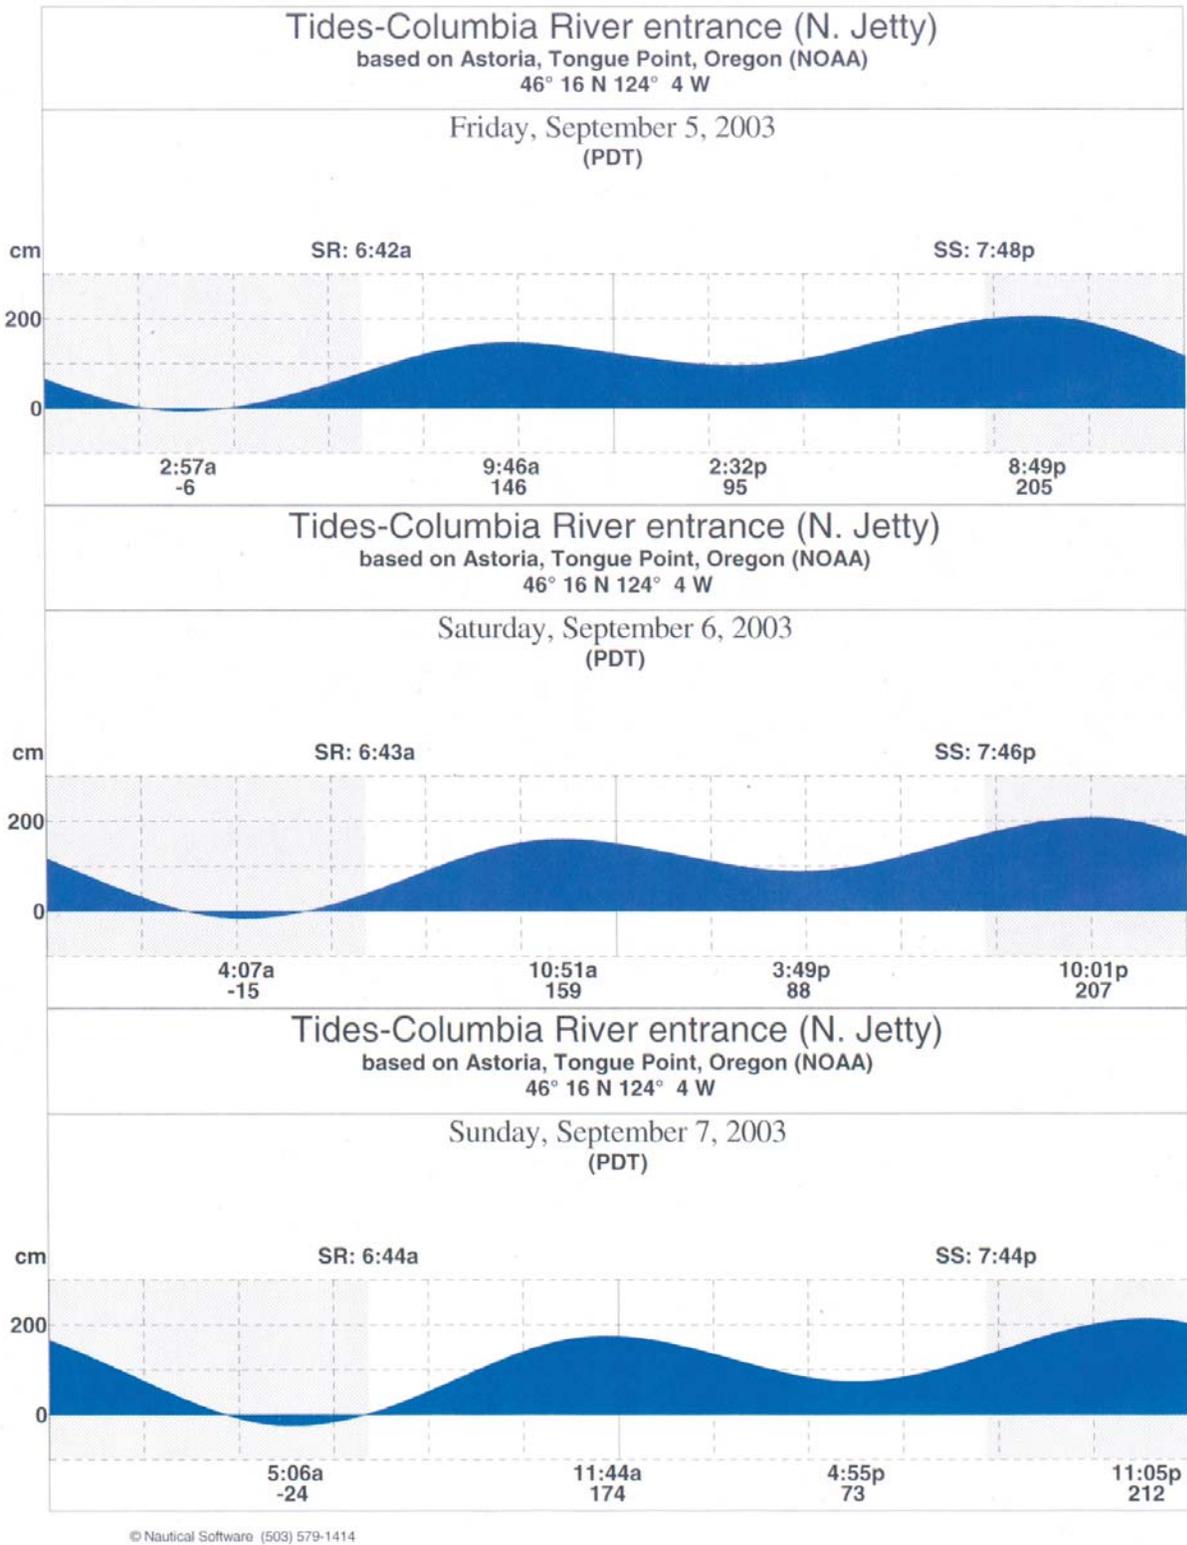
Fig. 9. Predicted tides at the mouth of the Columbia River during the coring operations.

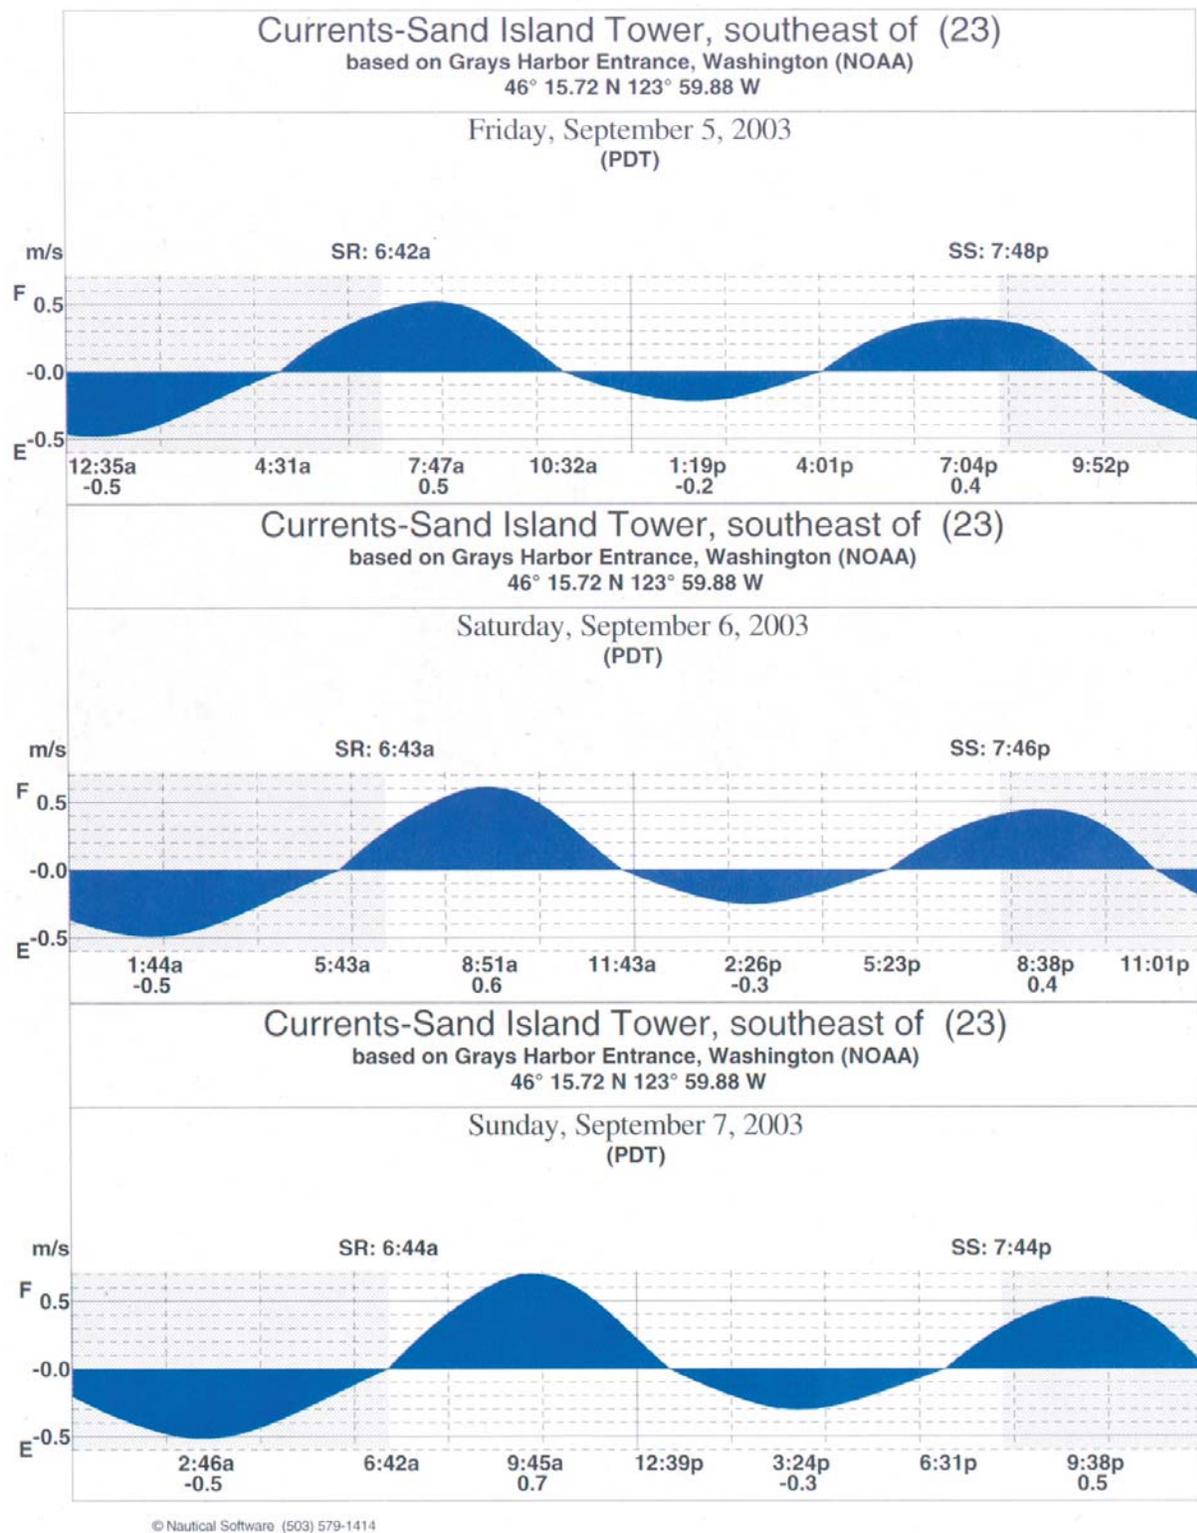
Fig. 10. Predicted tidal currents at the mouth of the Columbia River during the coring operations.

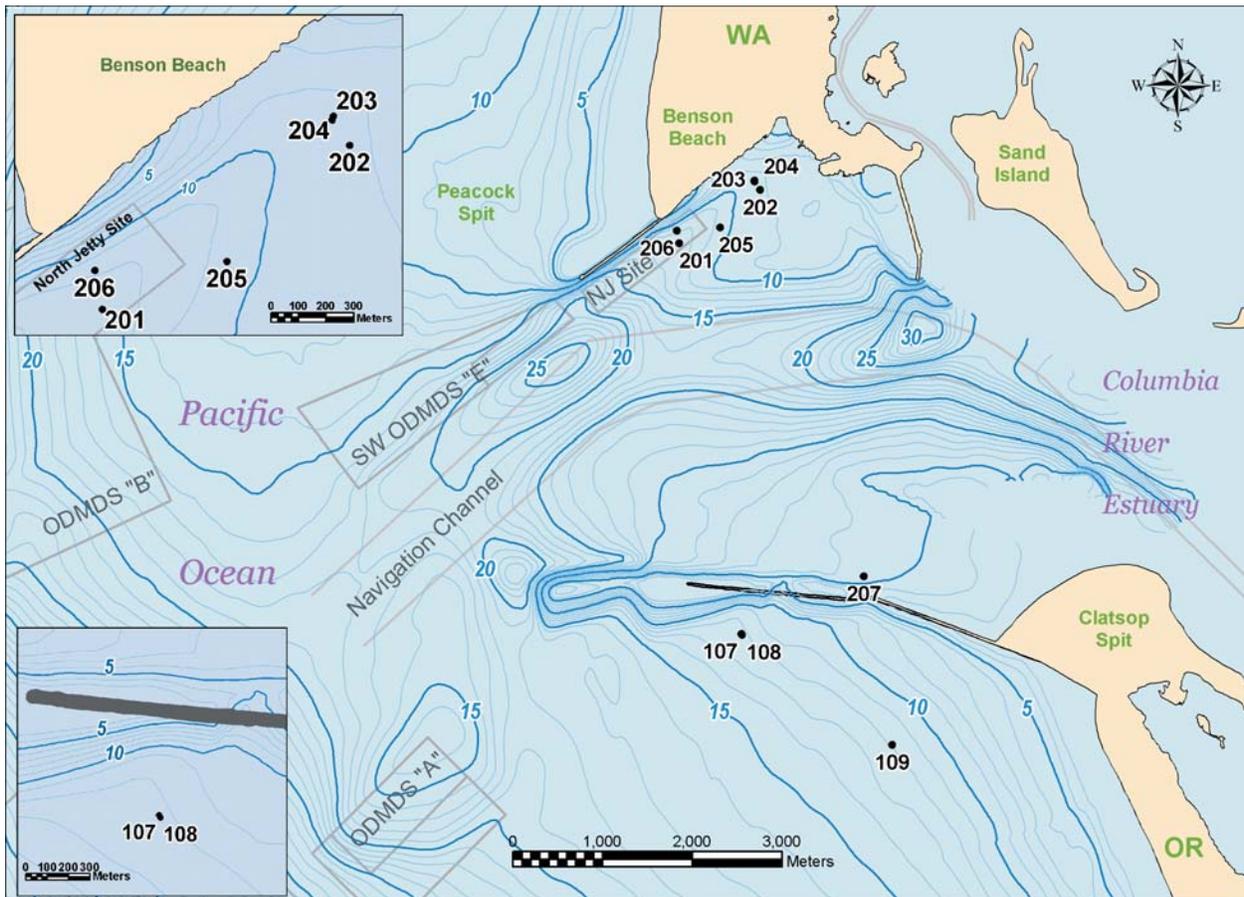
Fig. 12. Map of the locations of the cores collected in this project.

With the changing tide and increasing wind speed and wave heights, it was determined not feasible to attempt an additional core at Site A, where two cores had been originally proposed. Due to the strong northward current and forecast for worsening wind and wave conditions over the next few days, it was not economically justified to attempt additional cores. A total of 10 vibracores from 12 attempts were obtained during the field operations of September 5-7, 2003. Figs. 12 and 13 show the locations of the collected cores and Table 2 provides specific information about each core.

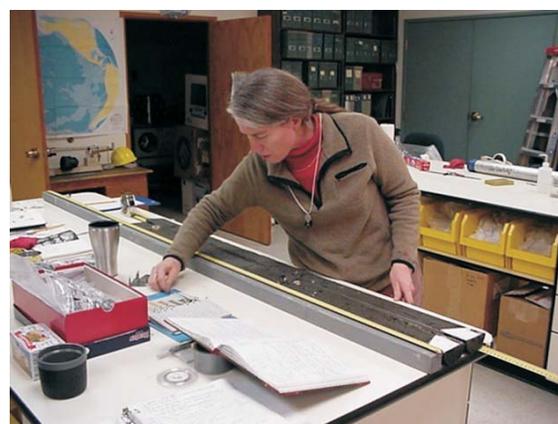
Fig. 14. Photo of core logging. Sediment properties and sedimentary structures are observed and recorded on core logs.

tape on a work table (Fig. 14). Visual descriptions of the cores included disturbance (if any), color using the Munsell Color Classification Chart, grain size at various depths, occurrence of shells and other organic material, and general observations/comments. Samples were also identified for possible future grain-size analysis and dating by the radiocarbon technique. After logging, both core halves were covered with plastic wrap, sealed, put in labeled plastic “D tubes” (Fig. 15), and placed in the OSU cold storage room (Fig. 16).

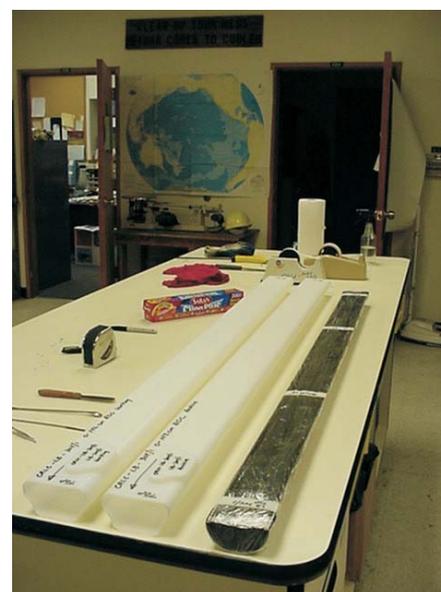
Fig. 15. Photo of core half sealed and labeled for archiving in "D-tube".

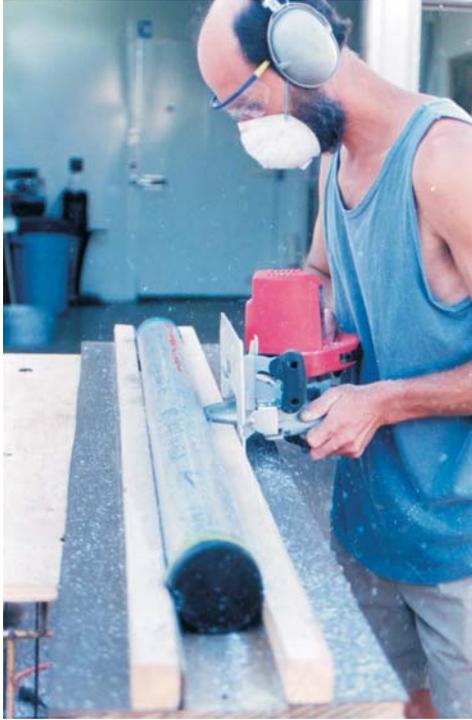
Fig. 13. Photo of cutting core sections length-wise. Once the core barrel was cut on opposite sides, a wire was pulled through the sediment to split the core in half; one half used for sampling and the other half kept as an archive.

Core processing began Tuesday morning, September 9 and continued through Saturday, September 13. For initial core processing, the cores were split (Fig. 13), photographed, briefly logged (visual descriptions; Fig. 14) and sampled. The archive half of each core section was placed on a horizontal platform illuminated by four bright lights. Digital photographs were taken at 10 cm intervals with approximately 50 percent overlap between successive photos. This overlap ensured that no distortion would be seen when the individual frames were joined together to construct the photomosaic image (Appendix A). The digital core photos were downloaded to CDs and catalogued.

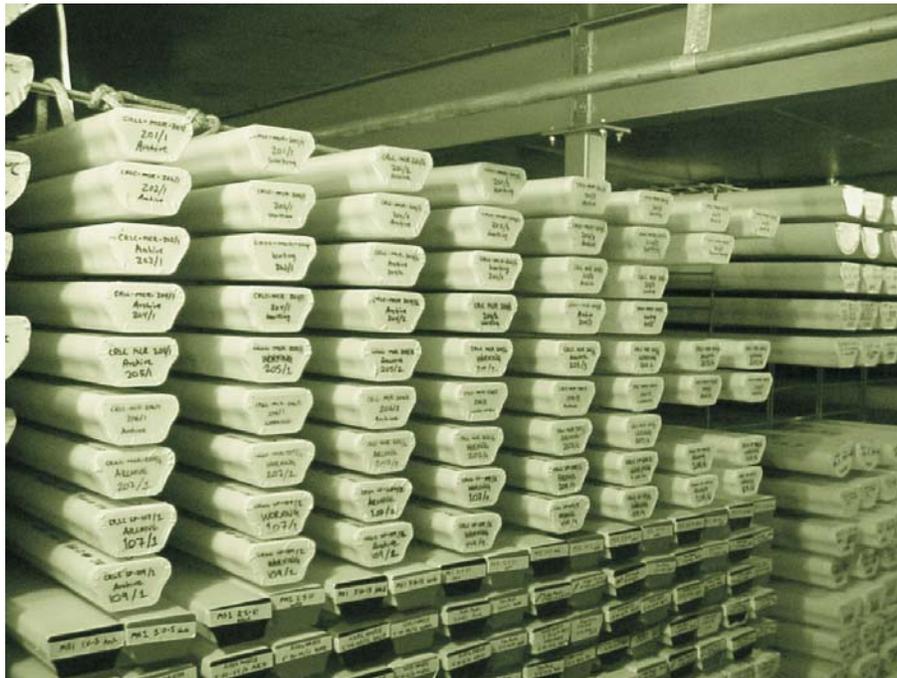
Fig. 16. Photo of the set of archived- and working-half core sections stored in “D-tubes” in the refrigerated facility of the OSU Core Laboratory.

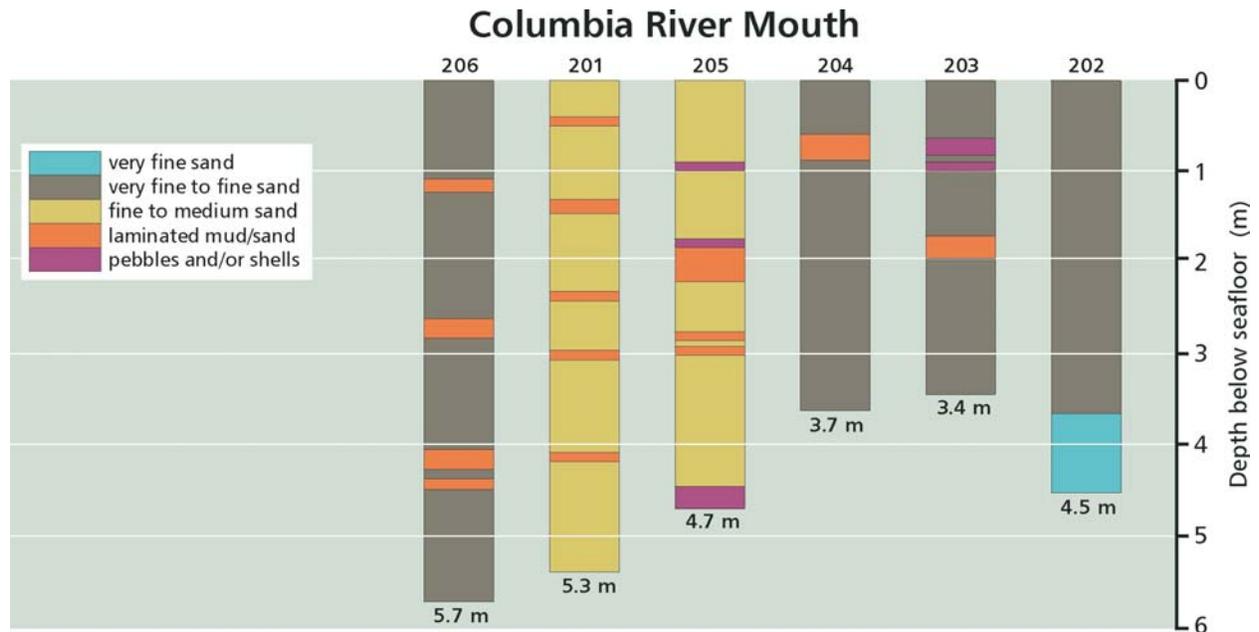
Fig. 17. Core logs showing basic sedimentary units observed in the cores collected along the Columbia River north jetty.

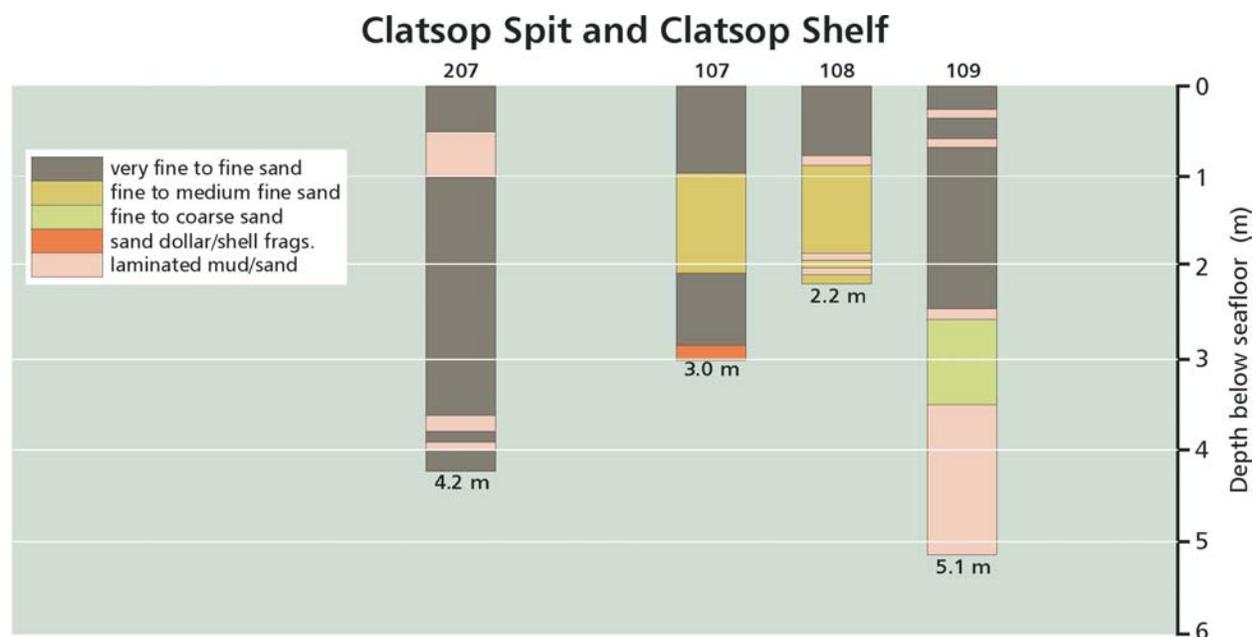
Fig. 18. Core logs showing basic sedimentary units observed in the cores collected along the Columbia River south jetty.

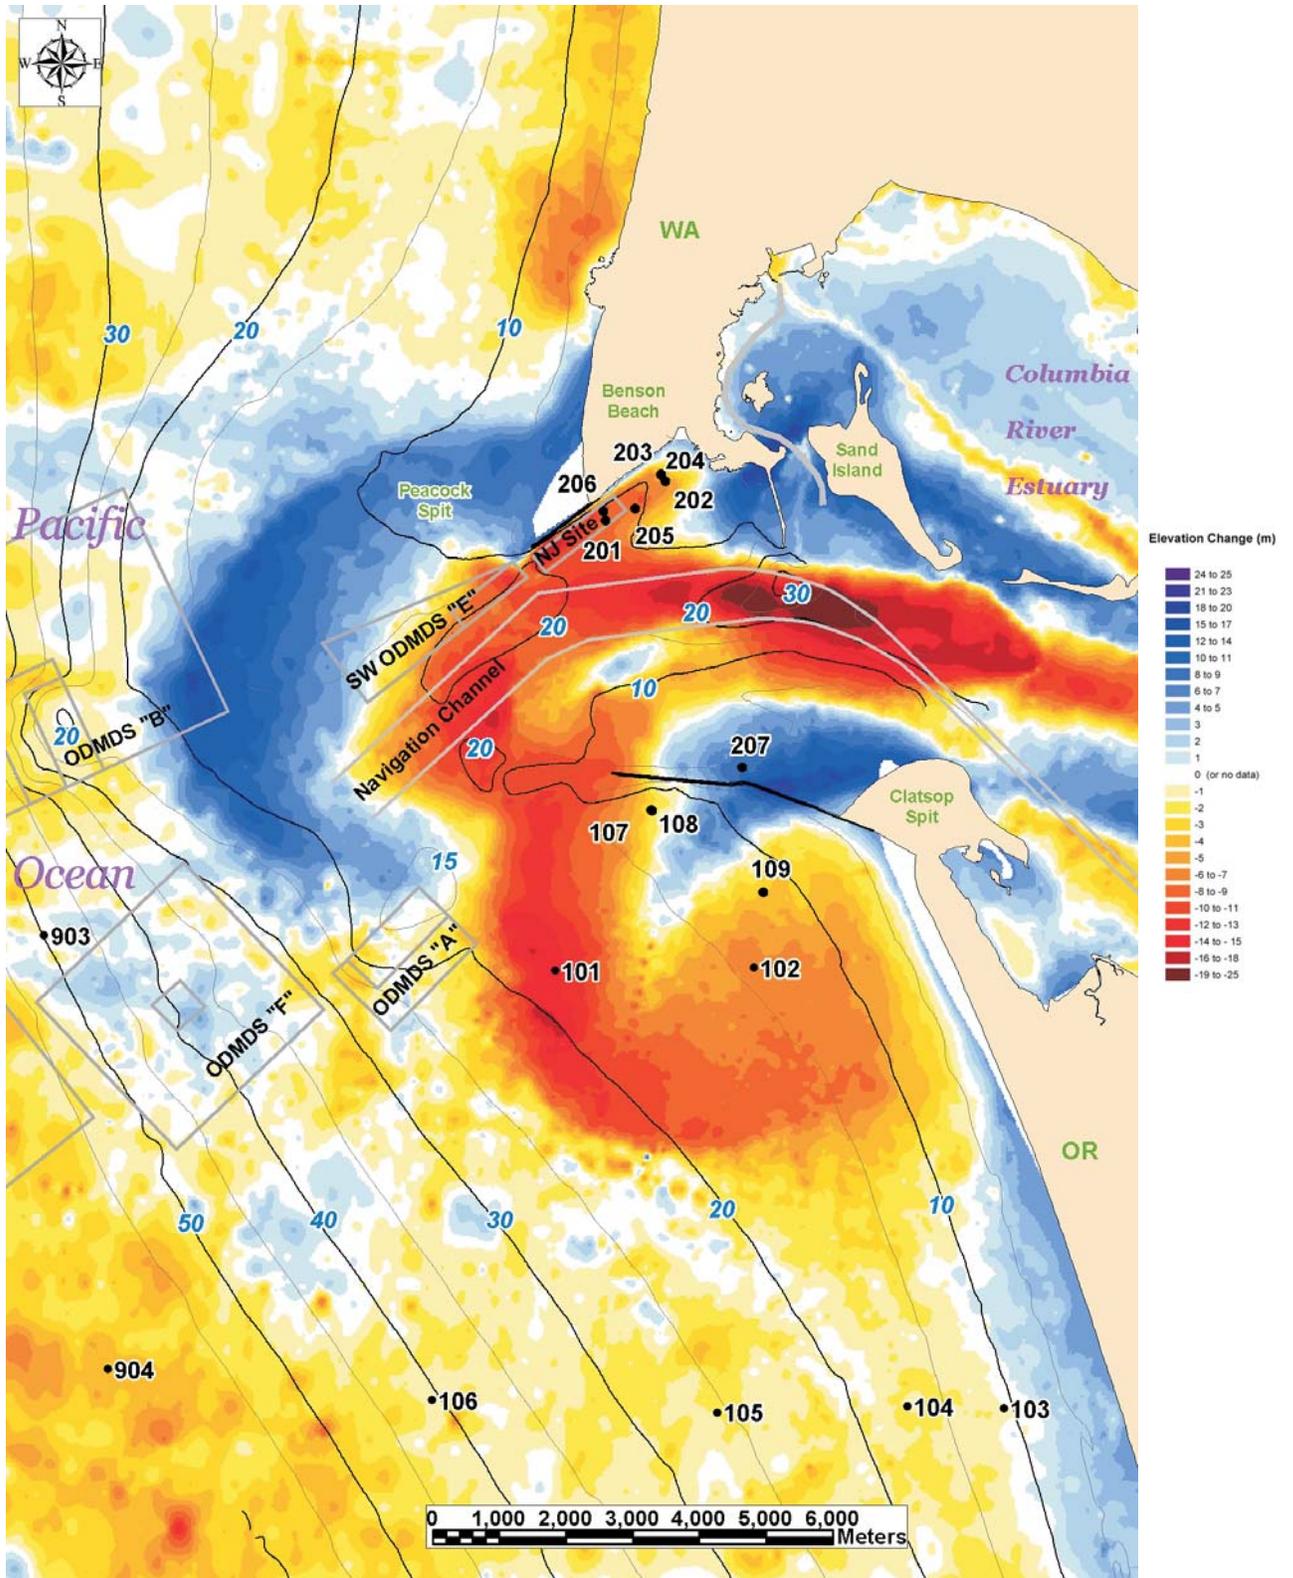
Fig. 19. Locations of vibracores collected in previous study in 2002 by the authors and this project shown with historical bathymetric change from Buijsman et al. (2003) during the period 1868 to 1935 (1877 to 1926 for shelf; 1868 to 1926 for delta; and 1868 to 1935 for entrance and estuary). Bathymetric contours in meters NAVD88 derived from data from 1998-2003.

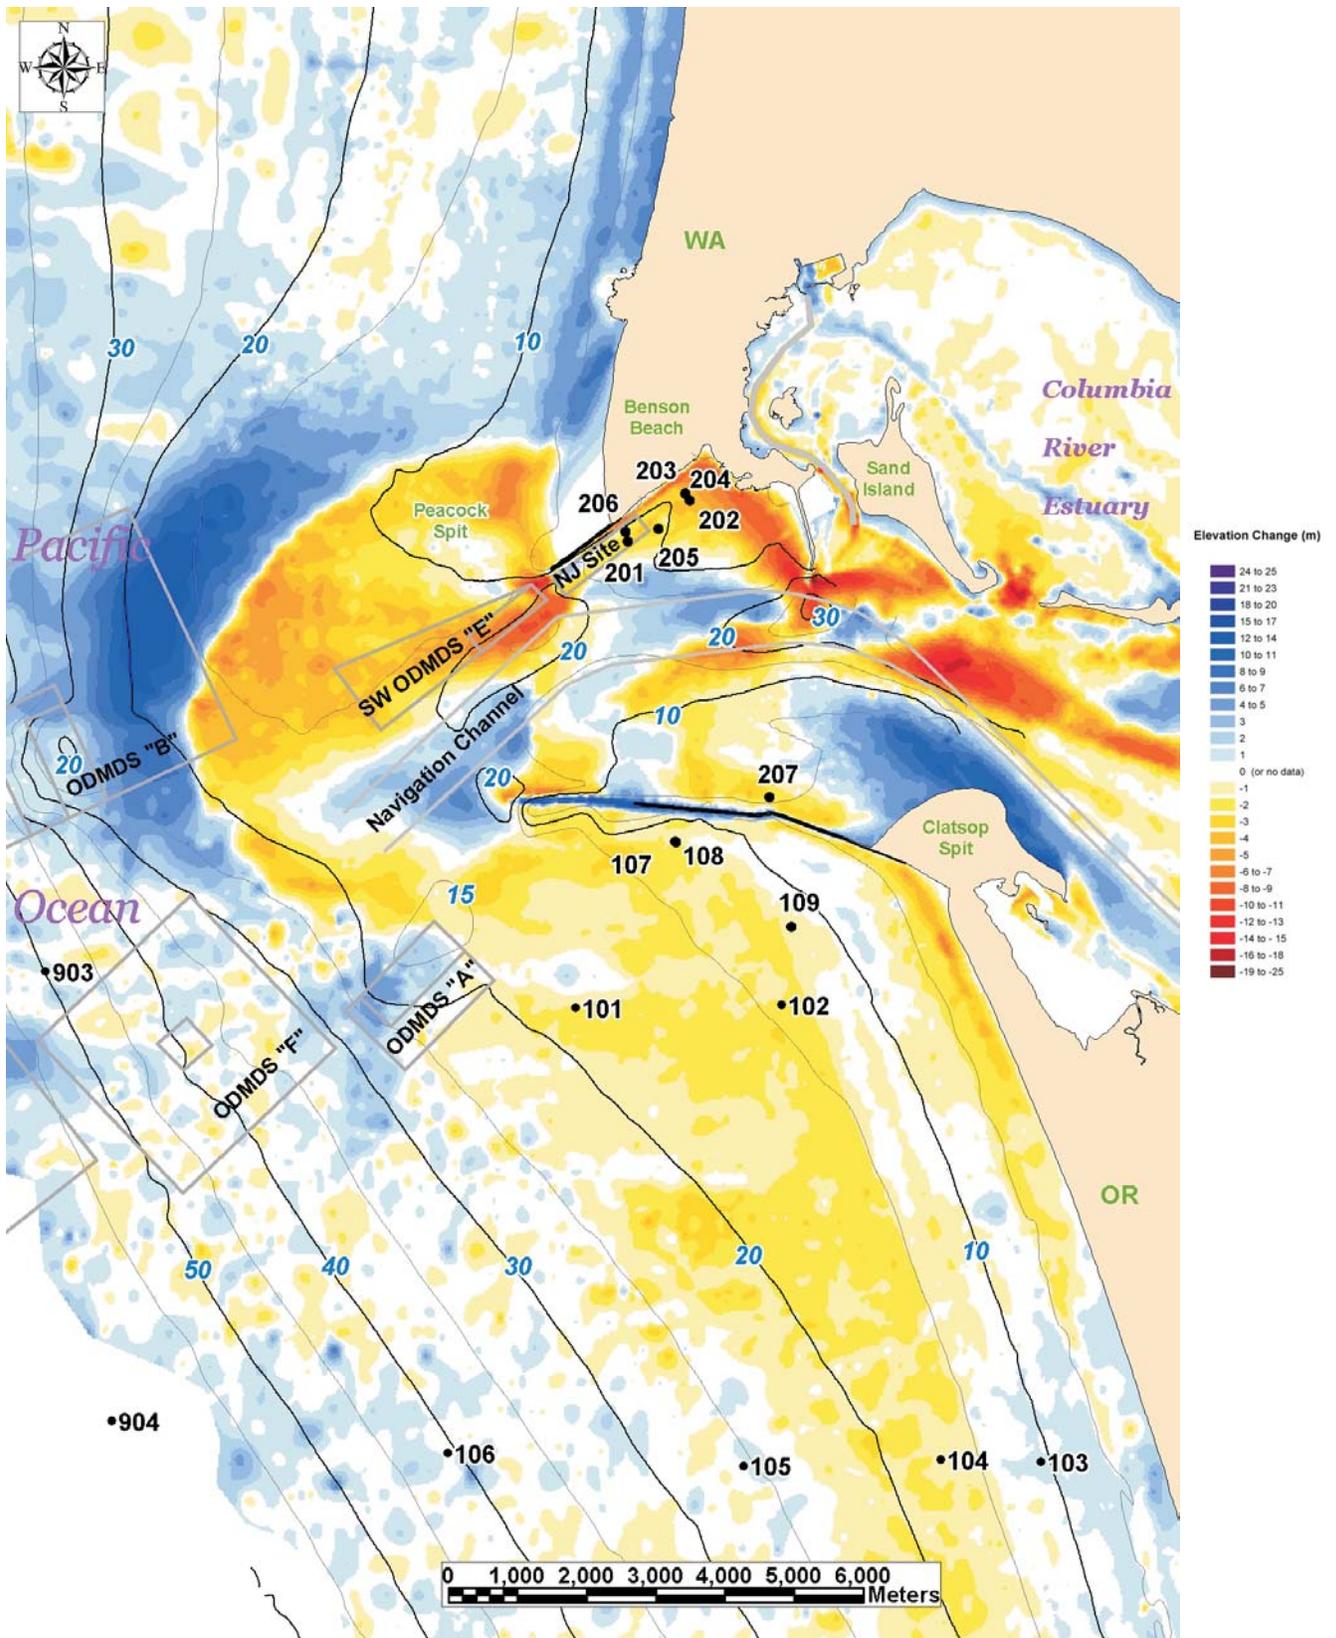
Fig. 20. Locations of vibracores collected in previous study in 2002 by the authors and this project shown with historical bathymetric change from Buijsman et al. (2003) during the period 1926 to 1958 (1935 to 1958 for entrance). Bathymetric contours in meters NAVD88 derived from data from 1998-2003.

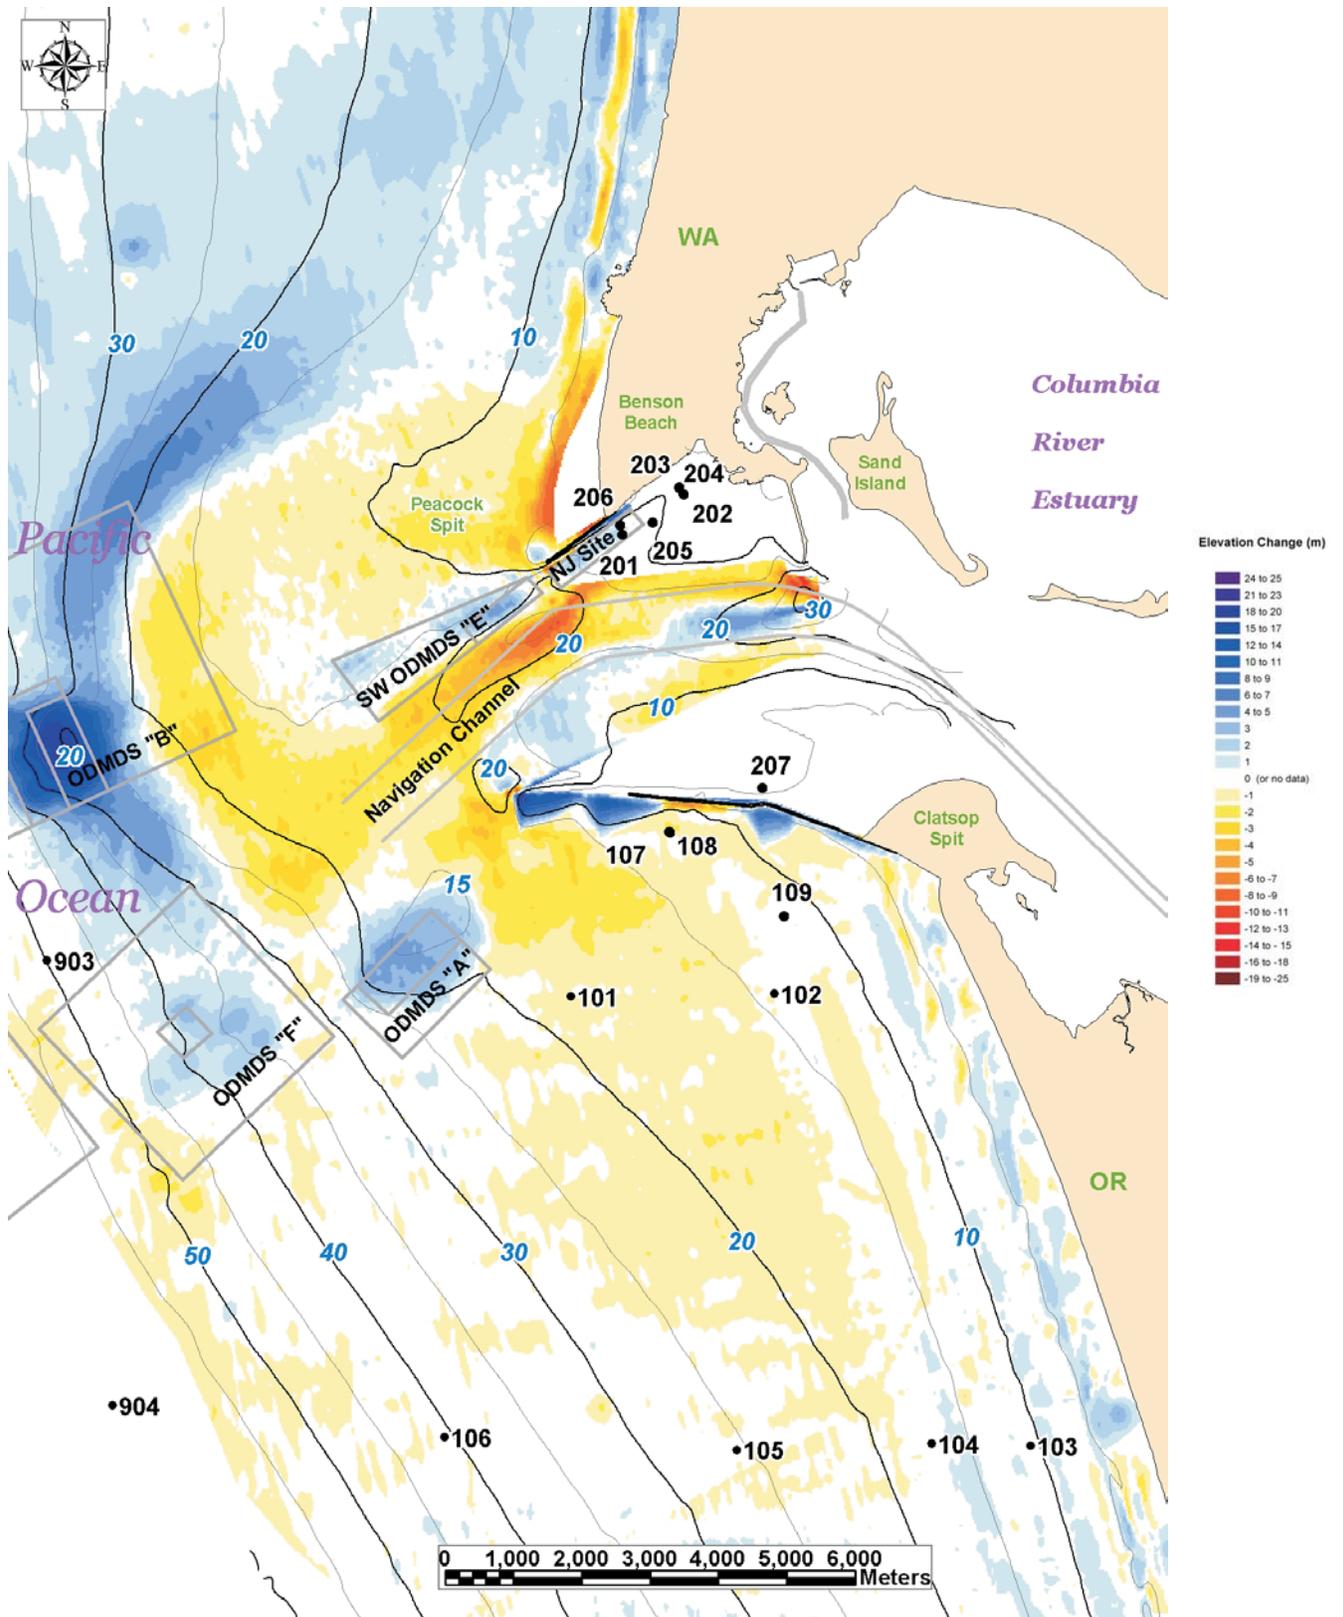
Fig. 21. Locations of vibracores collected in previous study in 2002 by the authors and this project shown with historical bathymetric change from Buijsman et al. (2003) during the period 1958 to 2000. Bathymetric contours in meters NAVD88 derived from data from 1998-2003.

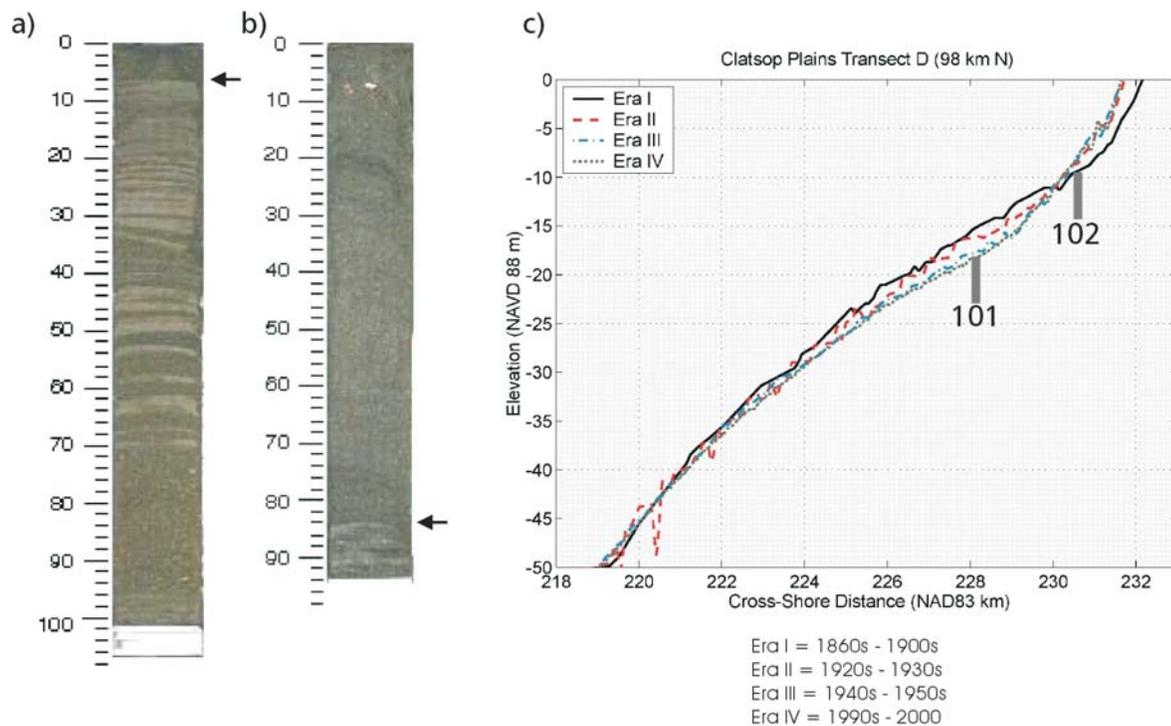
Fig. 22. a) Photograph of core 101 in 18 m water depth, b) photograph of core 102 in 9 m water depth, and c) historical profile change from Buijsman et al. (2003) showing shoreface lowering above core 101 and shoreface aggradation above core 102. Top of relict unit shown by ←

Closer to the Columbia River south jetty along the northern transect of the Clatsop Plains inner shelf, both cores 102 and 102 contain laminated clay and mud units in the shallow subsurface. In core 101, the relict unit is less than 10 cm below the seabed and it is only 85 cm below the seabed in core 102 (Fig 22 a, b). The cores corroborate historical bathymetric data that indicate net lowering of the shoreface at 18 m water depth (core 101) and modest aggradation on the upper shoreface in water depths shallower than 12 m (core 102, 8 m) (Fig. 22c). The shoreface steepening is a response to the construction of the jetties which reduced ebb tidal currents across the Clatsop shoal and increased wave-driven onshore sediment transport (Kaminsky *et al.*, 1999). Evidence of relict material just below the seabed also supports the conclusions of Kaminsky *et al.* (2001) that, as the supply of sand from the Columbia River has rapidly declined (and possibly been eliminated over the historical period), the Clatsop Plains lower shoreface is deflating towards a deeper equilibrium profile. As erosion of the lower shoreface into relict consolidated mud deposits continues, the availability of the shelf to supply beach-quality sand will be diminished.
