**Development and Evaluation of a Lamprey Passage Structure in the Bradford
Island Auxiliary Water Supply Channel, Bonneville Dam, 2004**

Portland District
U.S. Army Corps of Engineers
P.O. Box 2946
Portland OR 97020
Contract E96950021

November 2006

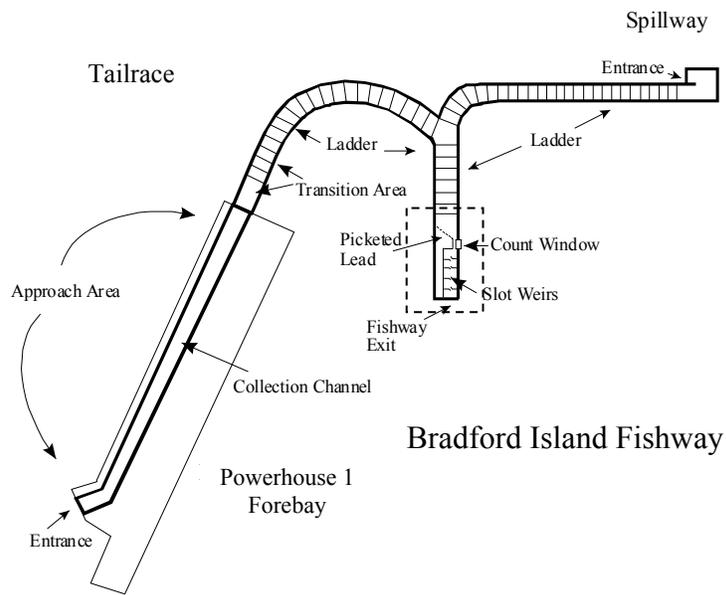
Figure 1. Schematic drawing of the Bradford Island fishway system at Bonneville Dam. The top of the fishway is indicated in the dashed box.

In 2002 and 2003, we designed, installed, and tested lamprey collectors in the Bradford Island AWS to see if lamprey could be attracted into a lamprey-specific fishway. The results of this work were encouraging. Up to 18% of the lamprey that we marked and released into the AWS were collected in an “open ramp” type of collector. By the end of 2003, over 5,400 lamprey had been collected from AWS channels during the course of the experiments. These fish were released above Bonneville Dam by placing them into a chute that emptied into the forebay upstream from Powerhouse 1 (Figure 1).

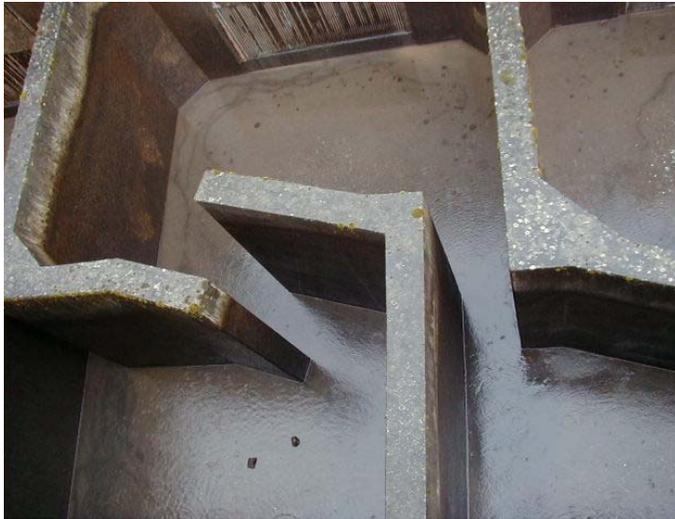
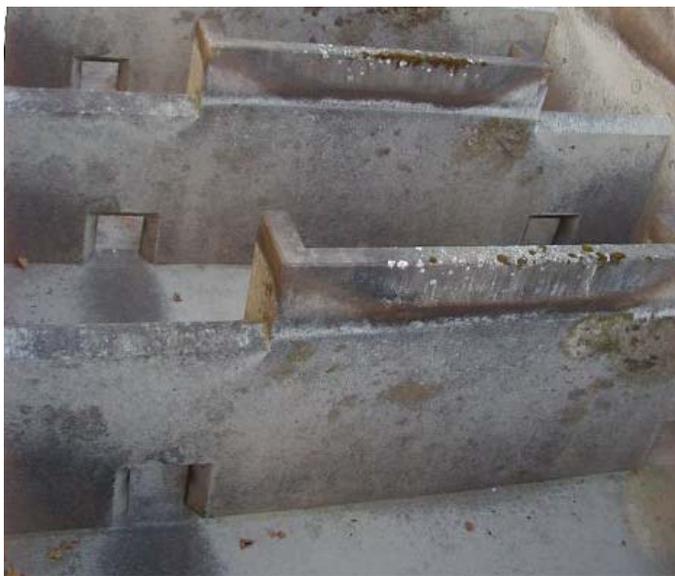
Figure 2. De-watered views of serpentine weirs (upper photo) and overflow weirs (lower photo) used in fishways at lower Columbia River dams.

Construction differs between Bonneville and The Dalles Dams in the flow-control section at the top of the fishways. At Bonneville Dam, this part of the fishway has serpentine weirs (Figure 2, top), whereas at The Dalles Dam there are overflow weirs at the top of fishways. At the top of Bonneville Dam fishways, adult Pacific lamprey are routinely delayed and/or obstructed by the serpentine weirs located immediately upstream from the count stations at both the Bradford Island and Washington-shore fishways (Moser et al. 2002c, 2003b, 2005a). In contrast, at the Dalles Dam from 1997 to 2002, 99% of radio-tagged lamprey that approached the top of fishways passed successfully over the dam (Moser et al. 2005a).

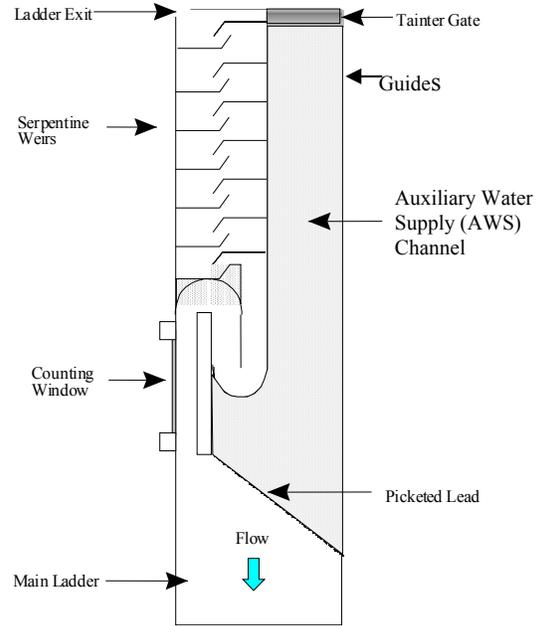
Figure 3. Detail of the top of the Bradford Island fishway.

In previous years, the LPS collector was positioned on the west wall at the upstream end of the Bradford Island AWS channel (Figure 3). Guides were installed during winter dewatering and were placed so that the entrance to the passage structures was approximately 15 m downstream from the Tainter gate at the upstream end of the AWS channel. In 2004, the same guides were used, and the collector ramp was installed at this location (see Moser et al. 2005a for details of collector construction).

However, the study area was not closed. Lamprey could leave the AWS by falling back downstream through the picketed lead and into the Bradford Island fishway (Figure 3). This would result in an underestimate of LPS efficiency.

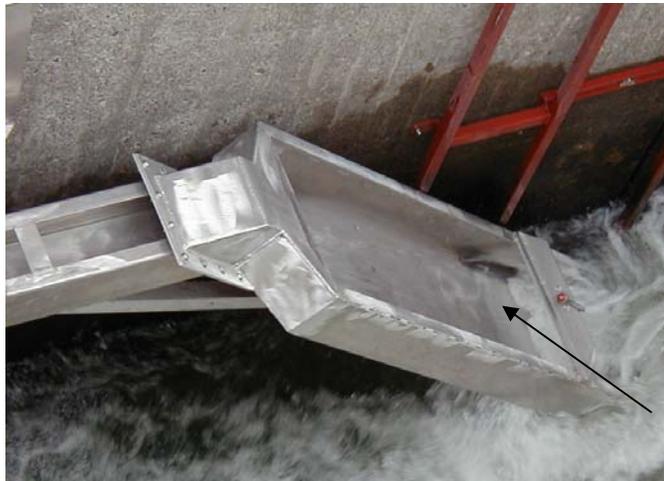
Figure 4. Photo of the Bradford Island LPS collector. Arrow points to a lamprey that is moving up the ramp near the water surface.

The 0.5-m wide collector ramp was made of schedule-40 aluminum and extended from the bottom of the AWS channel to the level of the first rest box (3.3-m elevation, Figure 4). Lamprey could enter the collector ramp at any depth in the water column. A heavy rubber flange was used to create a seal against the wall and floor of the AWS channel and to help guide lamprey onto the ramp (see Moser et al. 2005a).

Most PIT-tagged lamprey were released directly into the LPS by carefully lowering them onto the steep ramp, so that they could slide into Rest Box 1 (Figure 4). To avoid crowding in the rest box on a given day, half of the lamprey were released in the morning (0800-1200) and half were released in the evening (1800-2300).

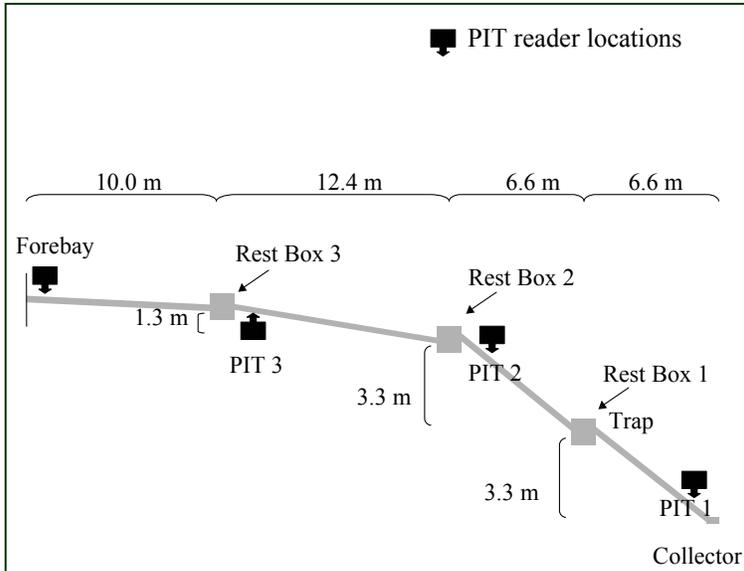
Figure 5. Schematic drawing of the Bradford Island LPS in side view. The light gray squares represent rest boxes and the black boxes indicate the location of PIT readers.

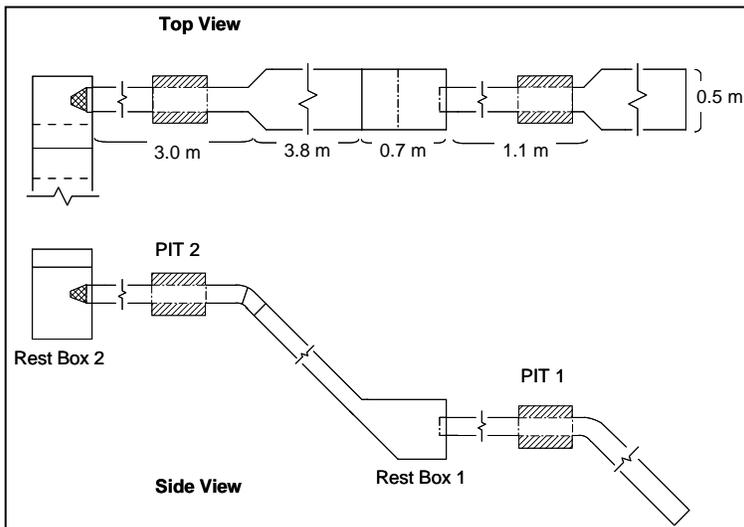
Figure 6. Top and side schematic views of the LPS section from Rest Box 1 to Rest Box 2.

This ramp (referred to as the “steep ramp”) was 3.8 m long and terminated in an open chute, similar to that at the upstream end of the collector (Figure 6). Lamprey passed through the chute and dropped into Rest Box 2.

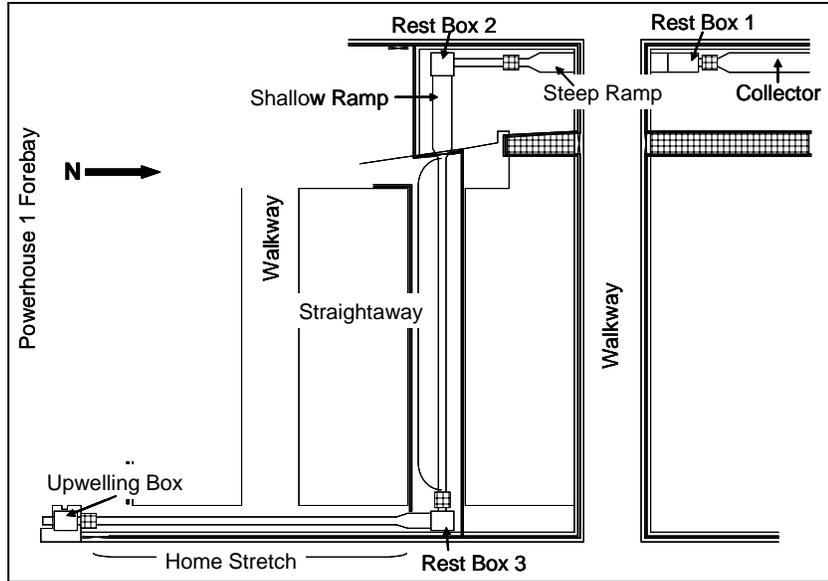
Figure 7. Top view of entire LPS structure.

From Rest Box 2, the LPS turned 90° to the east (up to this point, the LPS was oriented north-south, Figure 7). Lamprey entered at the north end of the rest box and could exit only to the east. Upon exiting Rest Box 2, they started up a 3.7-m, shallow (0.3:1) ramp (hereafter referred to as “shallow ramp”). At the top of this ramp, they

At Rest Box 3, the LPS turns 90° to the south (i.e., lamprey entered from the west and exited to the south, Figure 7). Upon exiting Rest Box 3, lamprey negotiated a 1-m long, 45° ramp up to a 9.6-m long closed tube (“home stretch”). At the end of this tube the lamprey passed through a plastic mesh funnel and dropped into an exit slide (30-cm diameter PVC pipe) that was lined with plastic mesh to prevent lamprey attachment (Figure 9). The 3-m long slide dropped the lamprey into the forebay of Powerhouse 1 approximately 10 m upstream from the Bradford Island fishway exit.

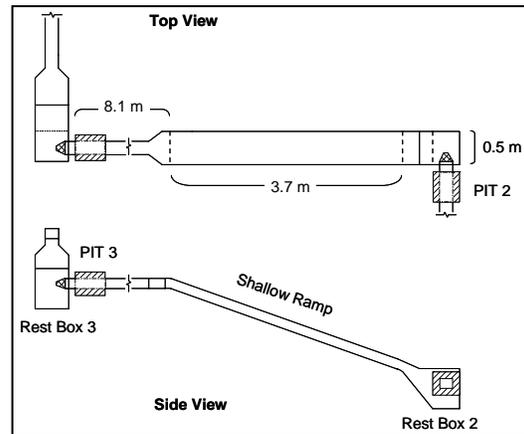
Figure 8. Schematic showing top and side views of the LPS section from Rest Box 2 to Rest Box 3.

entered a straight tube (8.1-m-long × 15.2-cm high × 20.3-cm wide), dubbed “straightaway,” before dropping into Rest Box 3 (Figure 8). The straightaway was fitted with a hinged lid to allow observation of lamprey passing through it while protecting the lamprey from avian predators.

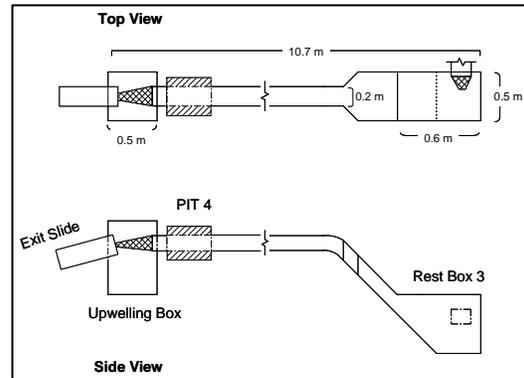
Figure 9. Schematic showing top and side views of the upstream LPS section from Rest Box 3 to the exit slide.

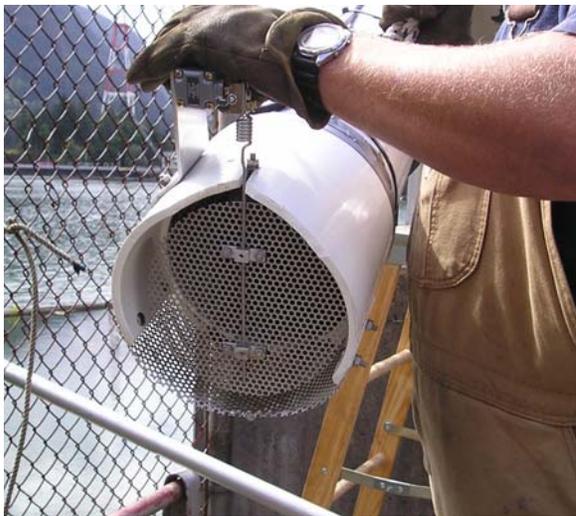
Figure 10. Lamprey activated switch at the terminus of the LPS exit slide.

The first iterations of the lamprey activated switches were installed in the upwelling box located at the top of the exit slide. As the lamprey entered the box, they passed through a plastic mesh funnel that forced them to move through a narrow opening (approximately 5 cm). We tested a variety of limit switch sensitivities and positions near this constriction point. Next, we tested an infrared detector installed in the same location. The lamprey's body interrupted an infrared beam and thereby triggered the switch.

In each case, these devices were wired to an event recorder so that the number of lamprey that activated the switch could be recorded. Ultimately, we attached the limit switch to a large paddle, which was fitted into the slide near its terminus (Figure 10). As the lamprey fell through the slide, they contacted the paddle, and the switch was activated. The switch was connected to a digital event recorder that recorded the number of lamprey passing the switch.

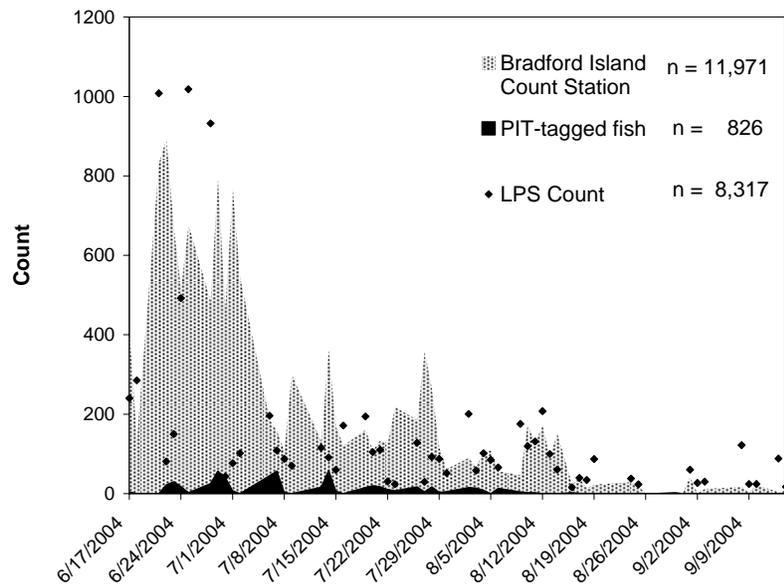
Figure 12. Numbers of lamprey counted at the Bradford Island count station, detected in LPS PIT tag readers, and counted at the upstream end of the LPS.

The LPS was installed by 3 June, before lamprey counts at the Bradford Island Count Station had peaked (Figure 12). We observed a lamprey using the LPS and successfully passing into the forebay of Bonneville Dam on the same day that the structure was installed. While we were able to make visual observations of lamprey use of the LPS immediately after its installation, the video system and lamprey activated counter were not fully functional until 17 June.

The estimated number of lamprey that used the LPS in the period from 17 June to 14 September (based on video and corrected counter data) was 8,317, with a peak at the end of June that coincided with the peak of lamprey counts at the Bradford Island Count Station (Figure 12). This number included 826 PIT-tagged fish that were known to have exited the LPS on days when counts were estimated (Figure 12).

An estimated 7,490 untagged fish used the LPS and volitionally passed into the Bonneville Dam forebay from the AWS channel. The LPS was installed in early June, just prior to the peak of adult lamprey migration (as indicated by visual counts at the Bradford Island count station, Figure 8), and lamprey were observed using the structure immediately after installation. The LPS counts were started on 17 June, and the estimated number of untagged lamprey that passed through the LPS was over 60% of the Bradford Island visual count after that date (Figure 12).

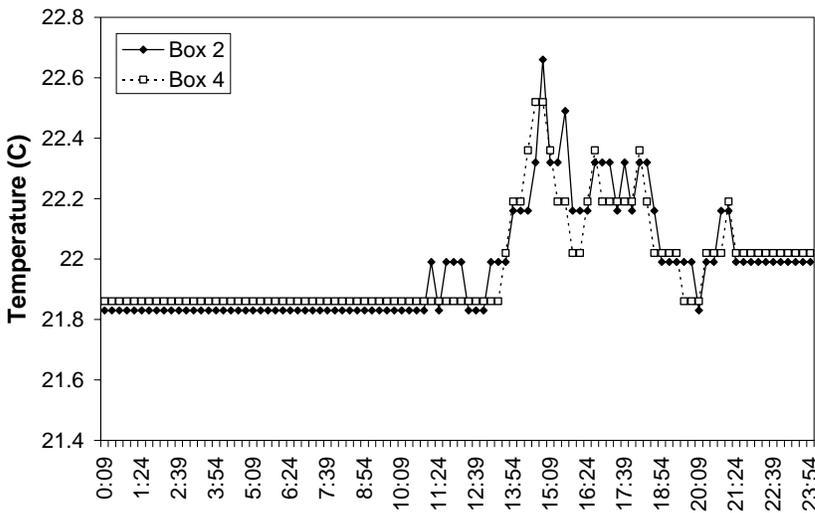
Figure 13. Water temperature recorded every 15 min in LPS Rest Boxes 2 and 4 of the Bradford Island lamprey passage structure on 7 August 2006.

In spite of relatively slow water movement through the flat stretches of the LPS, there was no evidence that water temperature increased significantly between Rest Boxes 4 and 2. Water temperature measured at 15-min intervals during a hot summer day (7 August) revealed differences in water temperature of no more than 0.2°C between the two boxes (Figure 13). The difference in water

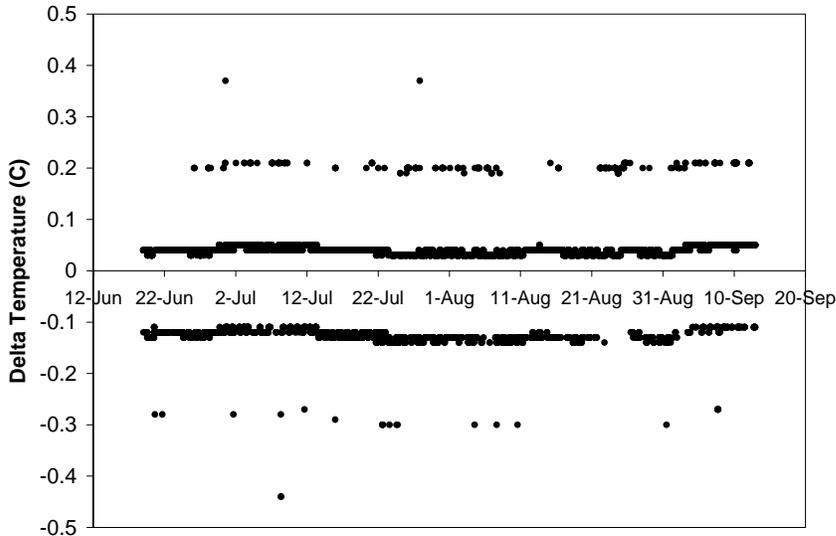
Figure 14. The difference in water temperature ($\Delta^{\circ}\text{C}$) between Bradford Island LPS Rest Box 2 and Rest Box 4 during 2006.

temperature between the two rest boxes rarely exceeded 0.2°C during the entire period of LPS deployment (Figure 14).

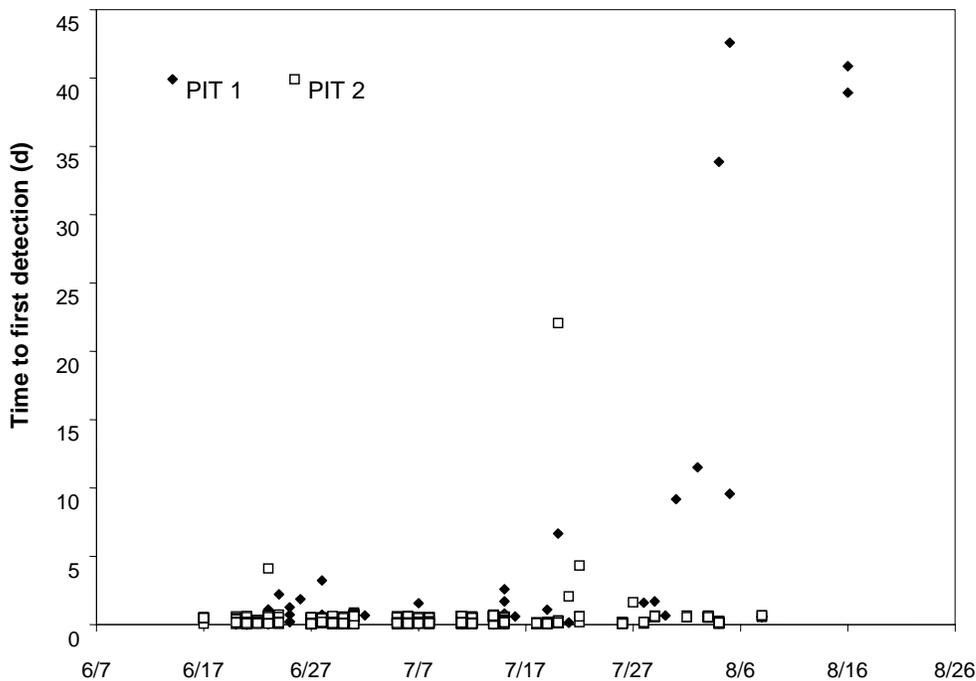
Figure 15. Days from release to first detection at PIT 1 (diamonds) and PIT 2 (squares) for PIT-tagged lamprey released into the LPS in relation to release date.

For all lamprey released into the LPS, the time from release to first detection on a PIT reader ranged from 5 min to 43 d (median 5.0 h). Of these fish, 209 (17%) were first detected at PIT 1 (downstream from the release location, Figure 4). The median time to first detection for these 209 fish was 11 h, but the range encompassed the entire range of times to first detection for all releases to the LPS (5 min to 43 d, Figure 15). The longest times to first detection occurred at the end of the study period, and fish with these longer times were those that re-ascended the LPS after initially falling back downstream and out of the structure (n = 28, Figure 15).

Fish that were not first detected at PIT 1 were either never detected after release ($n = 133$), had unknown first-detection times ($n = 18$), or were first detected upstream from their release location: 830 (68 %) at PIT 2, 13 at PIT 3 and 17 at PIT 4. The median time to first detection for fish first detected at PIT 2 was 4.6 h (range 0.5-22.1 h; Figure 15).

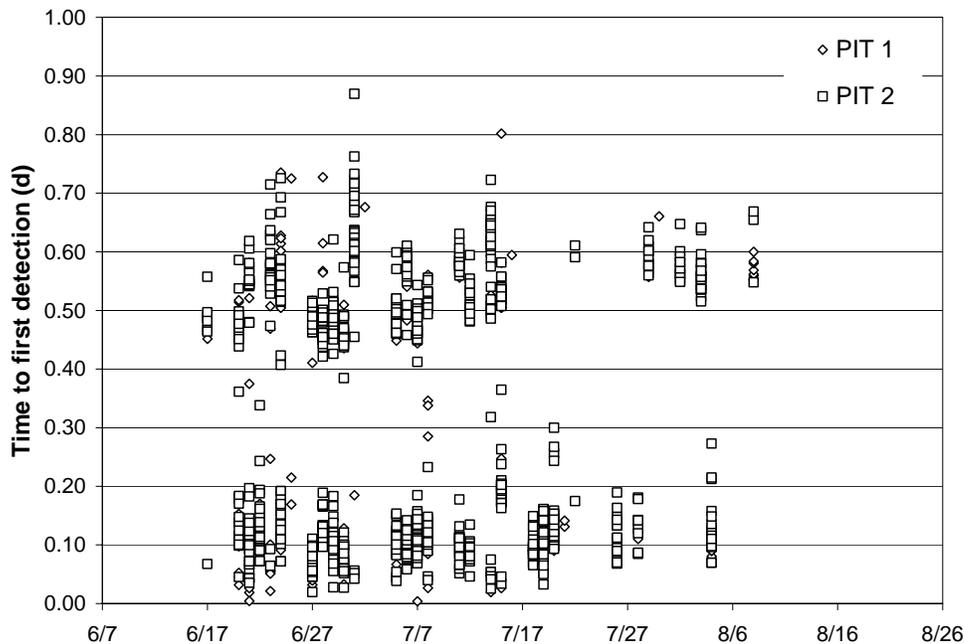
Figure 16. Days from release to first detection at PIT 1 and PIT 2 for PIT-tagged lamprey released into the LPS and first detected less than 1 day after the release date (x-axis).

A bimodal distribution was apparent among the times to first detection; fish released in the evening were detected within a few hours (median = 2.7 h) of release, while those released in the morning were detected after 12-16 h (median 12.7 h; Figure 16). Three fish that were first detected at PIT 2 were subsequently detected at PIT 1 (i.e., they fell back downstream). Of these, two reascended the LPS (noted above), and one was never detected again.

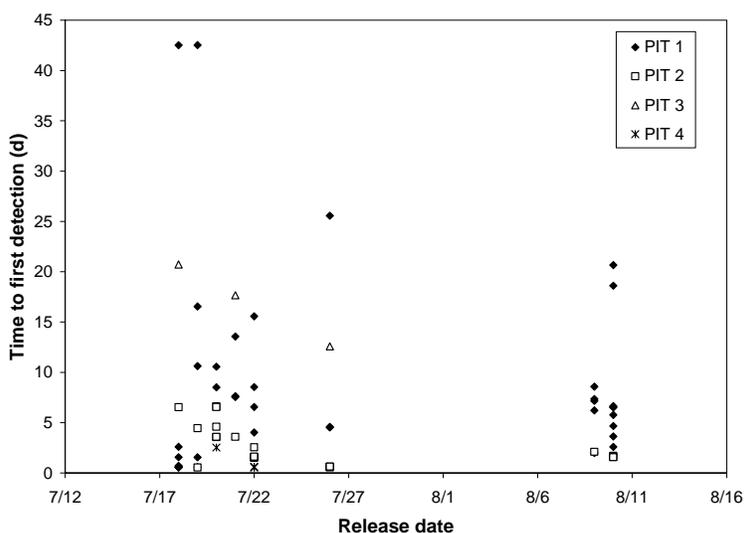
Figure 17. Days from release to first detection at PIT 1, PIT 2, PIT 3, and PIT 4 for PIT-tagged lamprey released into the AWS.

For fish released directly into the AWS channel, time from release to first detection ranged from 0.5 to 42.5 d (median 4.2 d; Figure 17). Most of these fish were first detected at PIT 1 (n = 39); however, 22 were first detected at PIT 2, 4 at PIT 3, and 3 at PIT 4 (Figure 17). Lamprey from 8 of the 9 AWS release groups were detected in the LPS (no lamprey from the last AWS release group was detected in the LPS; Figure 17).

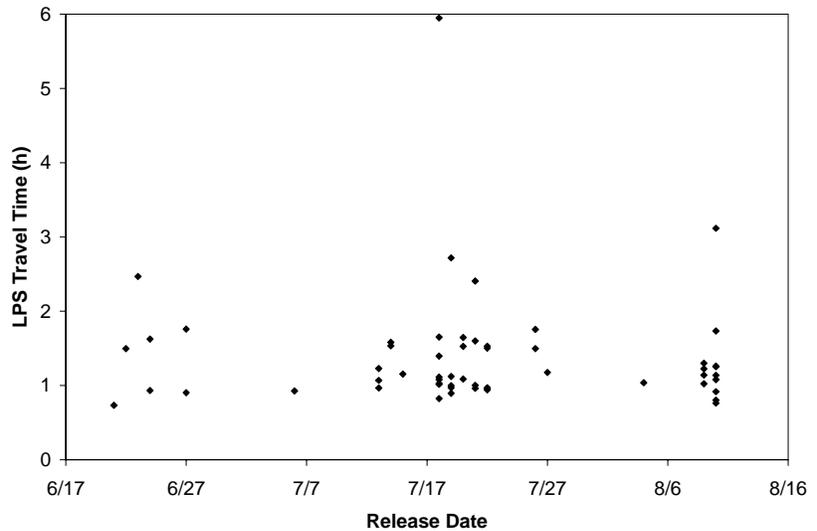
Figure 18. Time (h) that PIT-tagged lamprey took to travel through the LPS (PIT 1 to PIT 4) after entering from the AWS channel.

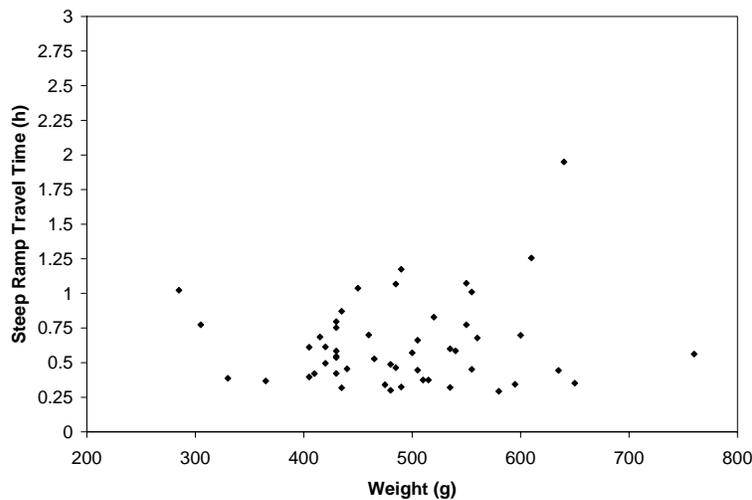
Figure 19. Time (h) that PIT-tagged lamprey took to ascend the steep ramp (PIT 1 to PIT 2) in relation to lamprey weight (g).

Regression analysis indicated no relationship between release date and the time to traverse the shallow sections (PIT 2 to PIT 4), the steep section (PIT 1 to PIT 2), or the entire LPS (PIT 1 to PIT 4, Figure 18). Lamprey length and girth were not significant factors in any of the regression analyses. However, heavier lamprey took longer to ascend the LPS from PIT 1 to PIT 4, and the effect of weight was most apparent when regressed against the time to ascend the steep ramp (PIT 1 to PIT 2, Figure 19). Lamprey weight had no significant effect on the travel times in the shallow and straight sections of the LPS (PIT 2 to PIT 4, Figure 20).

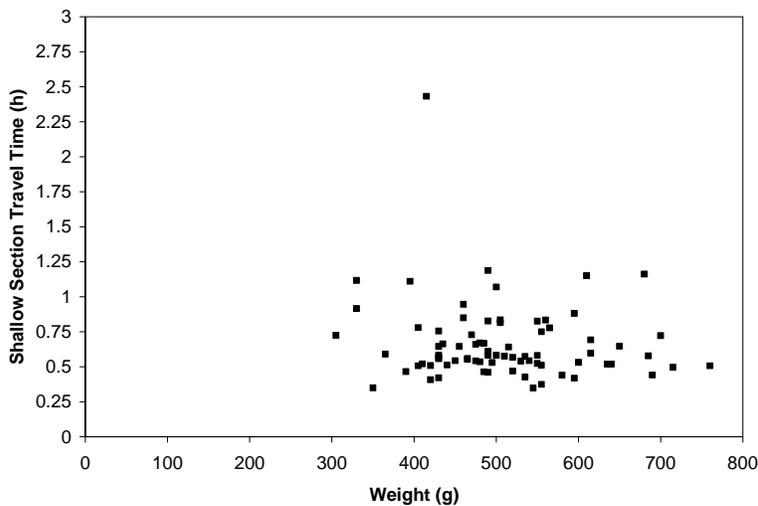
Figure 20. Time (h) PIT-tagged lamprey took to travel from PIT 1 to PIT 2 (shallow section) after entering from the AWS channel in relation to lamprey weight (g).
