# **PUBLIC NOTICE**

## **for PERMIT APPLICATION**

Corps of Engineers Action ID: NWP-1999-727

LAUNCH WAY CAPACITY INCREASE & PIER REPAIR  
WILLAMETTE RIVER MILE 9  
MARCH 2008

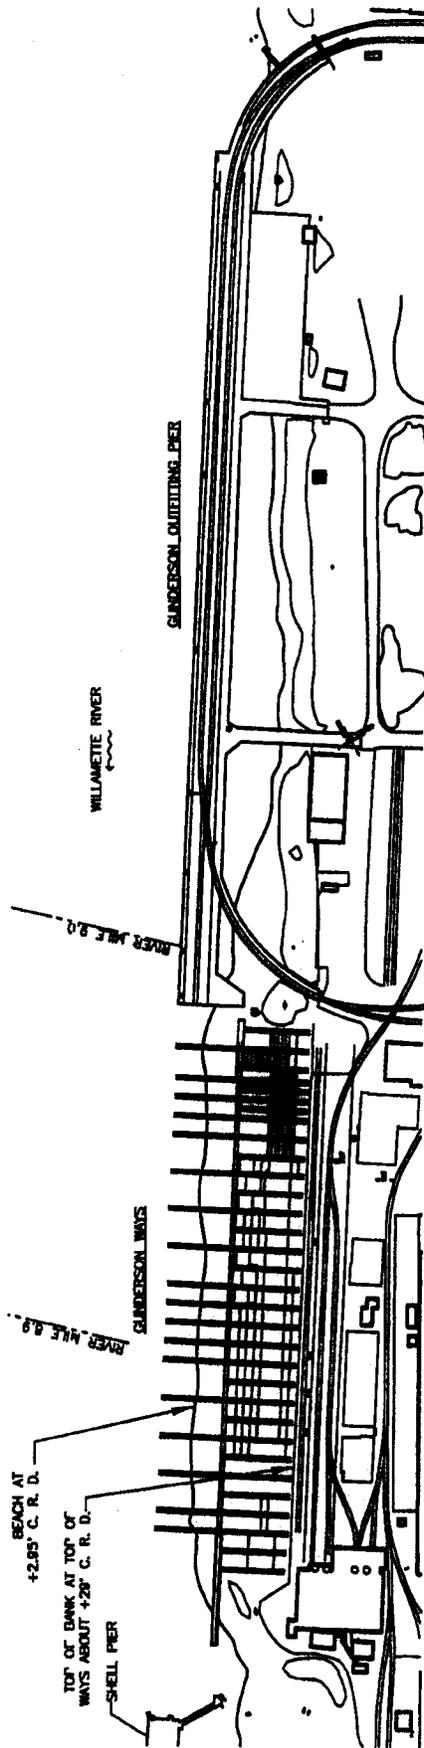
**SITE PLAN**  
 Scale: 1" = 240'

LAUNCH WAY CAPACITY INCREASE & PIER REPAIR  
 WILLAMETTE RIVER MILE 9  
 MARCH 2008

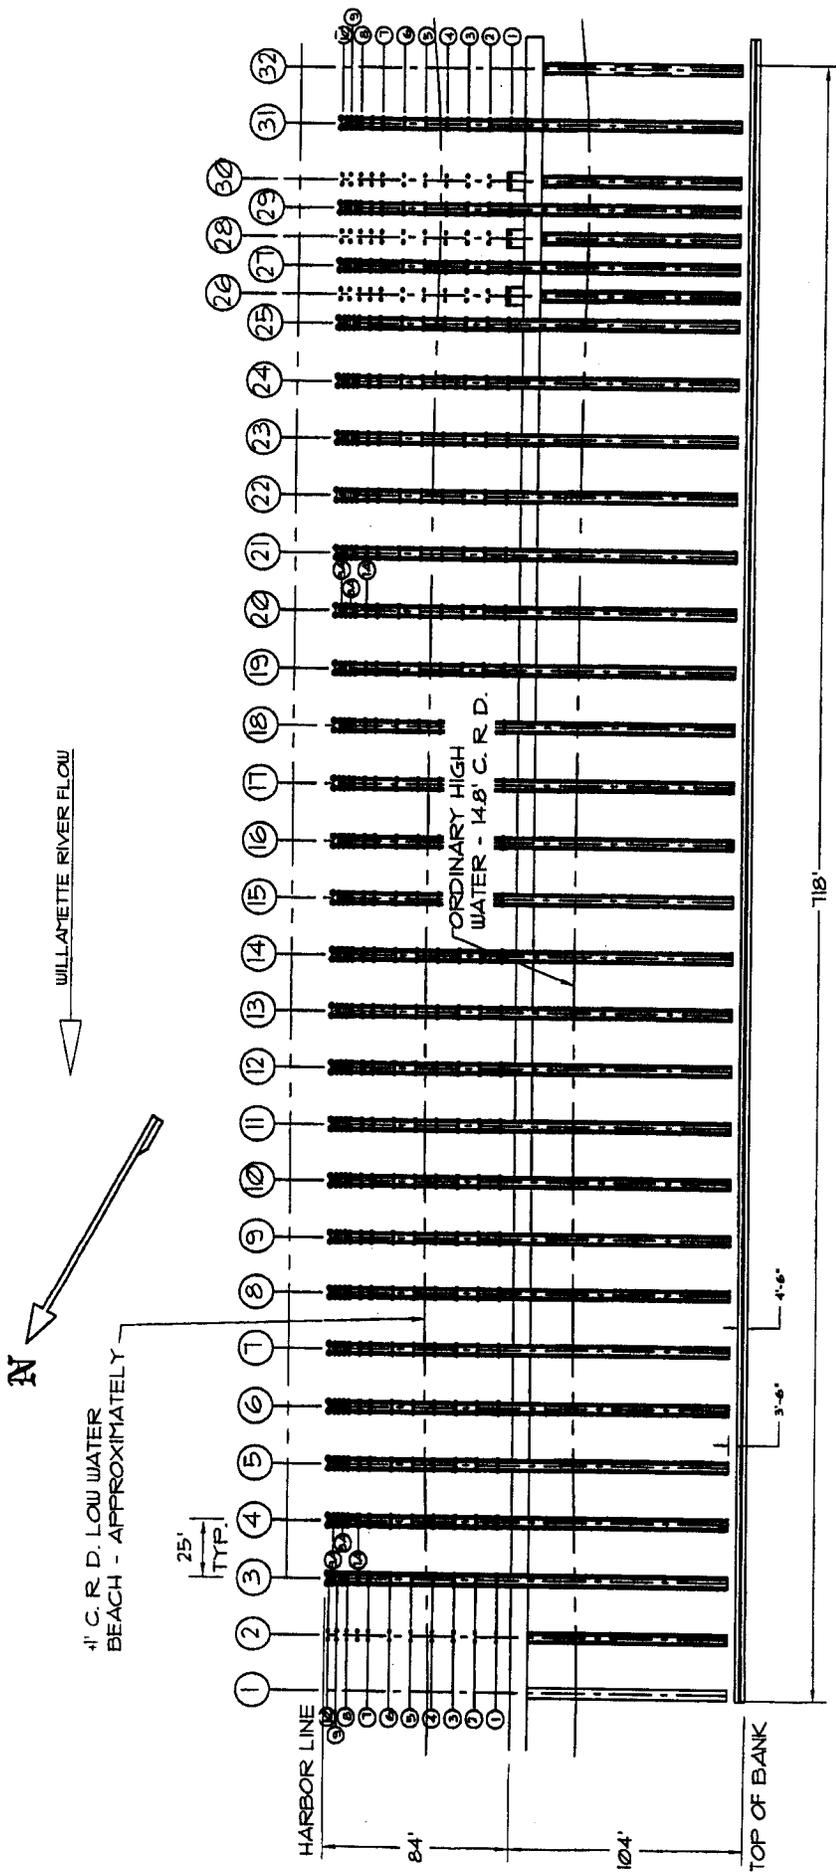
**LAUNCHWAYS AFTER 2008**  
**CAPACITY INCREASE & PIER REPAIR**  
**SCALE: 1" = 80'**

LAUNCH WAY CAPACITY INCREASE & PIER REPAIR  
 WILLAMETE RIVER MILE 8.9  
 MARCH 2008

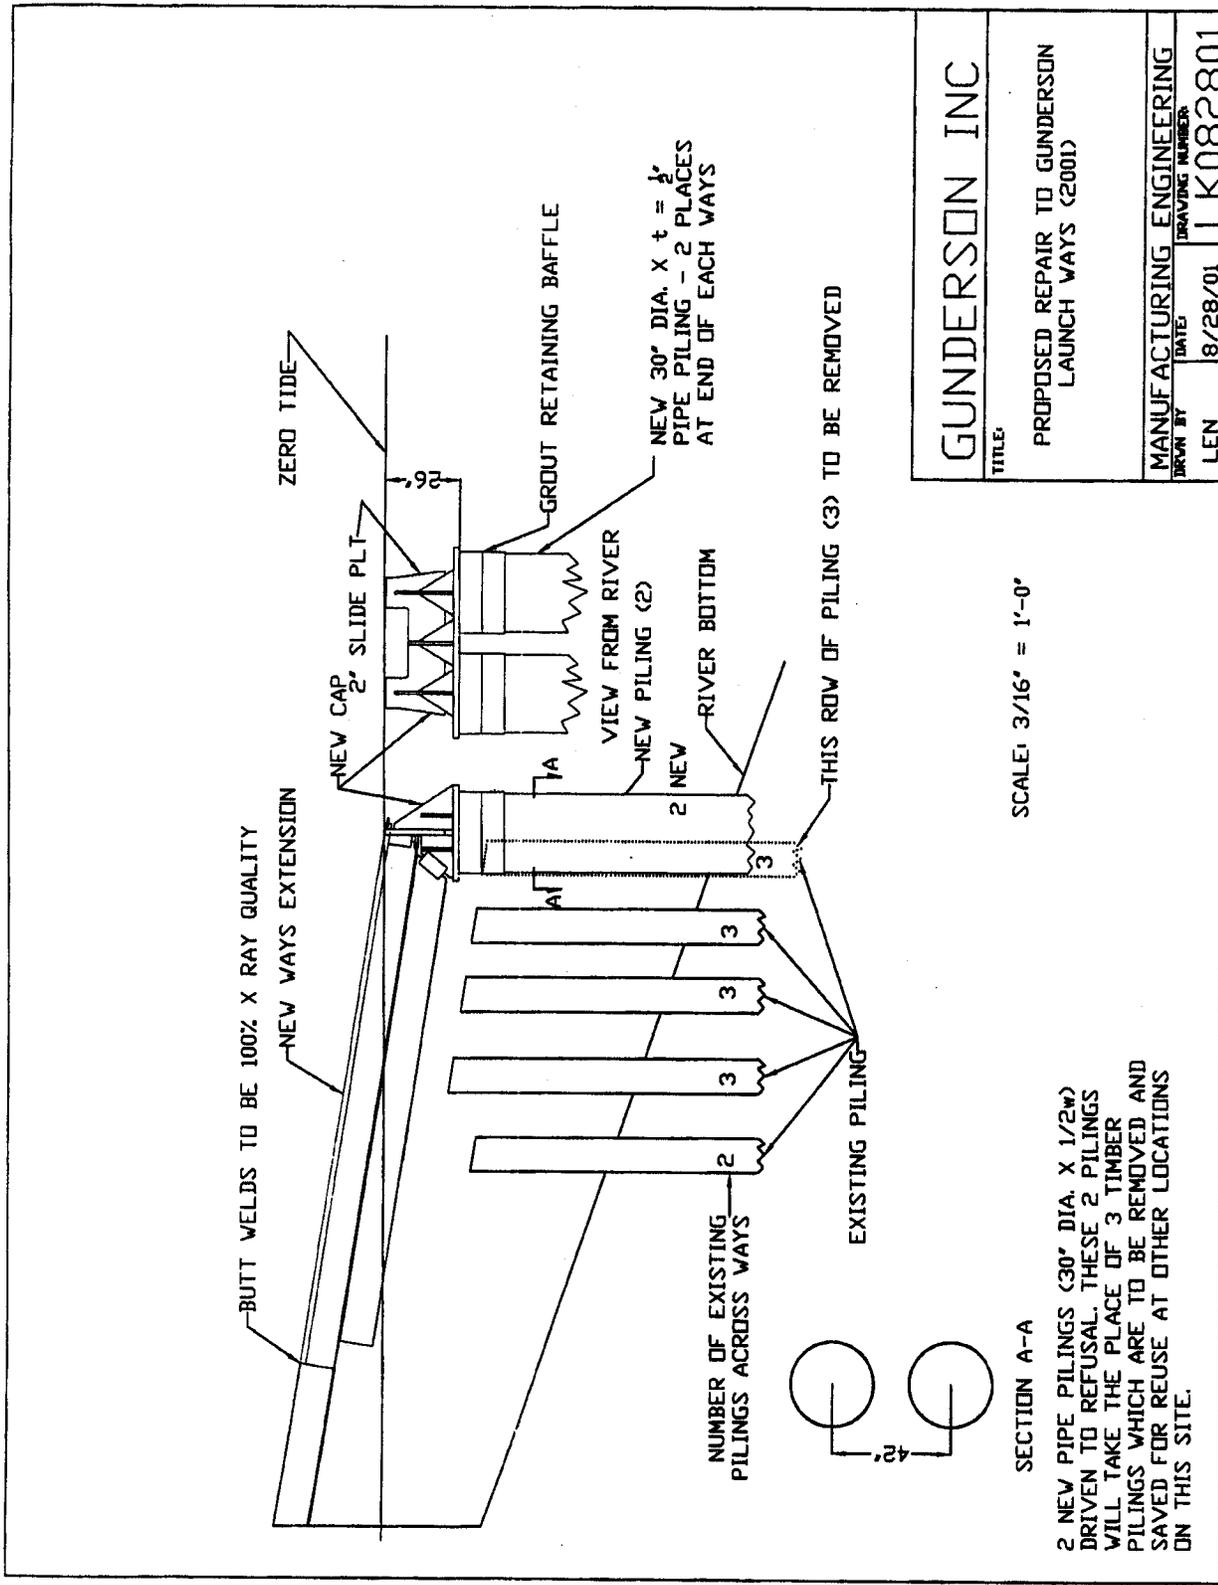
<b>GUNDERSON INC</b>	
TITLE: PROPOSED REPAIR TO GUNDERSON LAUNCH WAYS (2001)	
MANUFACTURING ENGINEERING	DRAWING NUMBER: LK082801
BY: LEN	DATE: 8/28/01

2 NEW PIPE PILING (30" DIA. X 1/2") DRIVEN TO REFUSAL. THESE 2 PILING WILL TAKE THE PLACE OF 3 TIMBER PILING WHICH ARE TO BE REMOVED AND SAVED FOR REUSE AT OTHER LOCATIONS ON THIS SITE.

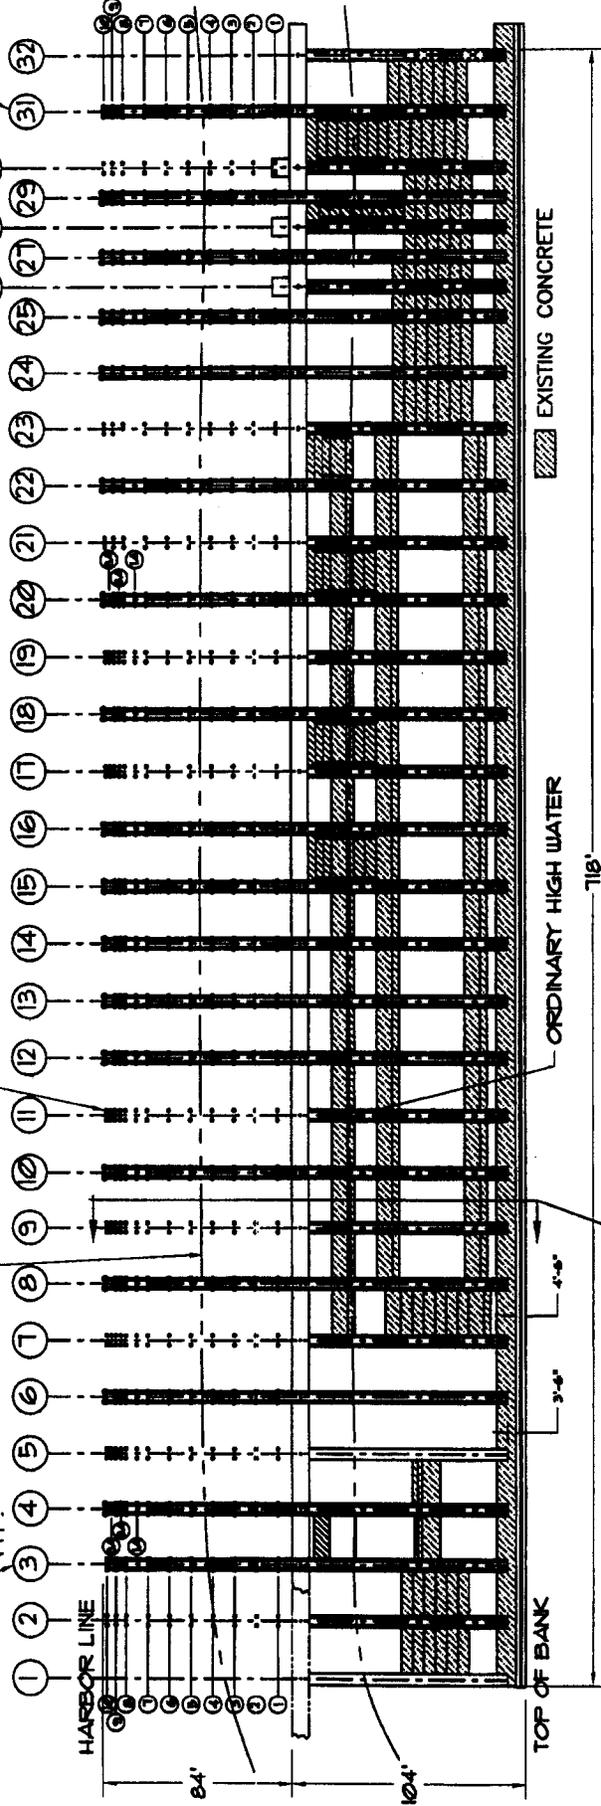
PLAN OF WAYS

7 of 23  
 LAUNCH WAY CAPACITY INCREASE  
 PAVING BETWEEN LAUNCHWAYS  
 WILLAMETTE RIVER MILE 8.9  
 MARCH 2008

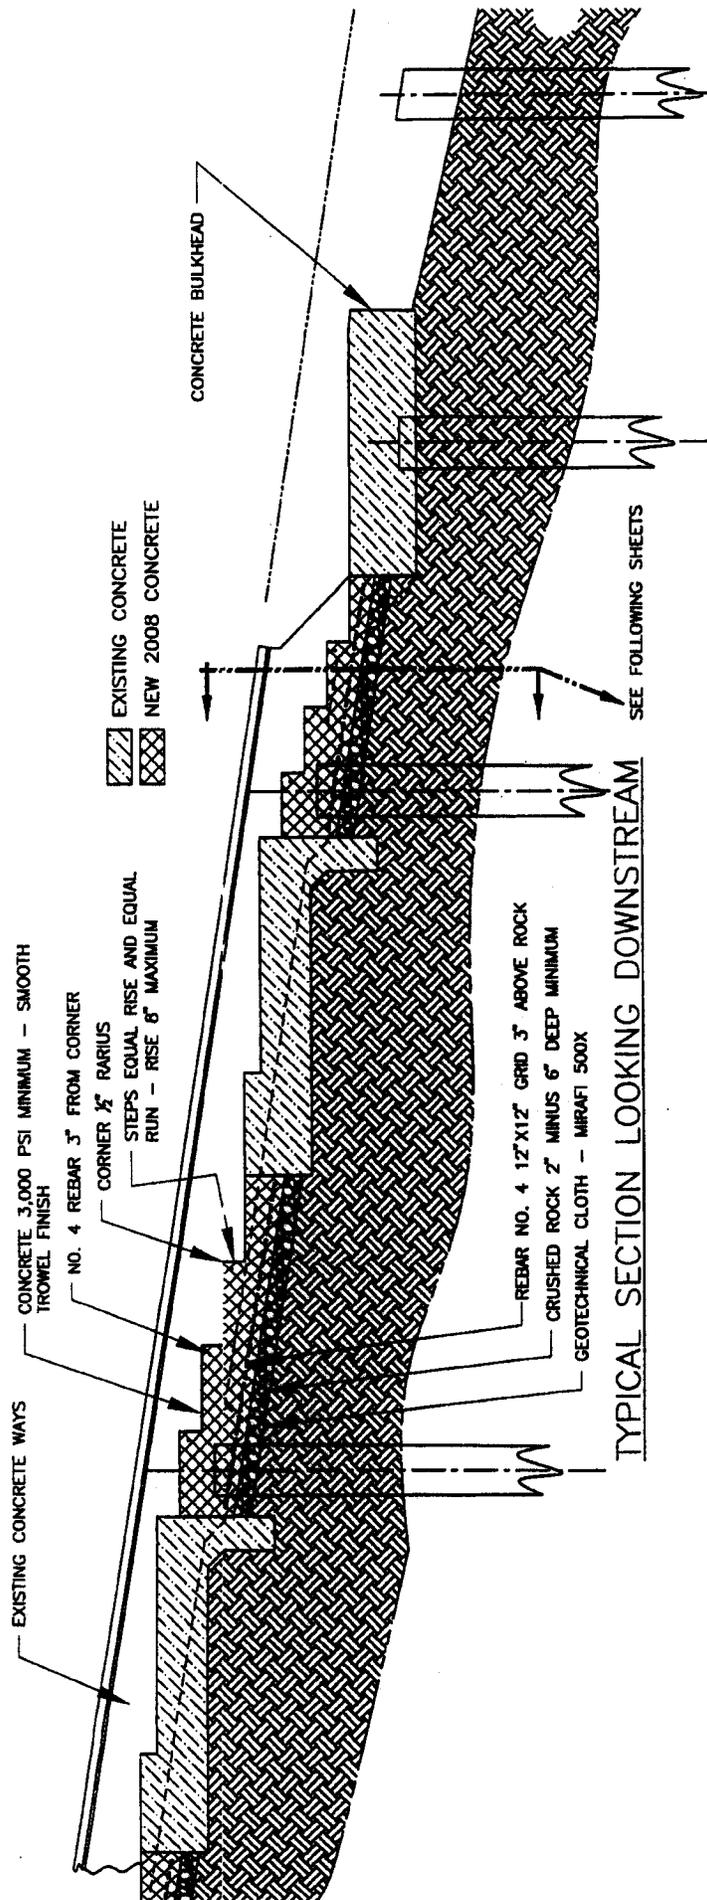
DETAILS - COMPLETED CONCRETE BETWEEN LAUNCHWAYS

TYPICAL SECTION LOOKING DOWNSTREAM

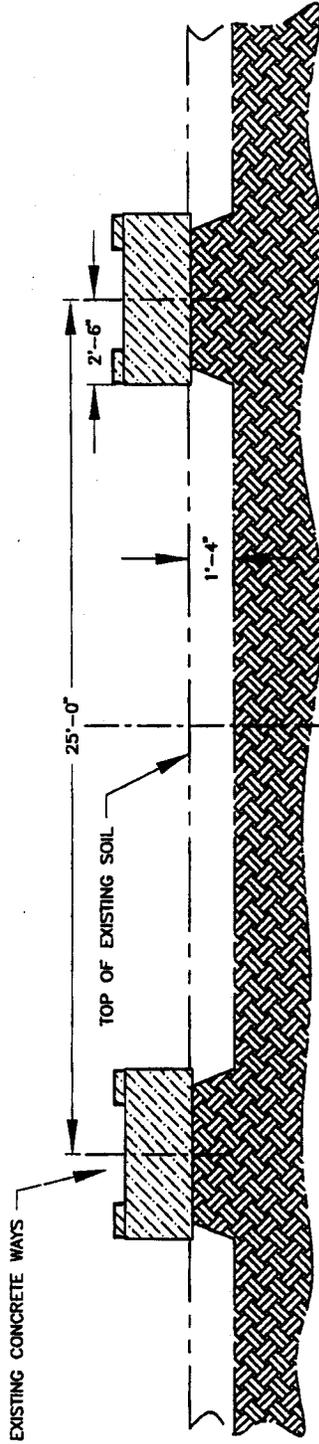
DETAIL - EXCAVATION BETWEEN THE WAYS

SECTION SHOWING REMOVAL OF TOPSOIL

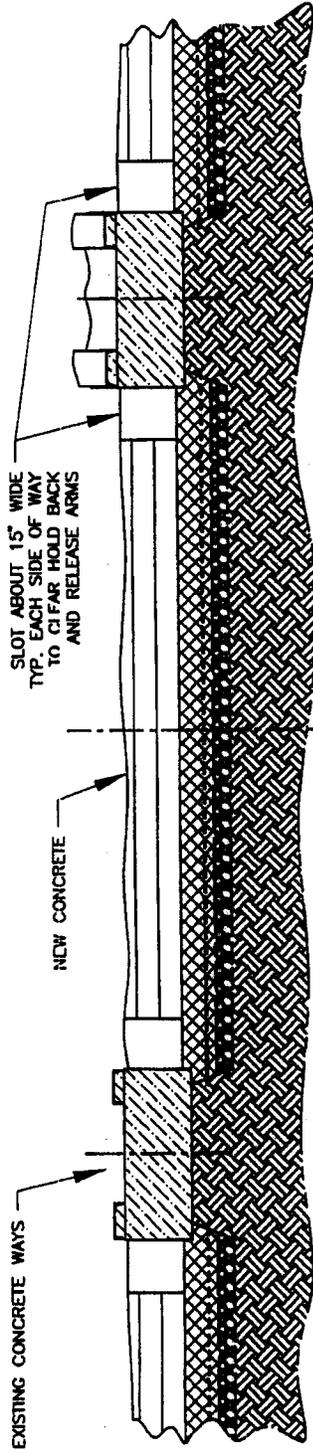
DETAIL - SHOWING NEW CONCRETE AND ROCK  
 SCALE: 3/16" = 1'-0"

SECTION SHOWING NEW CONCRETE AND ROCK

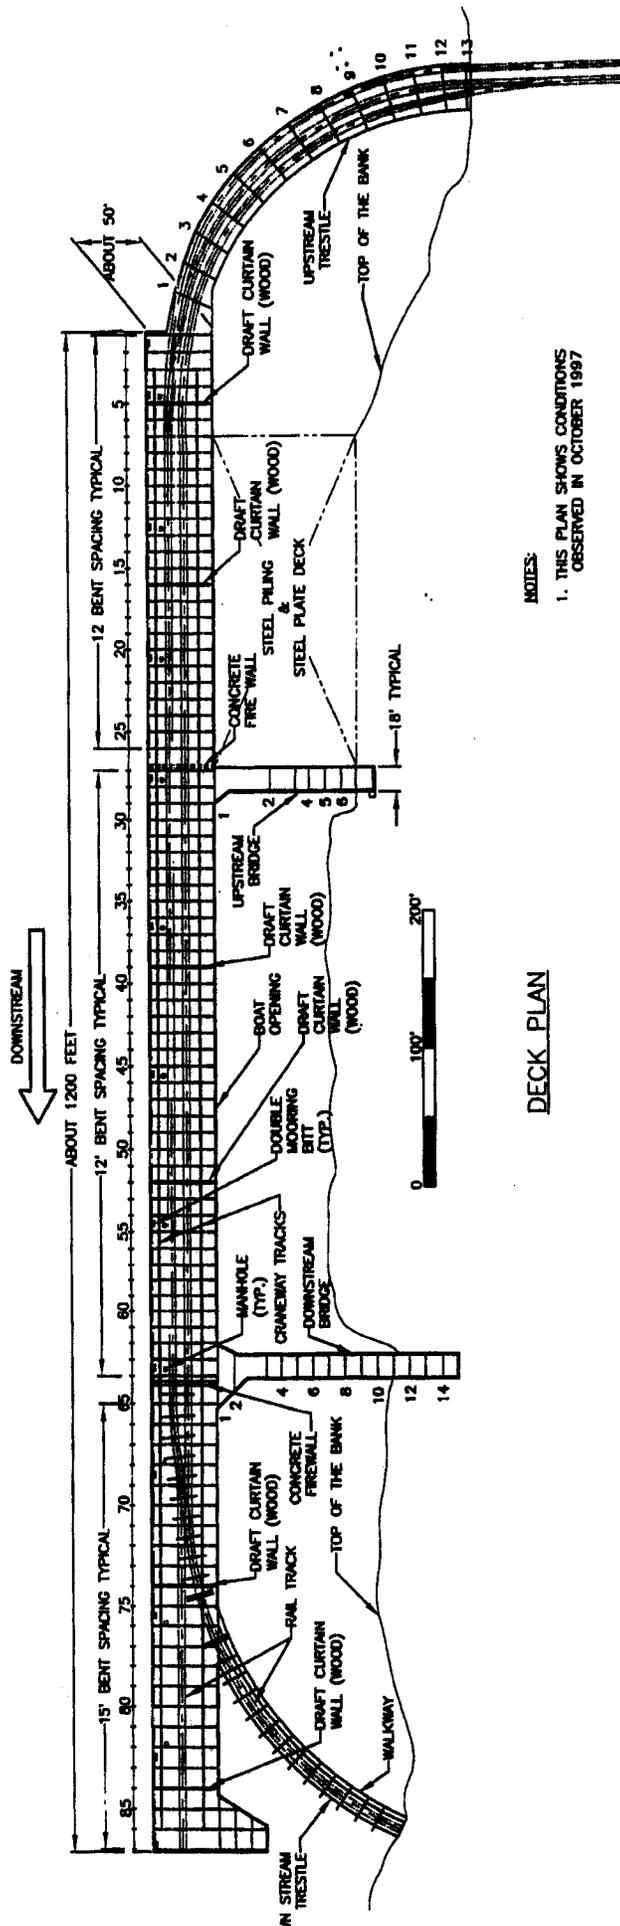
DECK PLAN

NOTES:  
 1. THIS PLAN SHOWS CONDITIONS OBSERVED IN OCTOBER 1997

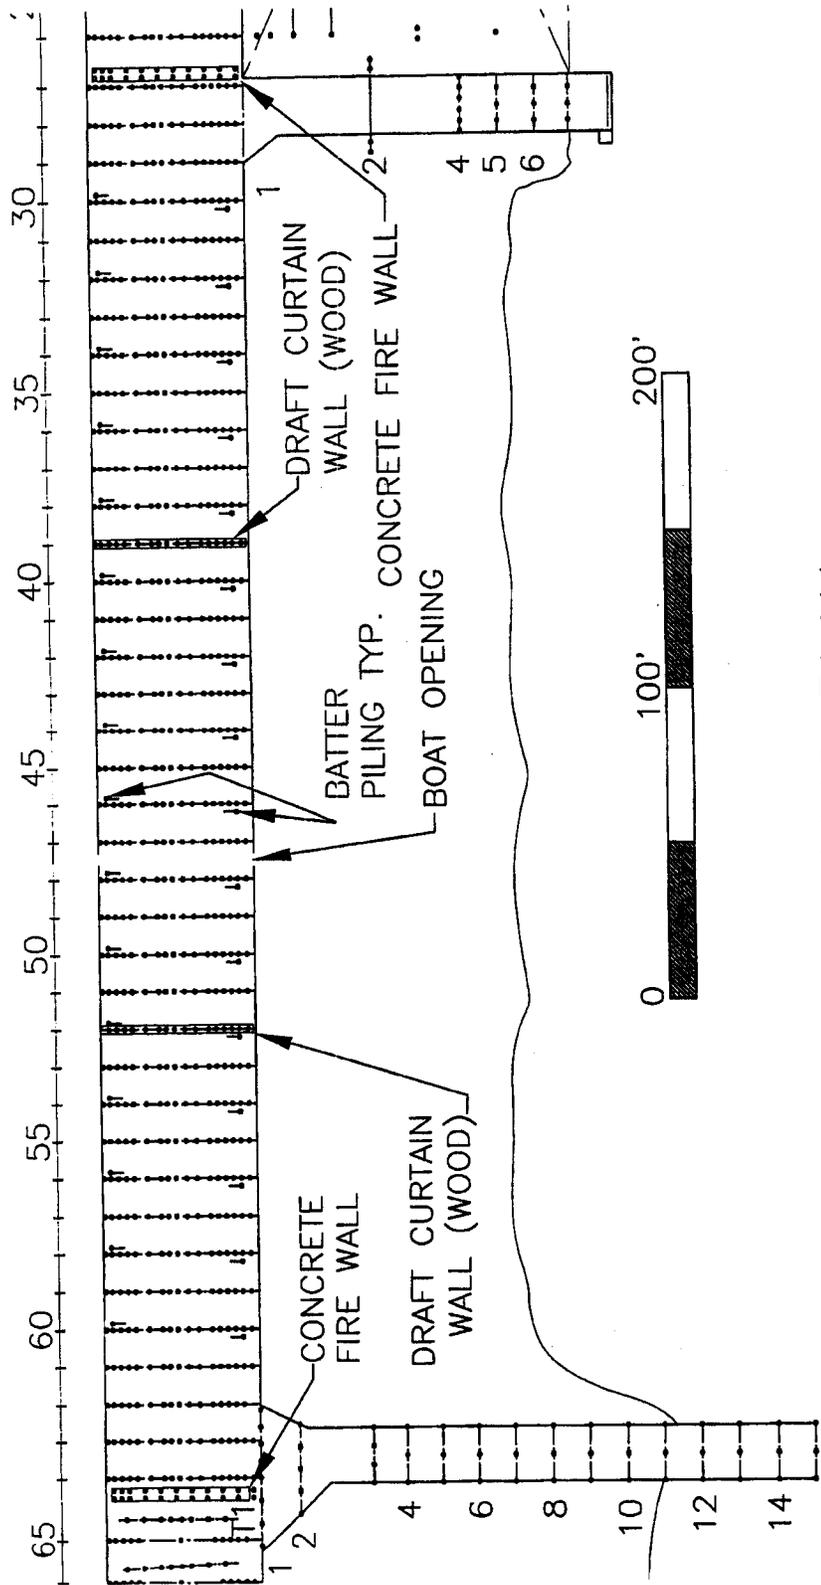
PILING PLAN

FENDER PILES ARE NOT SHOWN:

FENDER PILES ARE BASICALLY IN LINE WITH EACH BENT

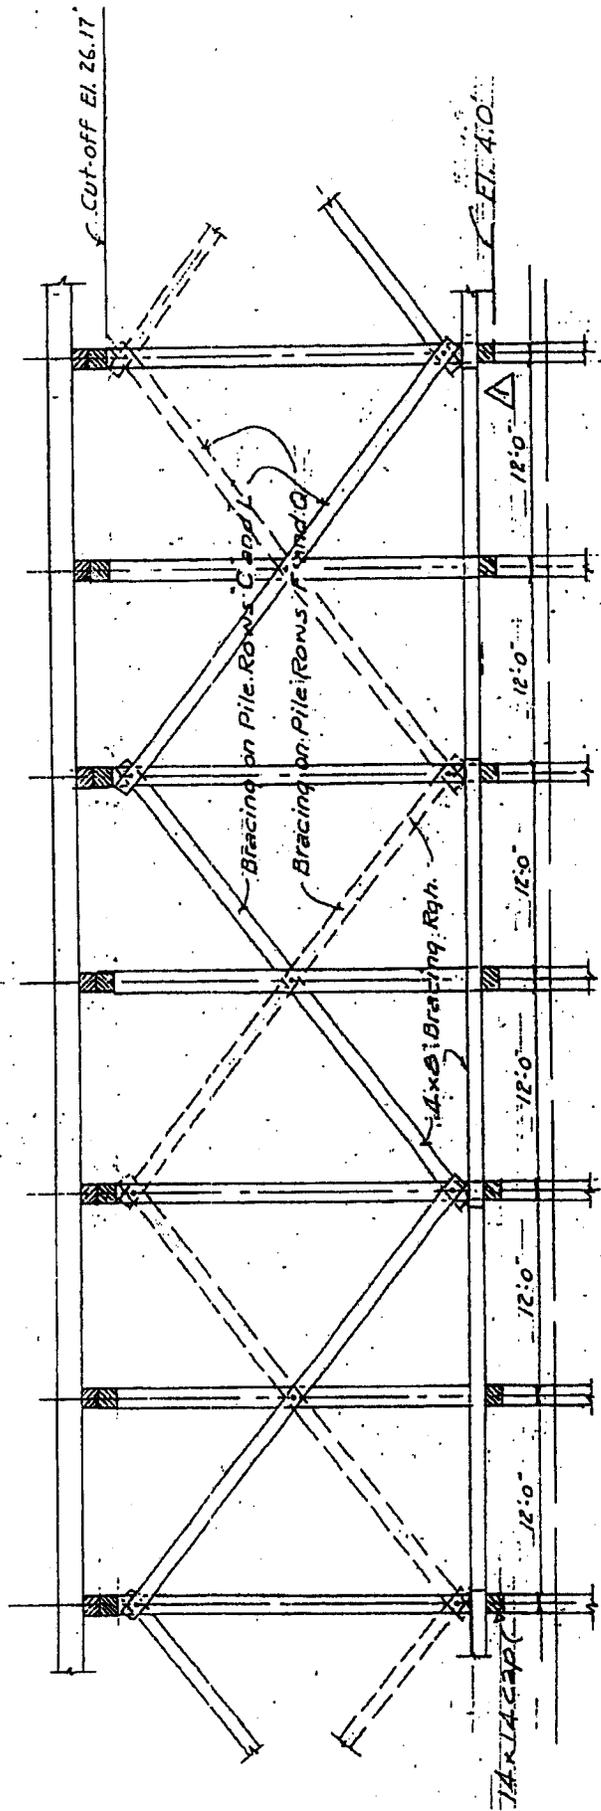
*LONGITUDINAL TOWER BRACING DETAIL (DOCK)*

LONGITUDINAL SECTION

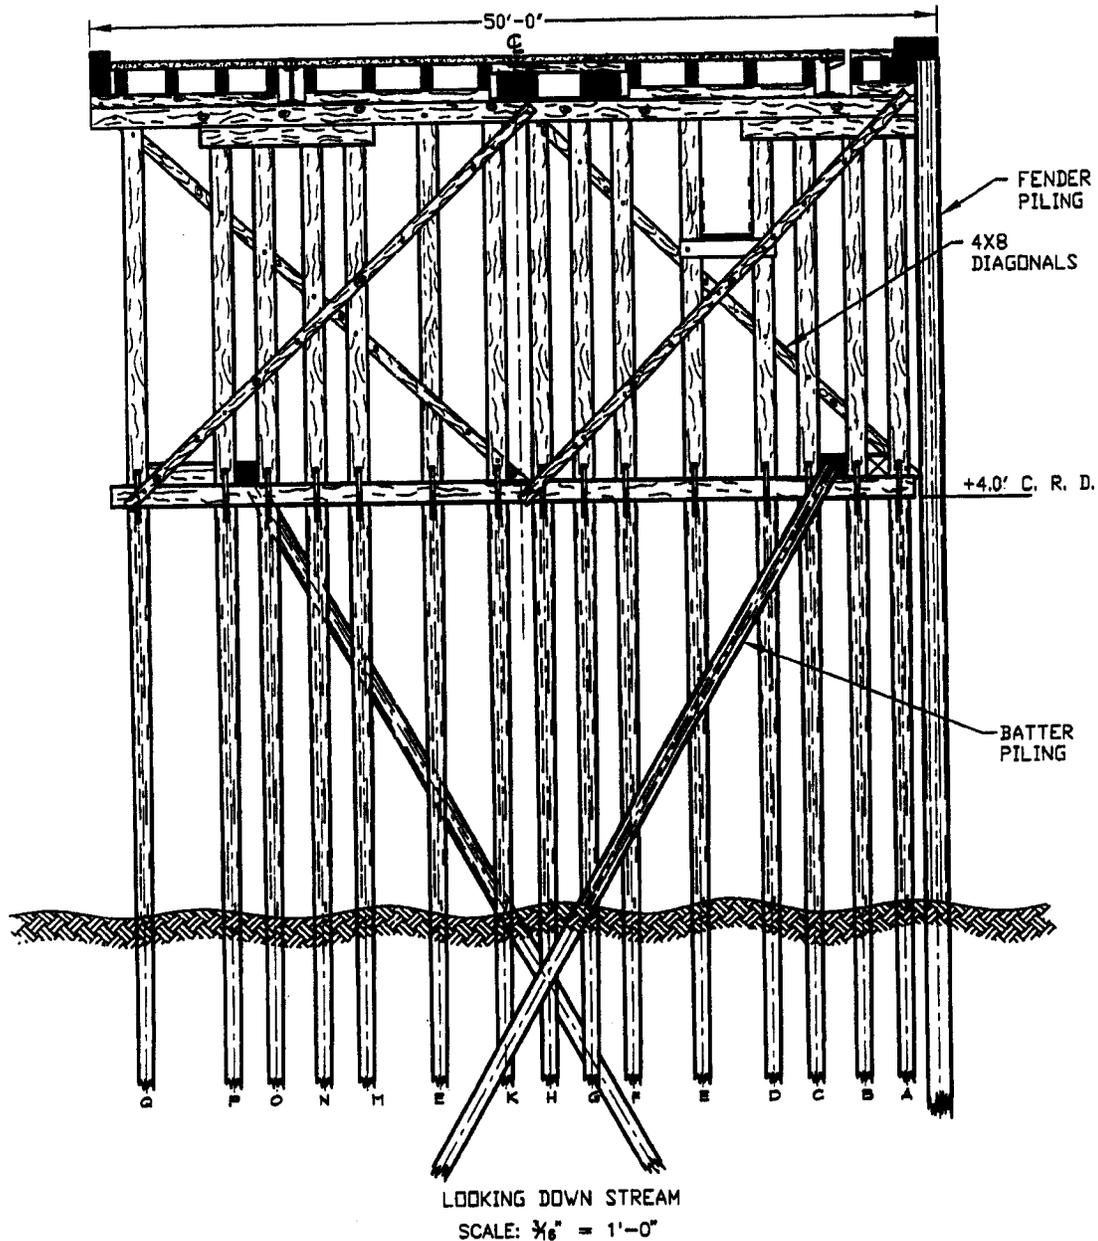
## TRANSVERSE SECTION

OUTFITTING PIER REPAIR  
 TYPICAL EXISTING BATTER PILING  
 BENT 82 SHOWN  
 WILLAMETE RIVER MILE 9  
 MARCH 2008

Batter piles are installed at every other bent along the full length of the pier. The batter piles are driven at an angle of about 50 degrees from the vertical and attached to the lower piling structure. Typical batter pilings are shown on Project Drawing Sheet 22. The batter piles prevent the pier from swaying sideways. The batter pilings are untreated round wood pilings they are fastened to the lower pier structure with round pins and bolts. The tops of all the batter pilings have rotted making the connections inefficient. Approximately 44 existing batter pilings are to be repaired.
