Figure 1. Location Map, USCG SARDET Rogue River, Curry County, Oregon (Rogue ODMDS Zone of Siting Feasibility basemap)

**ROGUE RIVER,
OREGON**

COAST GUARD STATION

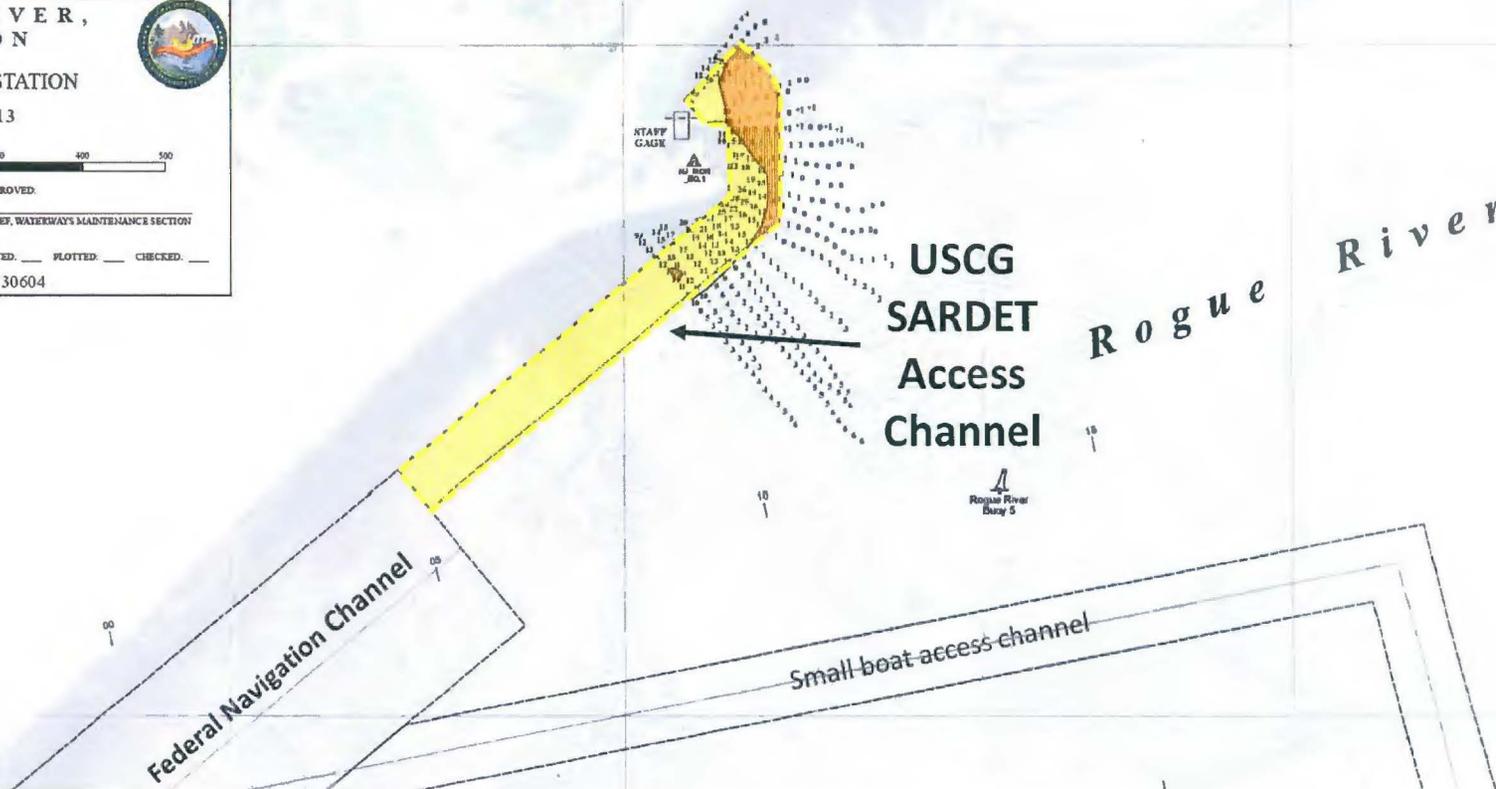
Revised Figure 4. Site Plan with revised dredge limits in yellow.

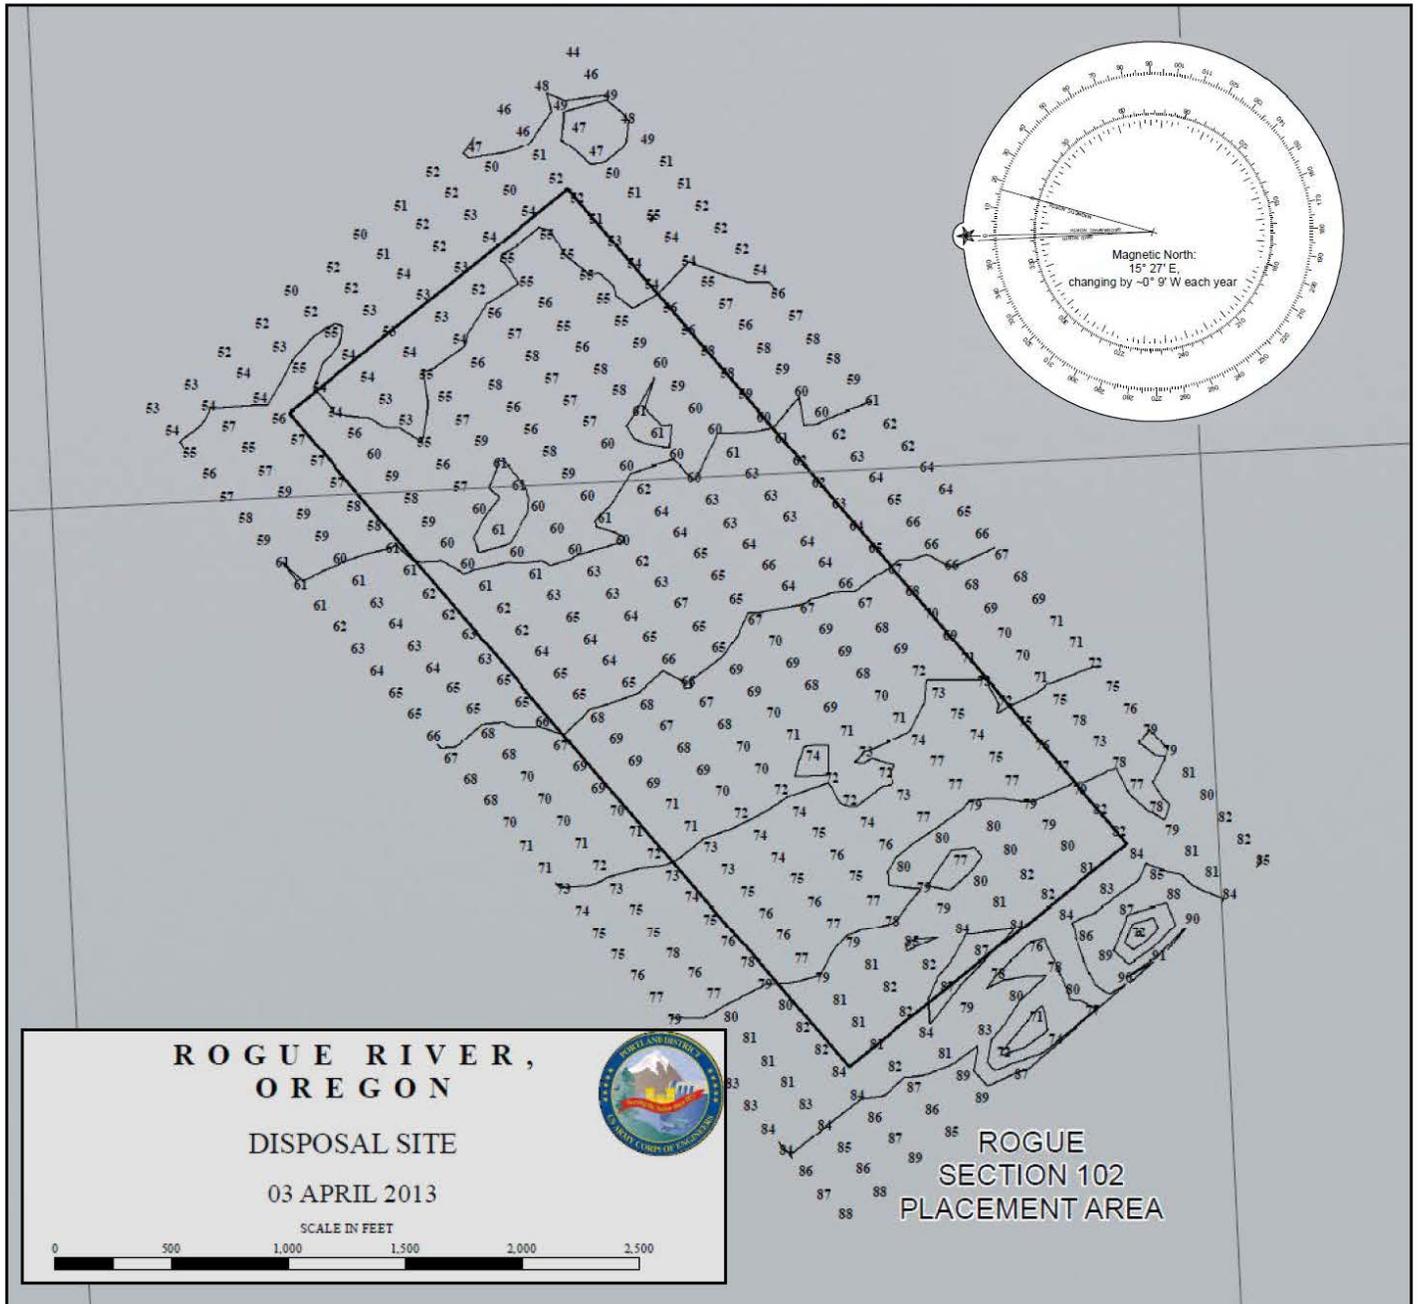
DISPOSAL SITE

03 APRIL 2013

Figure 6. Rogue River Ocean Dredged Material Disposal Site (USACE condition survey, 03 April 2013)
