DEPOE BAY SEDIMENT QUALITY EVALUATION REPORT

February 2005

**Portland District
Corps of Engineers
CENWP-EC-HR**

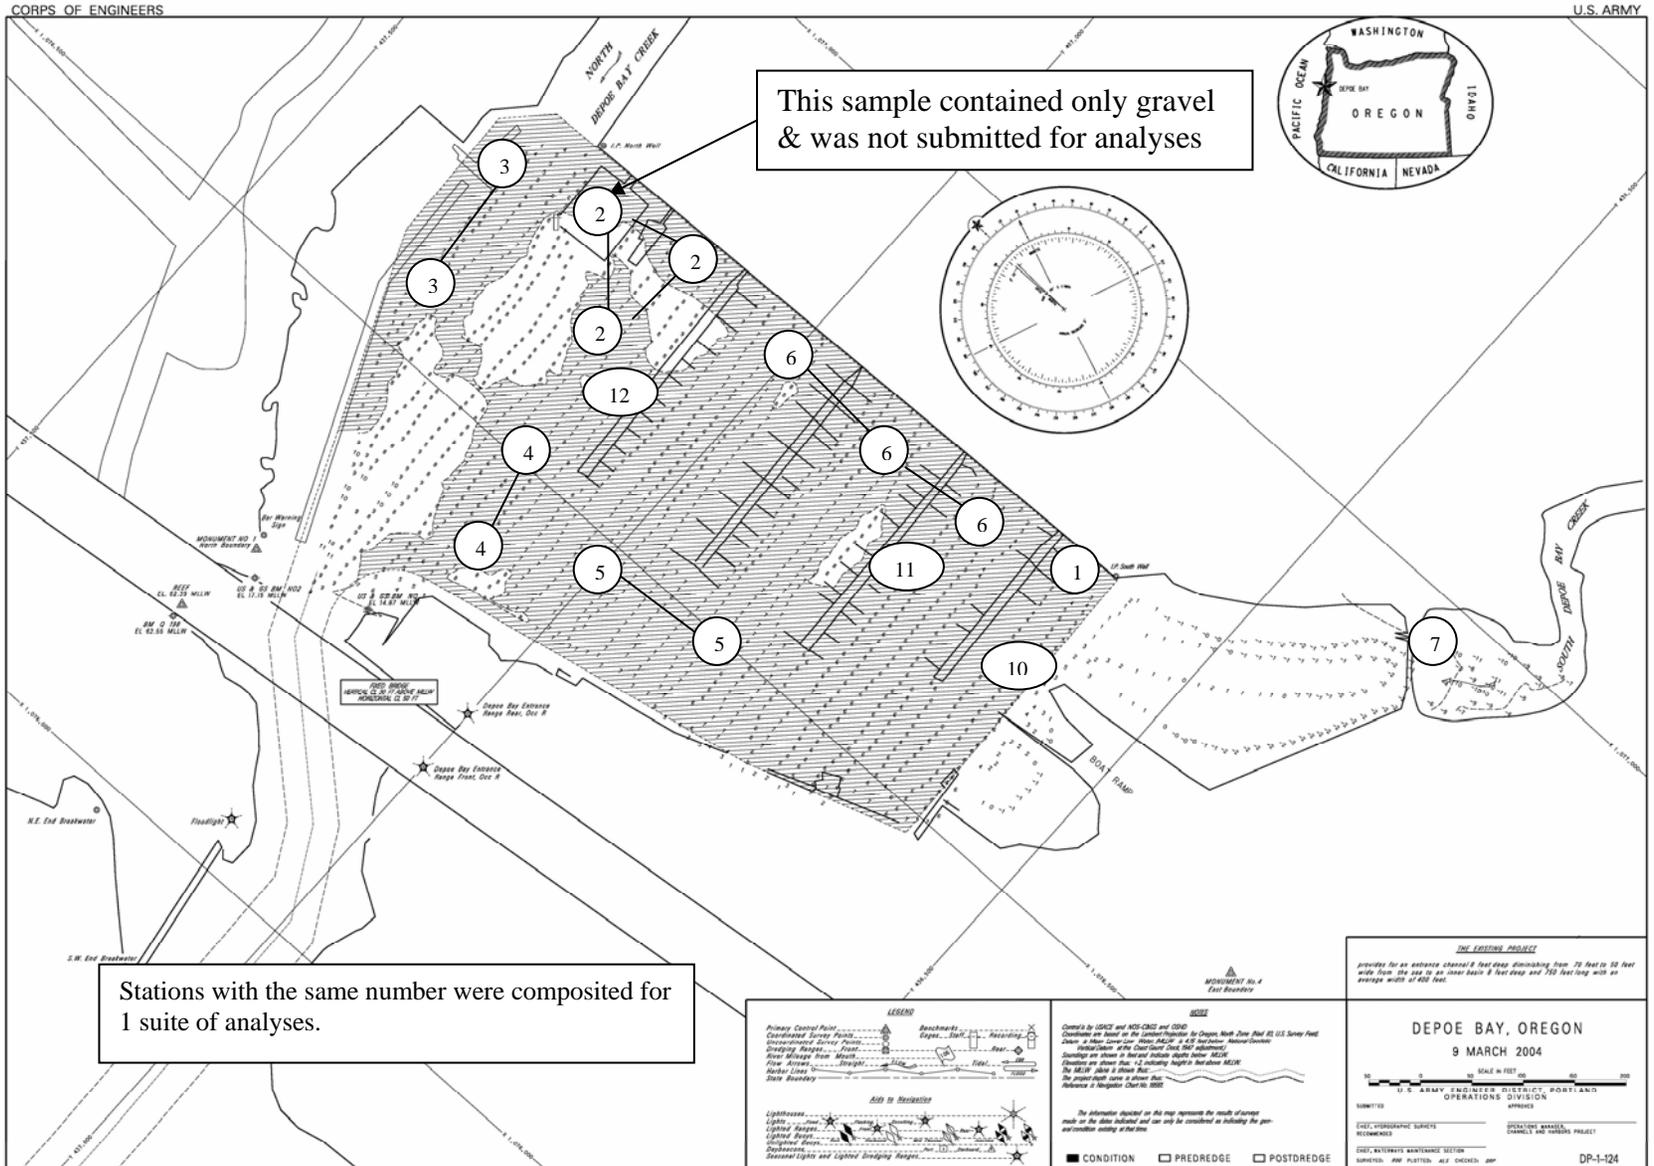
Figure 2: Depoe Bay, Sediment Sampling Station Locations

<https://www.nwp.usace.army.mil/op/n/wh/coastal/dbint.pdf> (Link to latest hydrosurvey map.)

The March 2004 hydrographic survey was the latest available to determine the depth of the dredging prism within Depoe Bay at the time of this sampling event; go to the following link to view the February 2, 2005 survey <https://www.nwp.usace.army.mil/op/n/wh/coastal/dbint.pdf>. Sample target locations and the compositing scheme have been selected, based on hydrosurvey results, from select locations within Depoe Bay, with one additional, 3 sample composite sample, collected behind the sediment retention dam (see Figure 2). Where the dredging prism was determined to be <3-feet in depth a Ponar boxcoring sampler was used. In areas where the dredging prism was >3-feet, a core sample was attempted. Sample 0202DB-HC-01 and 0202DB-HC-07 were the only core samples collected, penetration of the coring tube was limited to 12" to 16" these areas were primarily sand with silt. The ability to characterize the sections of the dredging prism that exceeded the penetration of the coring device is considered adequate based on the sandy nature of the samples collected and the homogenous source of shoaling material.
